Tether Line Breaks after Damaged by Bucket Move

Incident

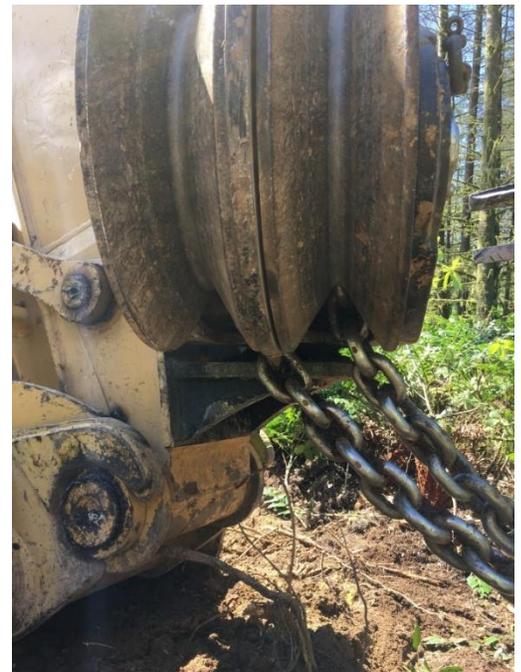
An investigation found that the flat edge of the socket could catch against the lower sheave housing when the bucket was being moved, which can cause damage to the wire rope.

Lower sheaves of base machine showing wear on the housing from socket striking.

- Always inspect cables and connections after repositioning base machine.
- Test components after repositioning the base machine before starting up work by putting the system into auto high tension and move the SSM back and forth on gentle ground while observing the line and connection points.
- Stop and thoroughly inspect lines if something unusual occurs. In this case the "popping" sound and line whip should have triggered an inspection.
- Make sure the termination point sockets are positioned so that they cannot rub or catch on the lower sheaves on the boom arm before moving the base machine or the bucket.
- Bevel the edges on the sheave so that the flat edge of the socket cannot catch on it.
- Keep line tension low and do not set the parking brake when digging in the bucket.

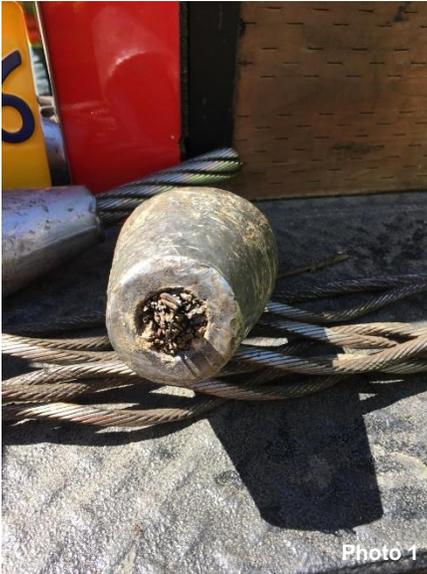
Photo 1

The 7/8” swaged wire rope tether line was severely damaged at the termination point after the socket was caught on the bucket. When the operator started to walk the steep slope machine downhill, the line broke at relatively low tension.

Photo 1. Connection socket on tether cable that broke at the point where the wire rope enters the socket.

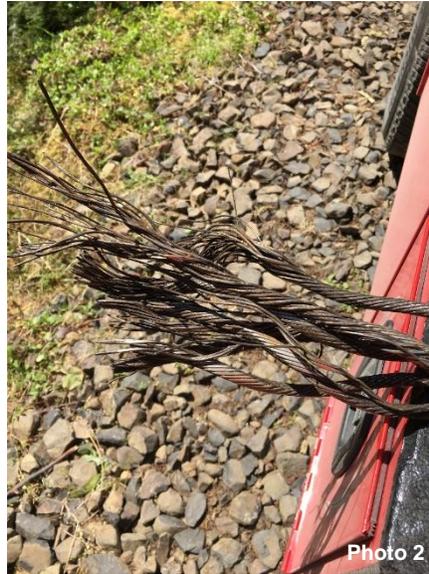
Photo 2

Photo 2. Broken 7/8" wire rope tether line.

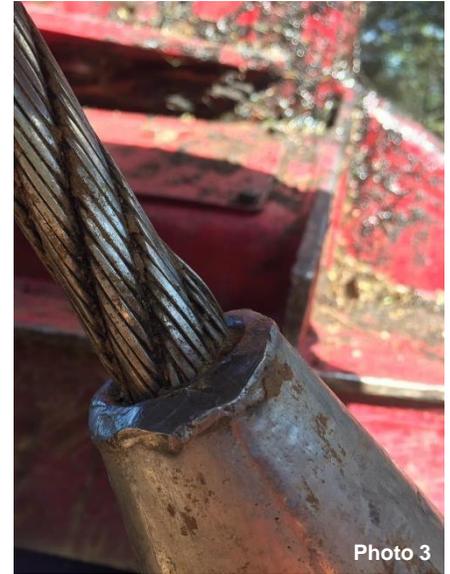
Photo 3

Photo 3. Signs of wear visible along the flat edge of the termination point socket on the second tether line that remained intact.
