Trucking Supervisor Crushed between Two Belly Dump Trailers

REPORT #: 71-172-2018s

INDUSTRY: Highway, street and bridge
construction

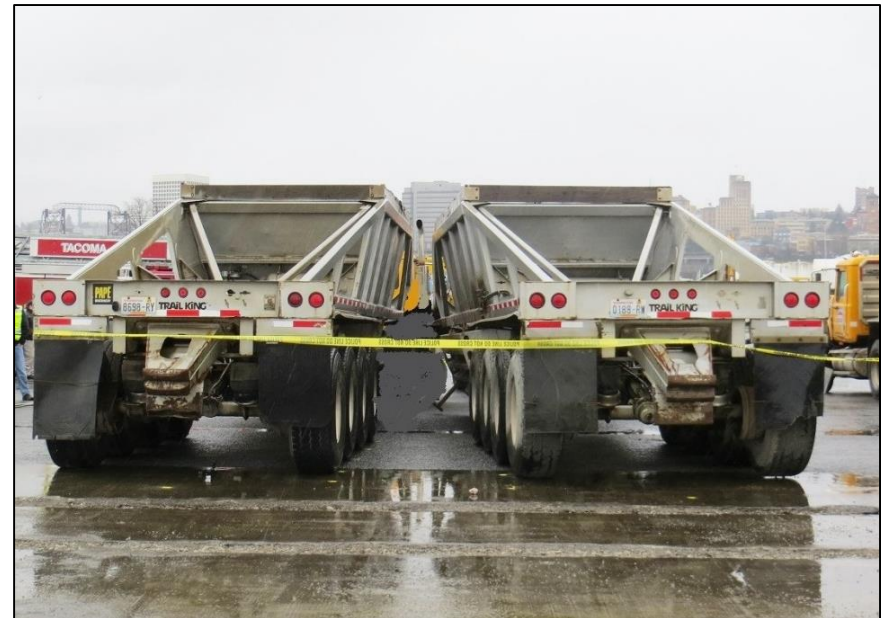
A 60-year-old construction company trucking operations supervisor was crushed while assisting a truck driver coupling a belly dump trailer to his truck when the trailer shifted.

As the truck moved forward, the kingpin, which was not properly secured, came loose from the 5th wheel jaws and slid across the 5th wheel plate, causing the trailer to shift sideways, crushing the victim between the fenders of the two belly dump trailers.

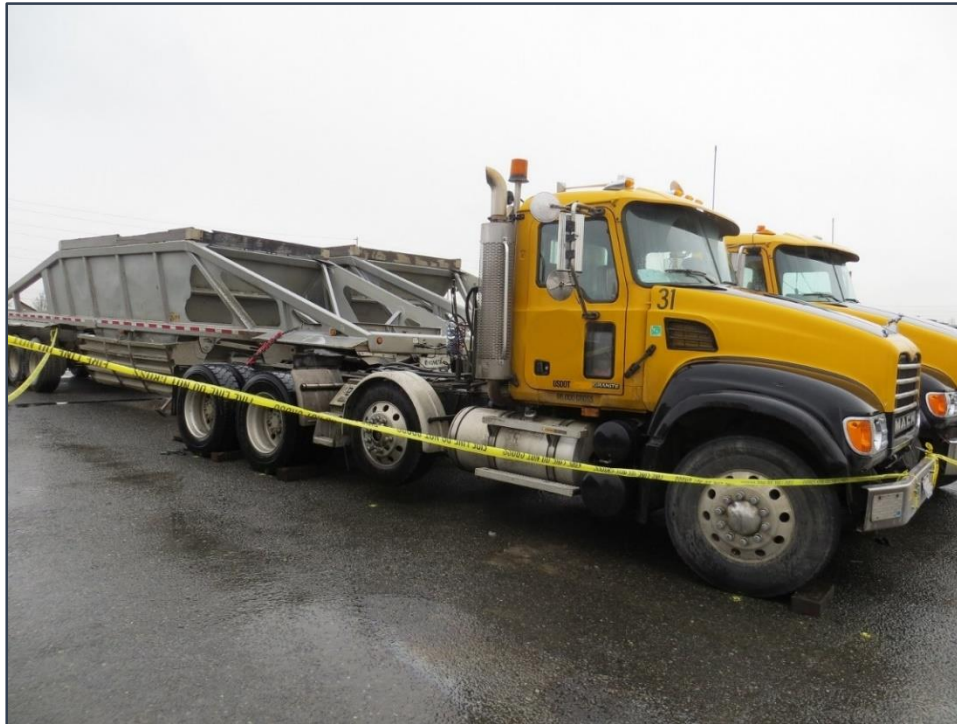
Photo 1. The incident scene with the two belly dump trailers and trucks. The truck that the victim was assisting the driver with coupling the trailer to is shown in the foreground.

- Drivers should visually confirm that the 5th wheel closes and locks on to the trailer's king pin.
- Develop and implement written safety procedures for connecting belly dump trailers that reflect the operator's manual and established best practices.
- Ensure that drivers are familiar with and know how to use the specific operational features of the trucks and trailers to which they are assigned; if they are not, then train them and observe that they are able to use them.
- Never work in tight spaces or pinch points between vehicles in motion and trailers.
- When performing duties outside of trucks, always wear an ANSI class 2 or 3 high-visibility safety vest or other safety apparel.

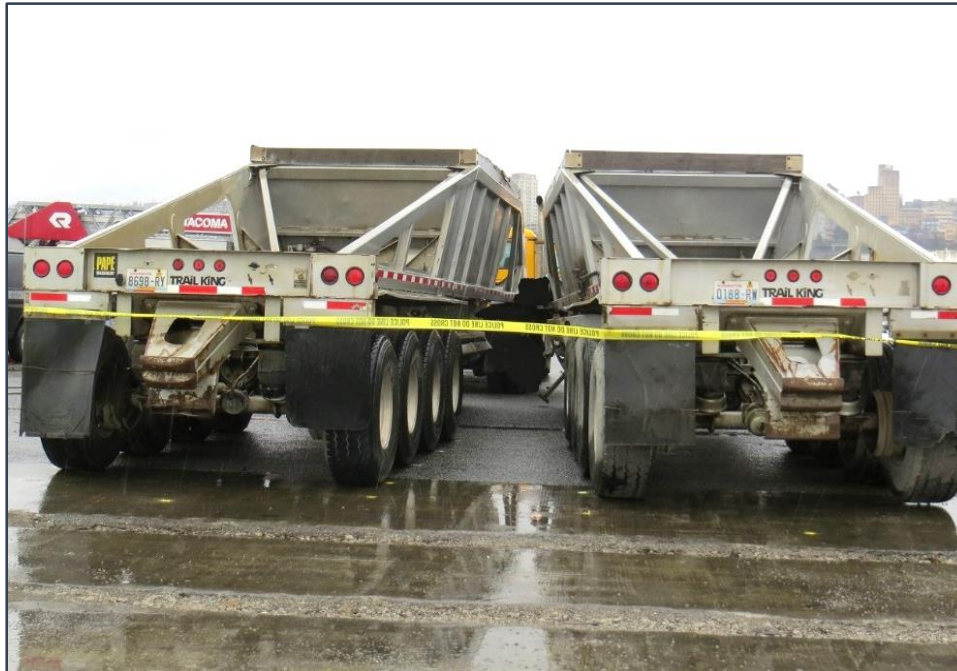
Photo 2. The incident scene showing both trailers from the rear.

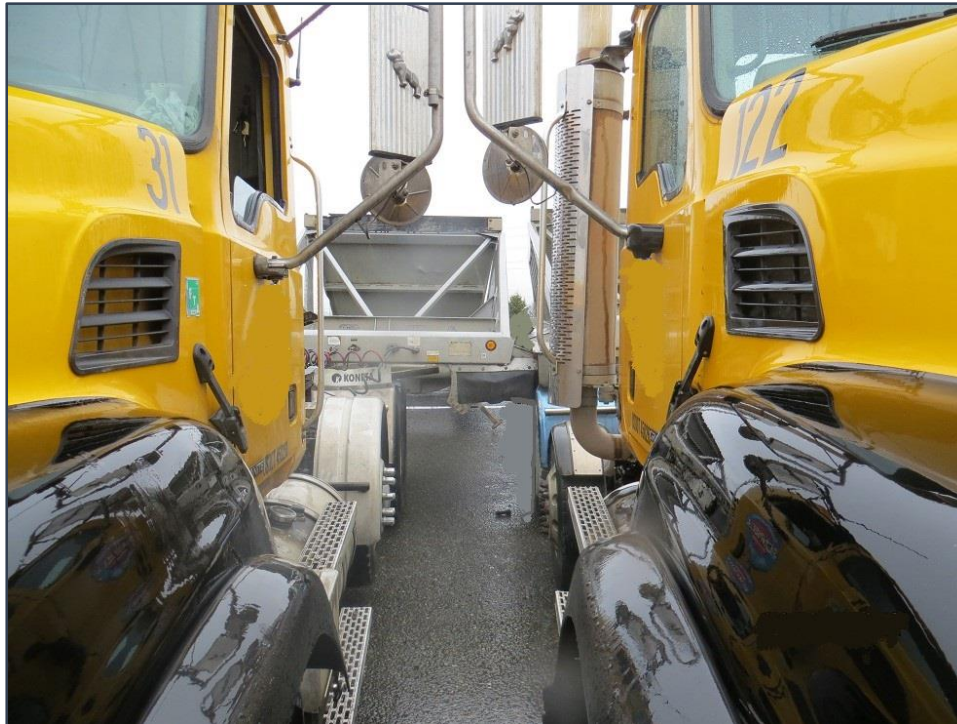
Photo 3. The incident scene showing the trailer shifted to the side.

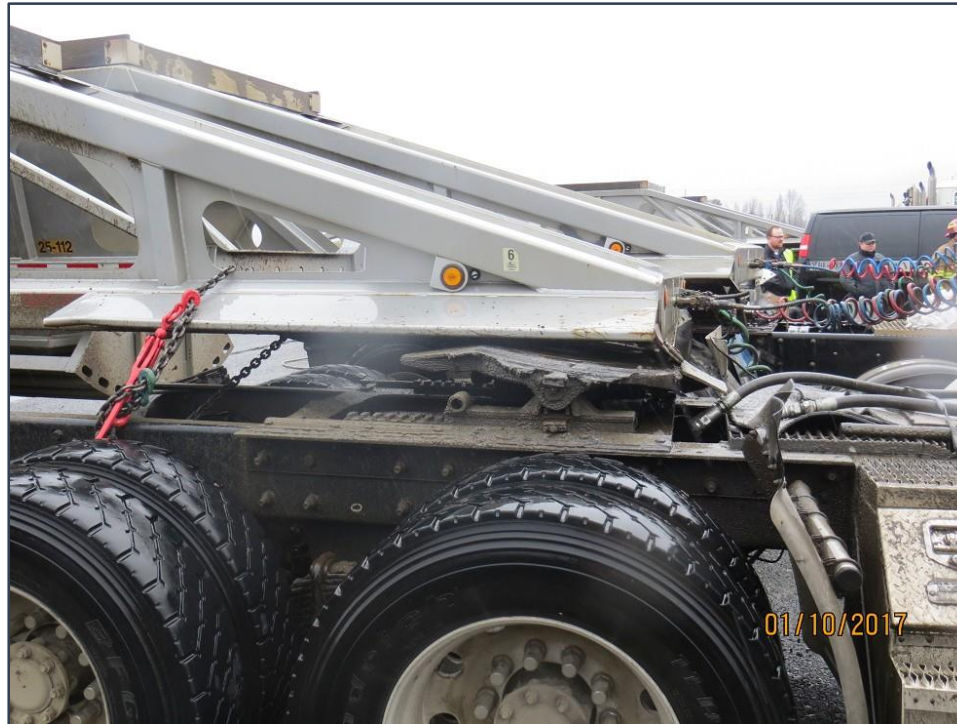
The landing legs supported the weight of the trailer on the pavement and needed to be raised for the truck to be able to couple with the trailer properly. The driver unsuccessfully attempted to pull the pin locking the legs in the down position. He had backed his truck toward the trailer and heard a sound that he believed indicated that the truck's 5th wheel's jaws had closed and locked onto the belly dump trailer's kingpin, but he did not visually confirm the coupling had occurred.

Photo 4. The incident scene showing the belly dump trailer's king pin and the truck's 5th wheel.

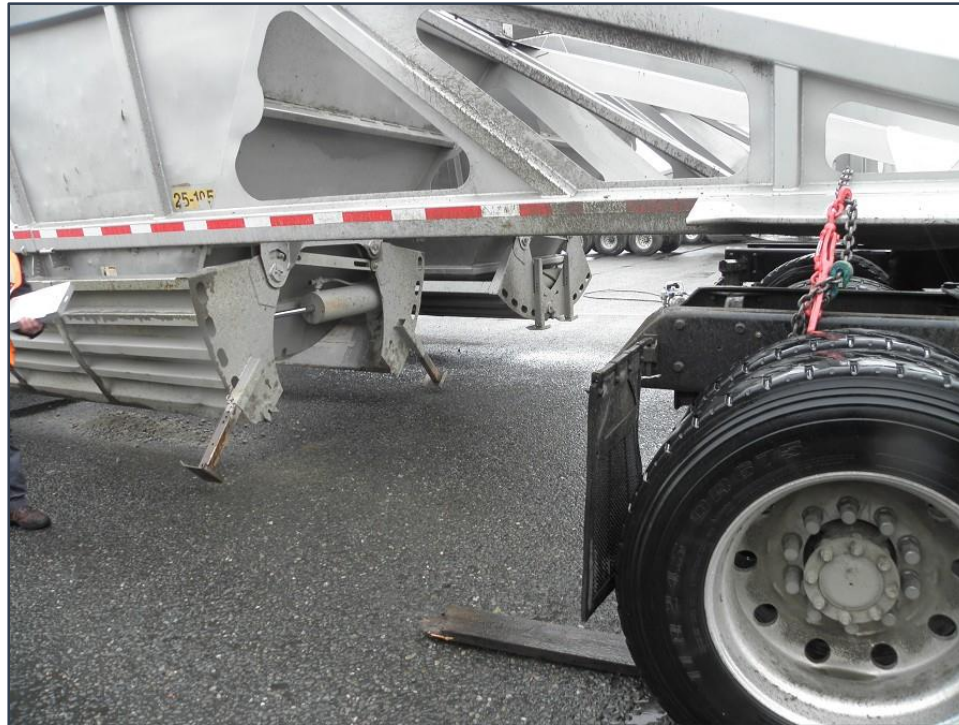
Photo 5. The incident scene showing the driver's trailer belly dump doors in the open position with the landing gear legs in the "down" position. The belly dump doors were opened after the incident.

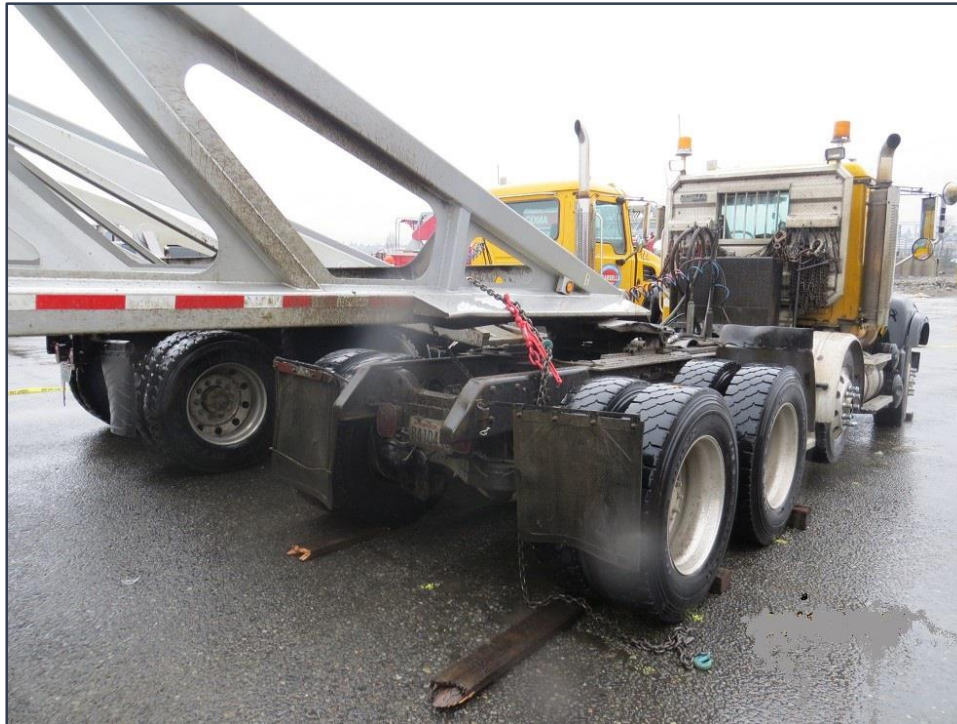
The victim determined that the truck's back was not elevated high enough to relieve the weight of the trailer so that the safety pins could be removed and the landing legs raised. He placed boards behind the truck's rear tires with the intention of having the truck back onto the boards to raise it.

Photo 6. The incident scene showing the boards under the truck's rear tires.
