**INCIDENT FACTS**

71-206-2021

## Operator Run Over by Combine Harvester when Engine Started by “Hot-wiring”

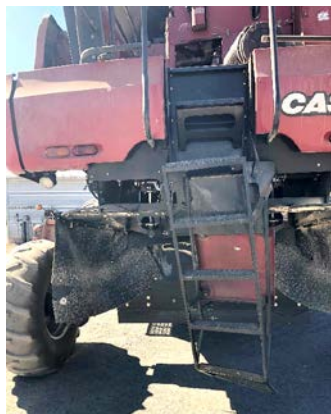
Rear ladder of combine that the operator fell from as the combine moved backward.

- Follow the machinery or equipment manufacturer’s make and model operator’s manual for operating procedures and maintenance to ensure the safety of operators.
- Do not bypass machinery and equipment safety features by “hot-wiring” engines, as this disables safety mechanisms and may cause inadvertent movement of the machine, endangering workers. In this case, the combine’s propulsion control lever had to be in “neutral” in order to start the engine with a key at the ignition. Because the engine was “hot-wired” at the starter solenoid and the propulsion control lever was in “reverse” this safety feature was disabled.
- Repair machinery and equipment as required so that unsafe practices are not used to start them.

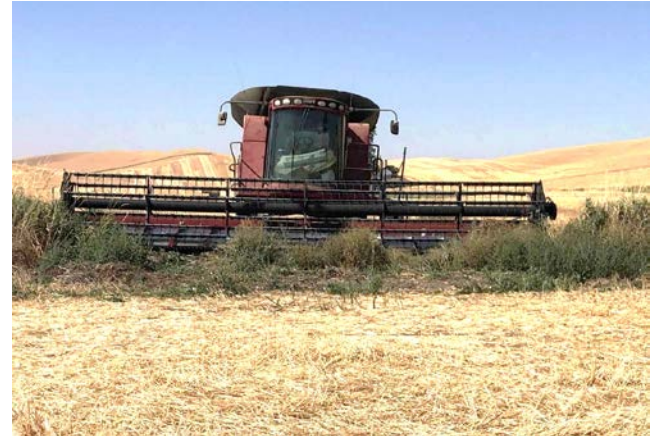
The operator entered the combine’s cab where he attempted to start the engine with a key in the ignition, but was unable to. For an unknown reason or by accident, he put the propulsion control lever in reverse before exiting the cab. He then went to the rear of the combine where the engine was located. He used an electrical cable to “hot-wire” the leads off the starter solenoid. The engine started and the combine began moving backward. He tried to climb down the ladder on the rear of the combine, but fell off it and landed on the ground between the tires. As the combine continued to move backward, the header ran over him. The combine stopped when it fell into a drainage ditch. He died at the scene from his injuries.

Combine that backed up and ran over the operator after he “hot-wired” its starter and then fell off the rear access ladder landing on the ground and was struck by the header.
