Roofer Falls From Extension Ladder

A residential roofing laborer was severely injured after falling when the extension ladder he was climbing slipped.

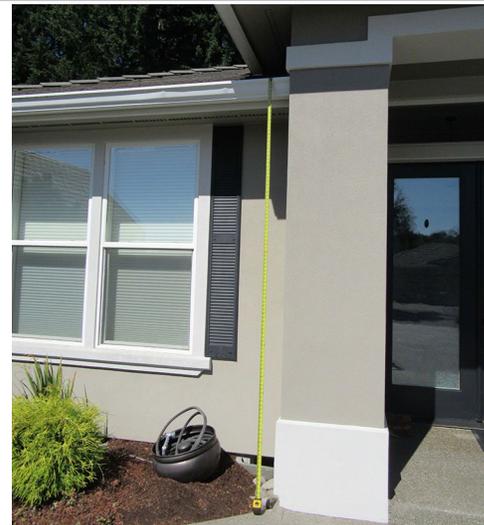
A more experienced roofer set up the fiberglass extension ladder and a tarp. He placed it at a 4:1 ratio on the edge of a flowerbed. One foot of the ladder was on the soft mulch of the flowerbed and the other foot was on the concrete walkway. The top of the ladder was leaning against the gutter, only extending above the gutter by a rung or two.

Figure 1: The tape measure shows where the ladder was set up. One foot was on the mulch, the other foot was on concrete.

The ladder was not on a firm, level surface. The base of the ladder was set up with one foot on the concrete walkway and the other foot in the soft mulch of the flowerbed.

- **Training.** Employers must train employees to recognize ladder hazards and the procedures to minimize these hazards. See [WAC 296-876-15005\(1\)](#)
- **Condition and inspection.** Employers must keep portable ladders in good, usable condition. See [WAC 296-876-30005\(1\)](#)
- **Support.** You must place the ladder either with a secure footing on a firm, level support surface, or secure the ladder to prevent accidental displacement. See [WAC 296-876-40015\(1\)](#)
- **Getting on and off ladders at upper levels.** You must make sure a ladder used to access an upper level has the side rails extended at least three feet above the landing surface if the ladder length permits. See [WAC 296-876-40030\(1\)](#)

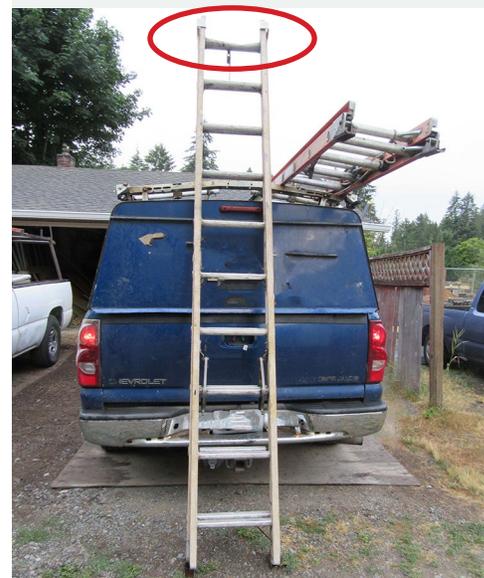
Figure 2: The fiberglass extension ladder involved in the incident was damaged. The top rung of the ladder was bent (circled). The damage was reported to the employer, but the ladder was not removed from service or fixed.

No ladder inspection. The employer did not ensure the ladder was in good working condition. The ladder was in service with a damaged rung. Workers previously reported this damage to the employer, but the ladder was not fixed or removed from service.

Proper ladder use. Face the ladder and maintain three points of contact while climbing and descending. Avoid leaning or reaching that could cause the ladder to tip sideways or the base to slide. Never use a damaged ladder.
