## Driver Crushed by Rollaway Woodchip Truck

**SHARP Publication # 52-52-2022\_summary.** The full version of this investigation report, along with the detailed recommendations and discussions section, can be found at: [www.lni.wa.gov/safety-health/safety-research/files/2022/52\\_52\\_2022\\_ChipTruckRollaway.pdf](http://www.lni.wa.gov/safety-health/safety-research/files/2022/52_52_2022_ChipTruckRollaway.pdf)

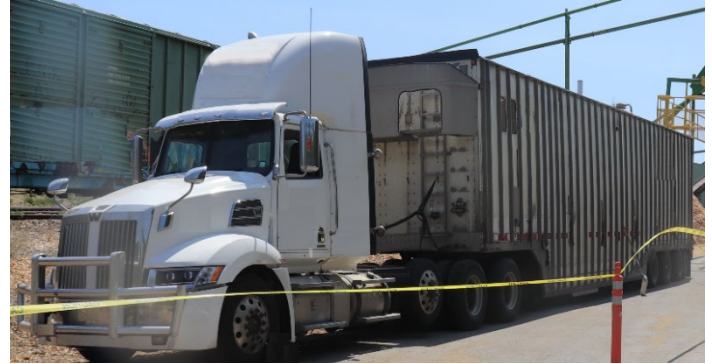
**Woodchip truck that rolled away and crushed driver. The driver parked the truck on a paved road under a tarping station. The road had a 2% downgrade. The driver left the truck running and did not set the parking brake before exiting the cab to access the top of the trailer.**

- Install electronic parking brake systems that automatically apply the parking brake when the driver has not set it before exiting the cab.
- Develop APP to have a parking brake and wheel chocking policy with strict requirements for preventing rollaways and unsafe responses.
- Collaborate with owners of remote customer sites outside of their ordinary daily travel range to ensure the sites are safe for their drivers.
- Assist safety supervisors to obtain work visas or hire safety consultants abroad to do safety audits at customer sites in other countries.
