Apprentice Ironworker Struck by Dropped Steel Wedge

REPORT #: 71-217-2022s

SCENE: New construction of cold storage
facility

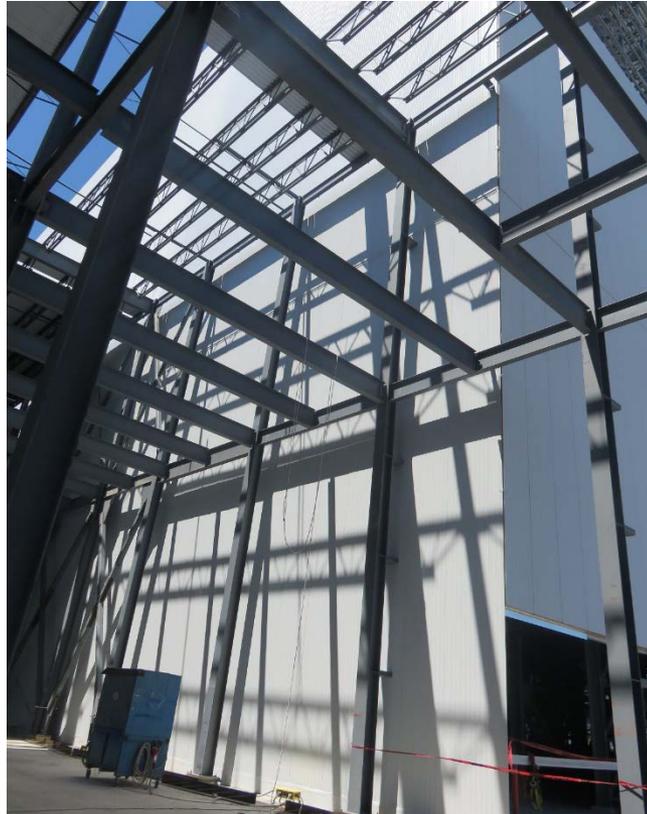
The ironworkers were using a steel wedge between the column and beam to help tighten the bolts securing them. One of the ironworkers was removing the wedge, which was under pressure, using a hammer to knock it loose.

As he was doing this, the untethered wedge broke free, but he was unable to hold on to it, and it fell approximately 50 feet.

Photo 1. Incident scene at the cold storage facility being constructed. This was the area where an ironworker accidentally dropped a steel wedge that he was attempting to remove from between a beam and column. The wedge fell approximately 50 feet, striking the apprentice on the ground floor below.

- Use red caution tape and/or have a spotter on the ground to keep workers from entering areas where objects may be dropped.
- Locate employee water stations away from active work areas.
- Provide safety training to new workers to ensure they understand the hazards associated with the work site.

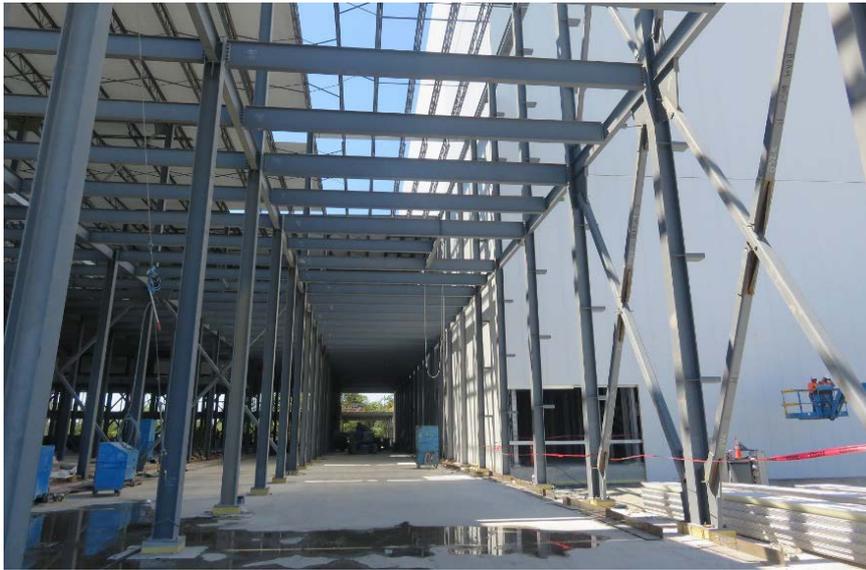
Photo 2. Interior view of incident scene at the cold storage facility under construction.

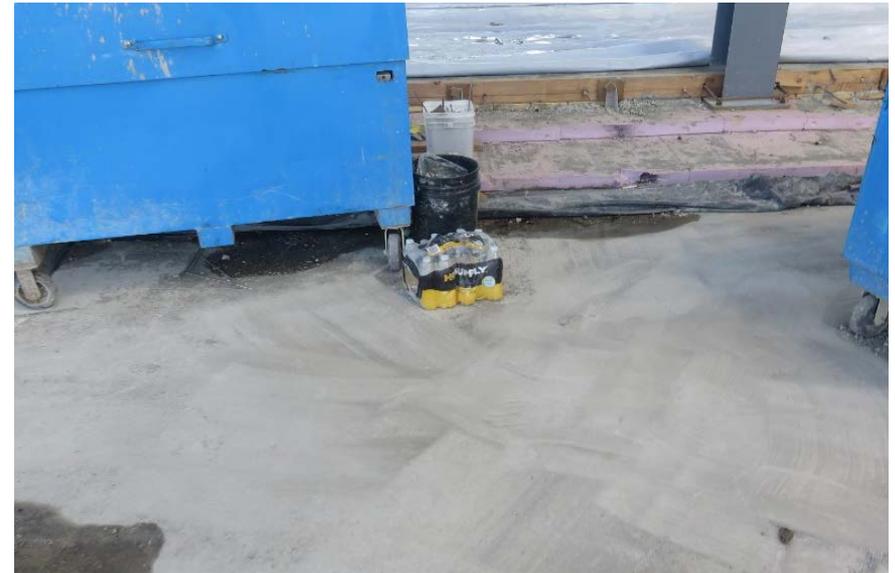
At this moment, the apprentice was in the area below getting a bottle of water that was being stored there for workers. As he was bending over to pick up the bottle, the wedge struck him in his upper back near his left shoulder.

- The employer had not provided workers with a means of securing wedges from falling or being dropped.
- The employer had not used red caution tape to keep workers out of the area below where the ironworkers were working.
- There was not a designated water station.
- The ironworkers did not expect anyone to be working below them because there were no other workers in the area.

Photo 3. Area where the apprentice ironworker went to retrieve a bottle of water when he was struck by the dropped steel wedge.

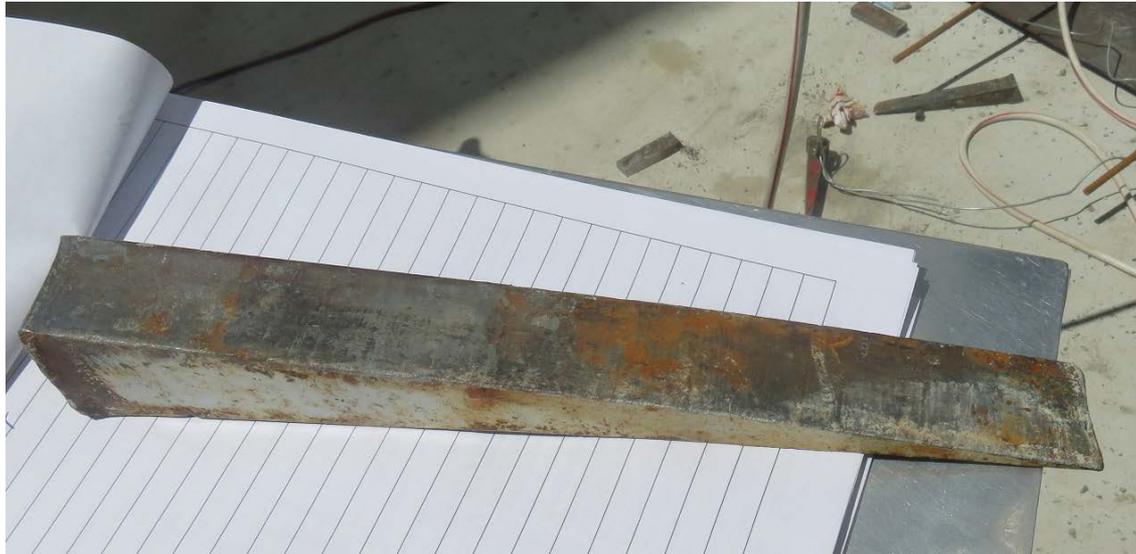
Photo 4. Steel wedge that struck the apprentice ironworker in his upper back near his left shoulder.

- Require that wedges and other tools used by workers at heights have lanyards, tethering devices, holsters, buckets and other devices to secure them.
- Add attachment points to wedges if they do not have them so they can be secured to a tether.
- Ensure that tethering systems are ANSI/ISEA 121-2018 Dropped Object Prevention Solutions compliant.
- Secure wedges and other tools, both when in use and not in use.

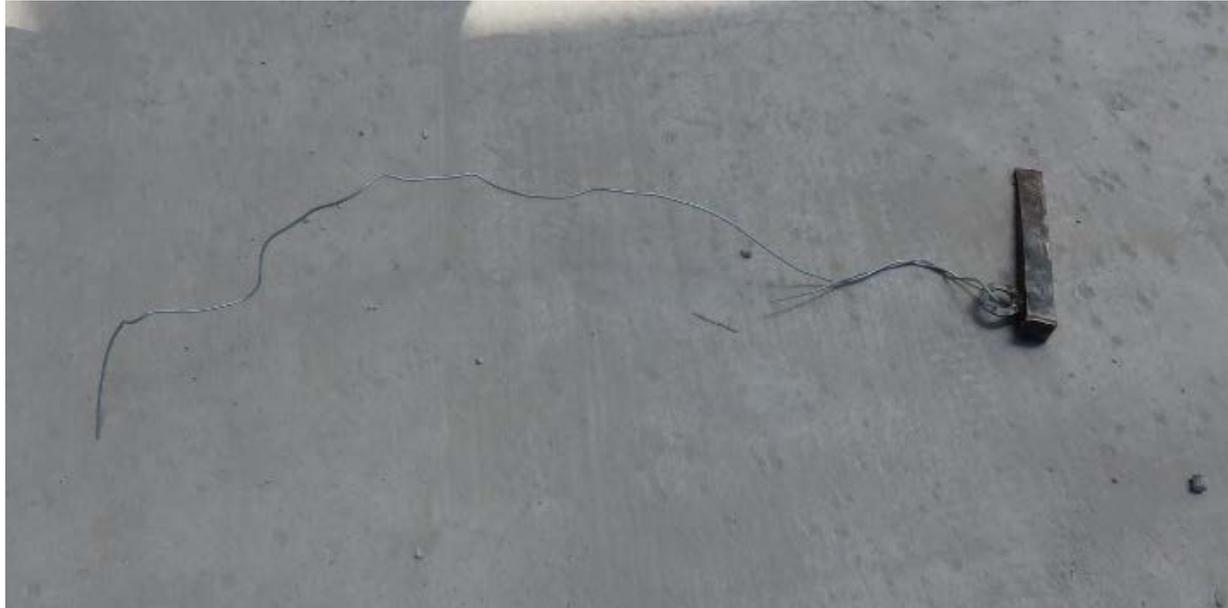
Photo 5. Employer modified steel wedge with a washer welded to the wedge and a wire attached to the washer that is used as a tether. Alternatively, a hole could be drilled into the wedge and a tether attached to it.
