INCIDENT FACTS

71-221-2022

Driver Caught Between Trucks at Warehouse Loading Dock

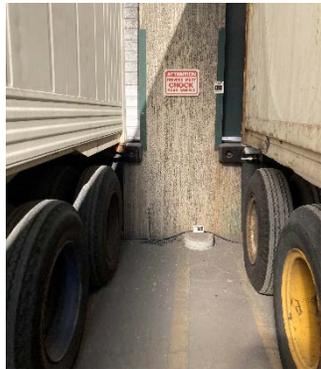
Space between trucks parked at loading dock similar to where the driver was walking when he was struck by the trailer.

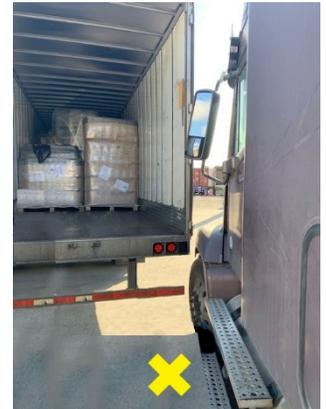
The dry van turned left before it was fully out of the parking slot. The forward position of its trailer's tandem axles caused the last ten feet of the trailer to swing rightward into the space between the trucks where the driver was walking. The swinging trailer struck and pinched the driver against the left side of his truck cab, causing him to go into shock, faint, and fall down. Another driver saw him on the ground and got the dry van driver to stop. First responders transported the injured driver to the hospital. He was released three days later with severe bruises.

The driver was caught between the dry van trailer on the left and his truck cab on the right. Yellow X shows where he was found on the ground unconscious.

Investigators found that the incident could have been avoided had the dry van truck pulled fully out of its parking slot before turning. Had the trailer's tandem axles been in the rear position, it would not have swung into the space between the trucks where the driver was walking. The contract between the owner operator and warehouse business placed the responsibility of safe vehicle operation solely on the operator. The warehouse did not provide any safety training to truck drivers and only verified that they met federal motor carrier requirements.

- Consider equipping trucks with commercially available turn assist systems that alert drivers when pedestrians are detected inside blind spots beside the vehicle.
- Require drivers to slide trailer tandems back before docking to eliminate tail swing when leaving.
- Require drivers to check right side hood tri-pod mirror and pull fully out of the parking slot before turning truck.
- Request customers with loading docks to identify vehicle struck by - caught between hazards and ensure adequate parking and maneuvering space for trucks and safe passage for pedestrians.
