## Contractor and Laborer Buried in Trench Collapse

### INCIDENT FACTS

**REPORT #:** 71-240-2023s

**EVENT TYPE:** Trench collapse

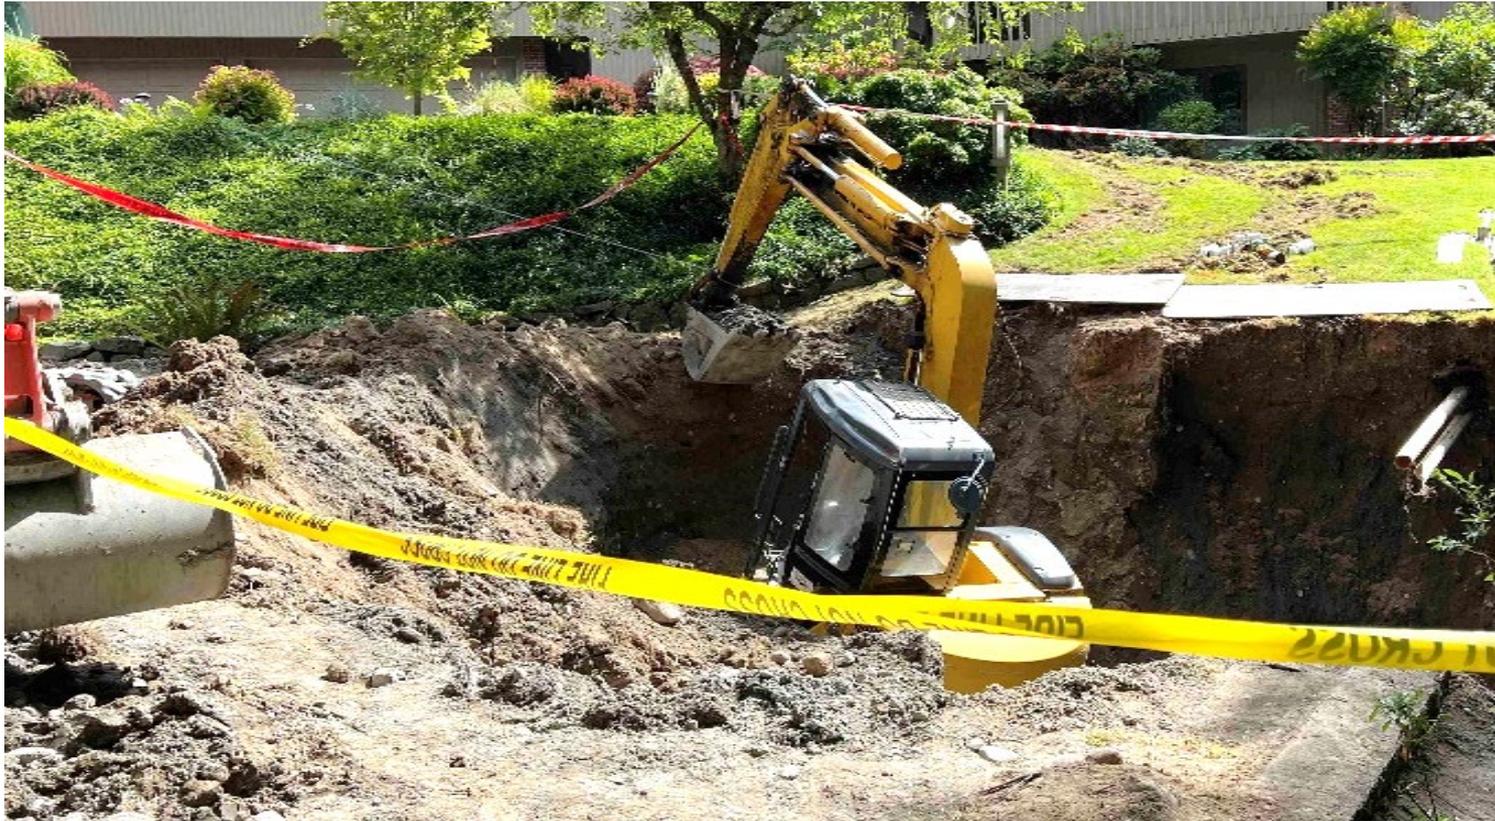
The sides of the trench were steep and nearly vertical.

They dug the trench in unstable Type C soil and did not use protective systems such as shoring, shields, trench boxes or sloping and benching of the sides. The day before the incident, the trench collapsed after a rainstorm.

**Photo 1.** View of incident scene showing steep, unprotected trench walls.

- Trenches must have adequate cave-in protective systems. See [WAC 296-155-657\(1\)\(a\)](#)
- Ensure that there is a safe way to exit a trench that is four feet or more in depth. See [WAC 296-155-655\(3\)\(b\)](#)
- A competent person must inspect trenches at the start of each shift and as needed throughout the shift and after a rainstorm to ensure that conditions are safe for employees. Remove employees from hazardous areas until precautions have been taken to ensure their safety. See [WAC 296-155-655\(11\)\(a\)\(b\)](#)

- Never enter a trench or excavation that does not have an adequate protective system in place.
- Inspect the trench or excavation before entering.
- Do not assume that there will be a warning sign before a cave-in or that you will have time to escape.

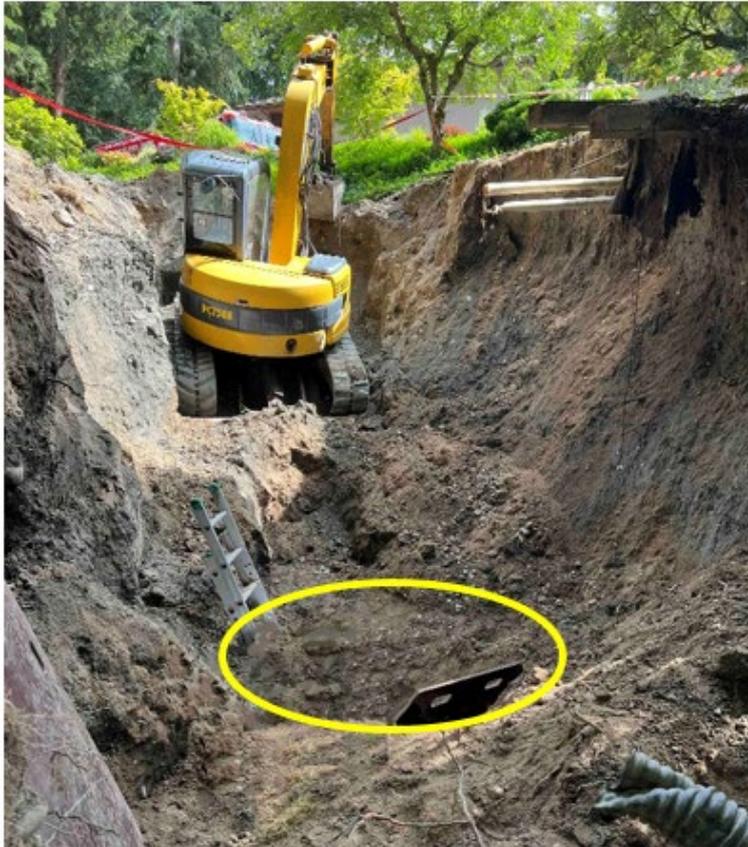
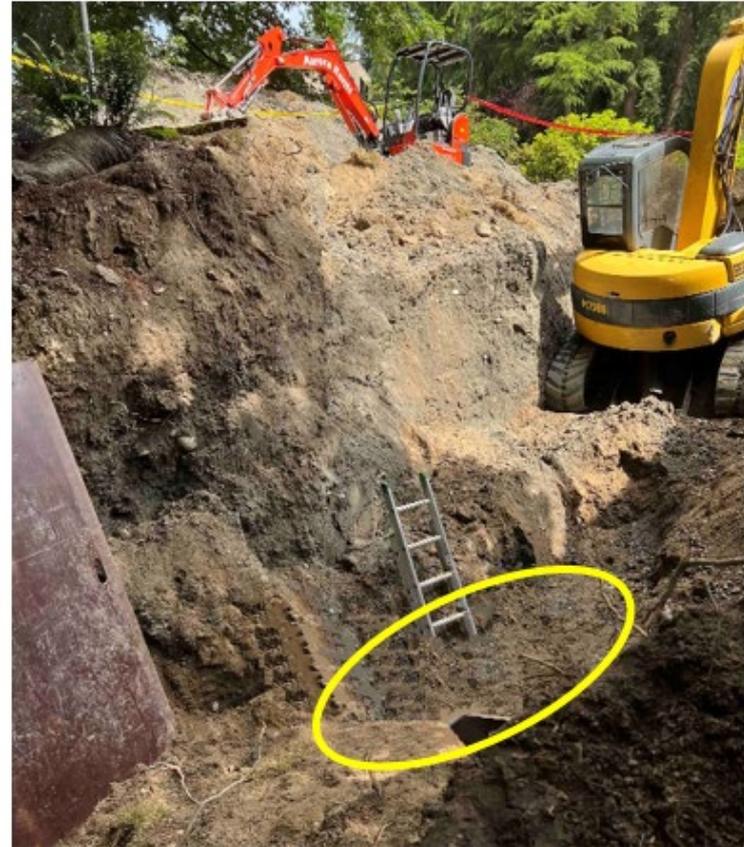
The contractor and a laborer then used an extension ladder to enter a 10-foot deep ditch in the larger trench.

A few moments later, the trench wall collapsed, burying him and the laborer.

**Photos 2 and 3.** Two views of the incident scene. The yellow circles show where workers were in a 5-foot wide, 10-foot deep ditch at the bottom of the trench.

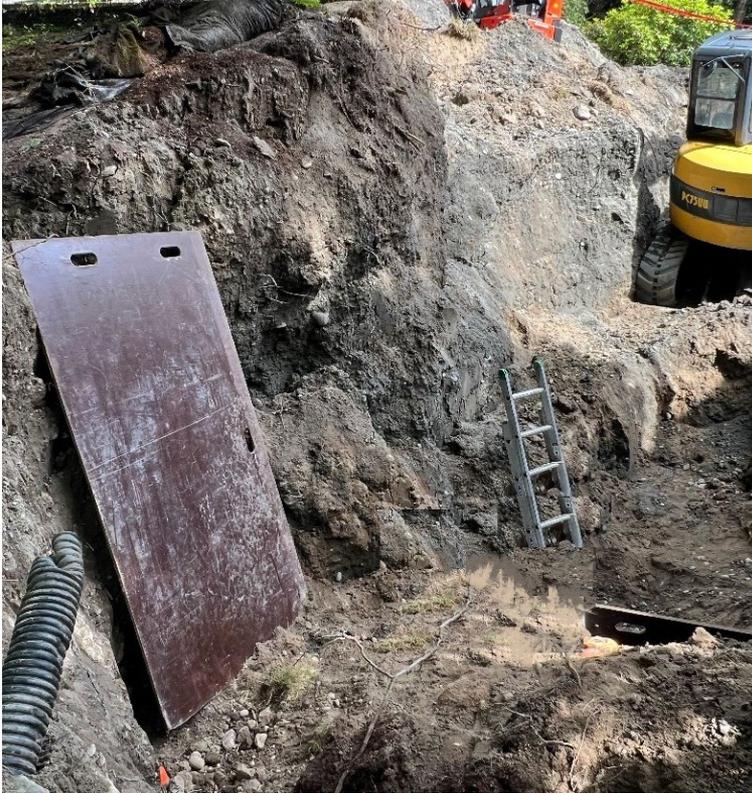
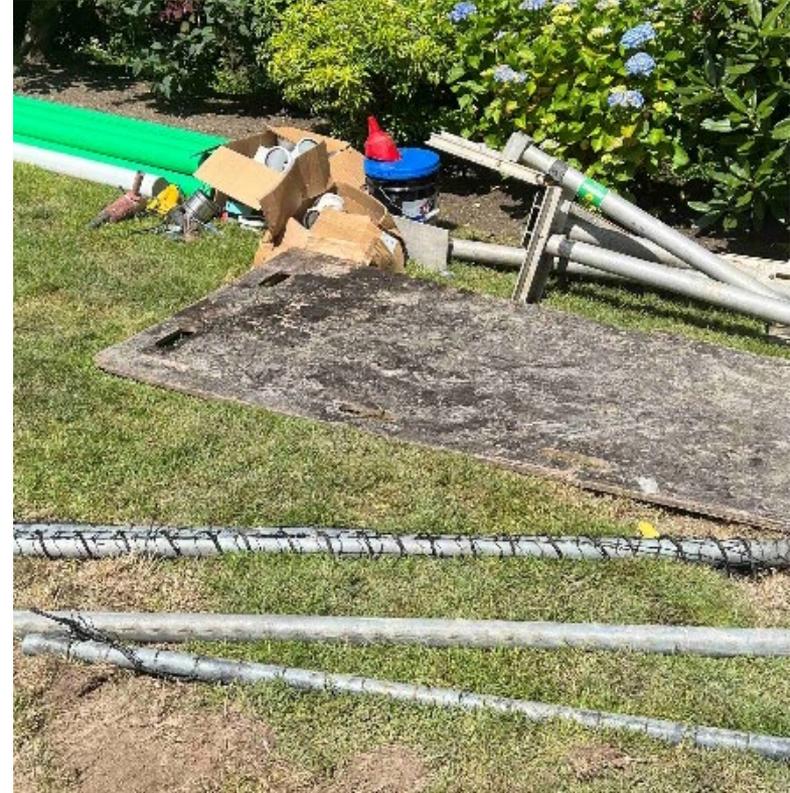
- Trench protection (shoring, shielding, benching, and sloping) was not used.
- There was some shoring equipment on site, but it was not adequate for the trench.
- No safe means of egress from trench.
- The employer had previous safety violations, including having workers in unprotected trenches and no ladder as a means of access and egress in a trench.

**Photos 4 and 5.** Photo 4 shows unbraced steel plate in trench placed against wall of type C soil. Photo 5 shows steel plates, fin boards, and shoring beams were not used and were inadequate for the trench.

- Sloping or benching for excavations greater than 20 feet deep shall be designed by a registered professional engineer. See Appendix B—Sloping and benching, Table N-1, Note 2 [WAC 296-155-66403\(3\)\(d\)](#)
- For additional requirements: See Part N—Excavation, Trenching, and Shoring [WAC 296-155-650](#)
