INCIDENT FACTS

71-241-2023

Sweeper Crushed in Hay Press Bale Elevator

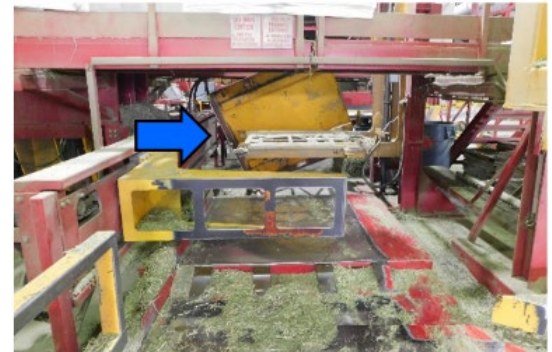
Pinch point between the lowered bale elevator on right and output platform on left.

The elevator was in full upward position over five feet above the floor when the sweeper walked under it. Seconds later, the elevator came down and pinned his legs on the floor and his torso on the output platform in front of him. Then, a 1,000-pound bale fell onto the elevator from the ejector above and crushed him facedown for 18 seconds before the pusher slid the bale out across his torso. Three co-workers heard a scream and ran to the elevator. The press operator saw the crushed sweeper and shut off the machine. First responders had the workers pull him from the press, but he died at the scene. Workers told investigators the sweeper knew about the machine's hazards and did not know why he entered the machine.

- The hay press had no physical barrier to stop workers from entering the elevator while the machine was running. The employer stated no barriers were installed because the sweeper would not be able to keep the area clean.
- A manufacturer's warning sign above the output platform stated, "Do not enter unless elevator is on the floor" in English and Spanish. The employer's hay press safety training was more protective in instructing workers to never enter the press when it was not locked out. No sign was posted on the machine where the worker entered.
- The employer did not ensure their hay press safety training program was effective and enforced.

Hay press bale elevator with output platform and pusher in foreground. Arrow shows elevator and yellow table that came off it when the worker was crushed. Warning signs are on the machine frame above the elevator. The worker entered the area from the back.

- Supervise, evaluate, and enforce worker performance of lockout/tagout (LOTO) procedure requirements according to hay press safety training and machine manufacturer's safety manual.
- Perform risk assessments with the machine manufacturer to improve safeguarding features, such as barrier fencing, fixed guards, interlocking gates, light curtains, and emergency stops (E-Stop) locations.
