# Apple Orchard Worker Dies When Tractor Rolls Over

**REPORT #:** 71-245-2023s

**SCENE:** Apple orchard

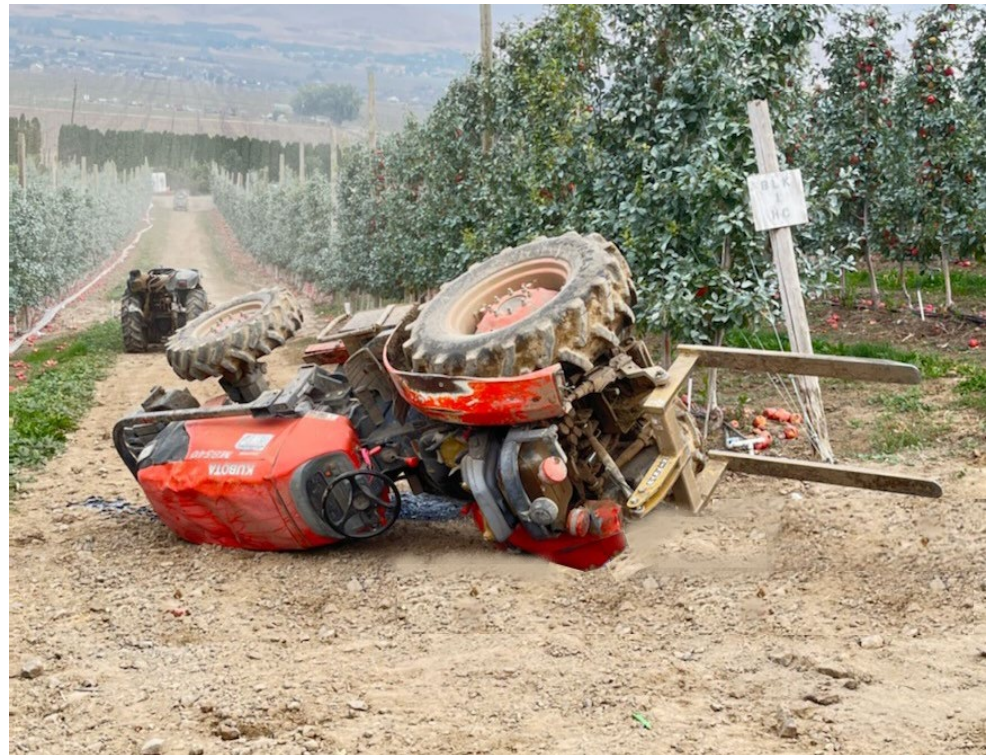
On the incident day, the worker was operating a low-profile utility tractor to pick and move wooden bins full of apples harvested at the orchard. The tractor had a set of forks attached to the rear 3-point hitch. The tractor had a rollover protective structure (ROPS) and a seat belt installed, but the operator was not using them.

The operator drove the tractor down a steep, rocky, uneven dirt road, which had an 18-21 degree grade. When he tried to make a right turn at the bottom of the hill, the tractor rolled to the left, and threw him to the ground towards the rear of the tractor. When the tractor rolled onto its side, the lower portion of the forks landed on the operator's skull. Although no one saw the incident, another operator saw the tractor on its side and yelled to a manager who was nearby.

- The tractor's ROPS was not in the upright position even though no substantial overhead obstructions were present. The employer did not ensure tractor ROPS was used as required.
- The tractor's seat belt had a faulty retractor and webbing covered with caked dirt, indicating it had not been used recently. The employer did not ensure tractor seat belts were used as required.

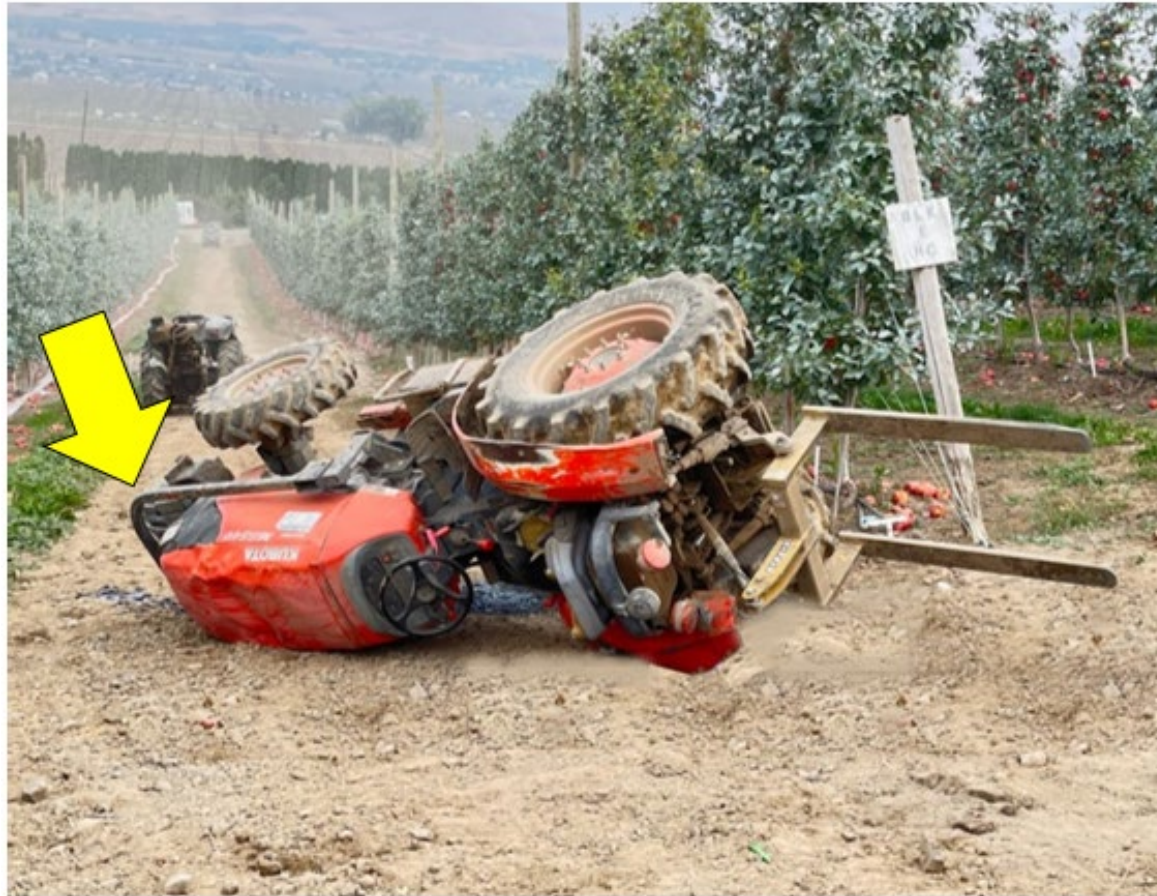
**Photo 1.** Tractor with ROPS folded down at rollover scene.

- Develop policy requirements for ROPS and seat belt use and tractor operator safety training in your written accident prevention program (APP). Review requirements with operators frequently.
- Provide ample supervision of tractor operators and always enforce tractor safety policy requirements.

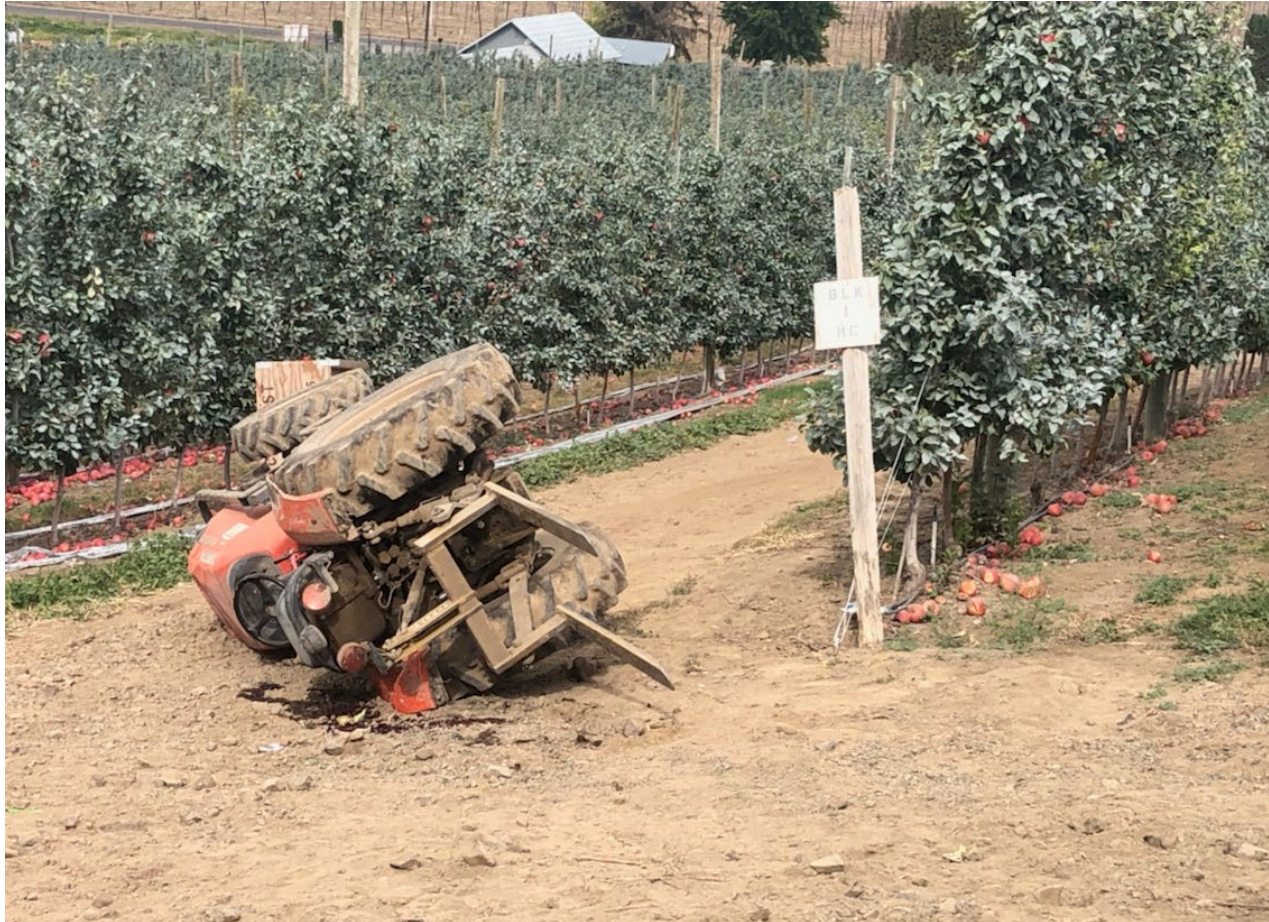
**Photo 2.** Rear view of tractor with attached forks at rollover scene.

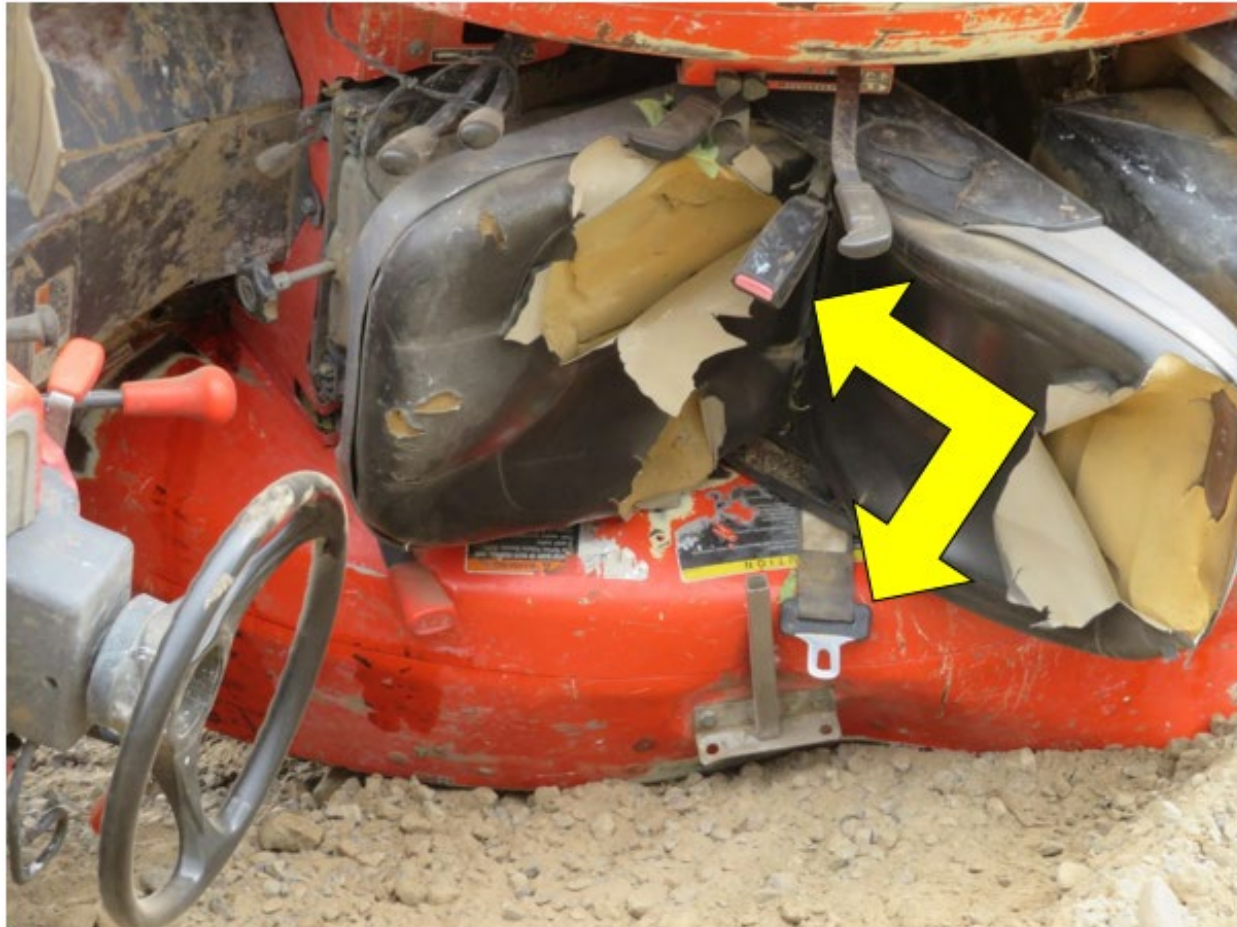
**Photo 3.** Unbuckled operator's seat belt on tractor that rolled over.  
Note worn out warning labels on left fender wall.

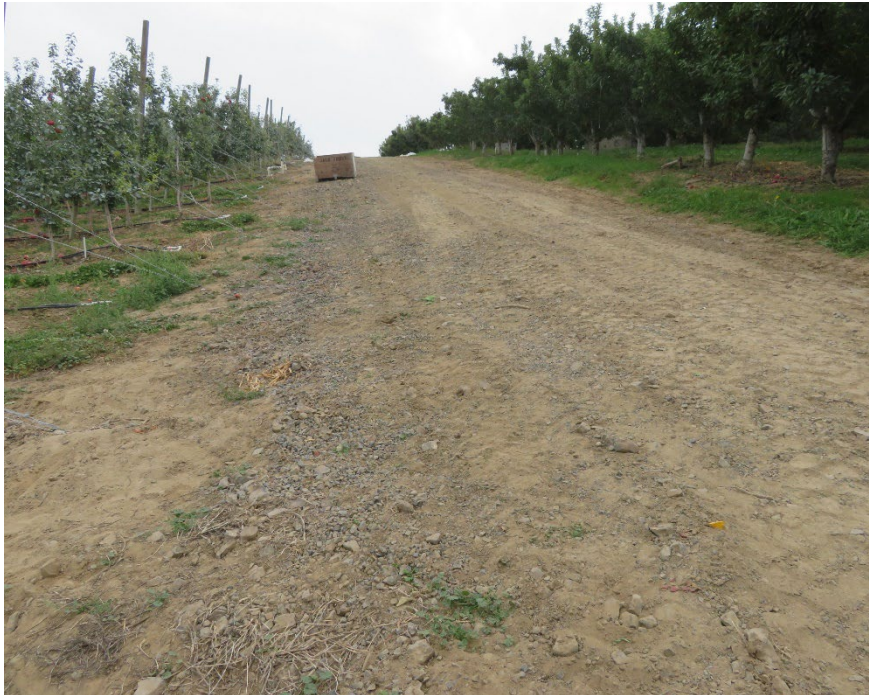
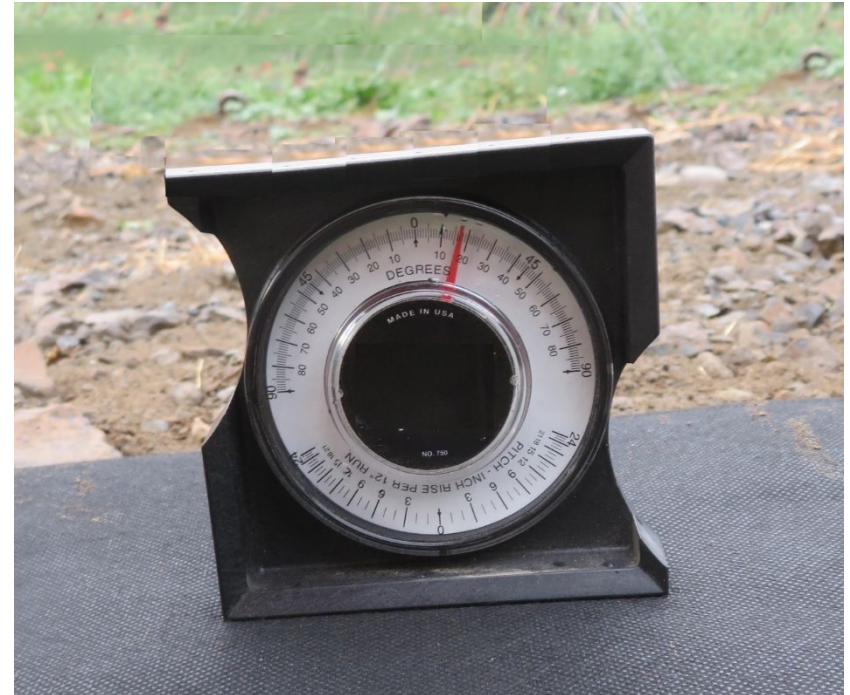
**Photos 4 and 5.** Photo on left shows uphill view of road from rollover location. Photo on right shows pitch and slope locator measuring degrees of slope at rollover location.

- Provide documented, hands-on tractor operator training, including refresher training, on a regular, ongoing basis. Ensure the training emphasizes showing operators how to prevent tractor rollovers by avoiding excessive speed, navigating rough and steep terrain, and maintaining a safe turning radius.
