TRUCKING & CONSTRUCTION FATALITY NARRATIVE

Heavy Equipment Mechanic Dies Repairing Excavator

REPORT #: 71-251-2024s

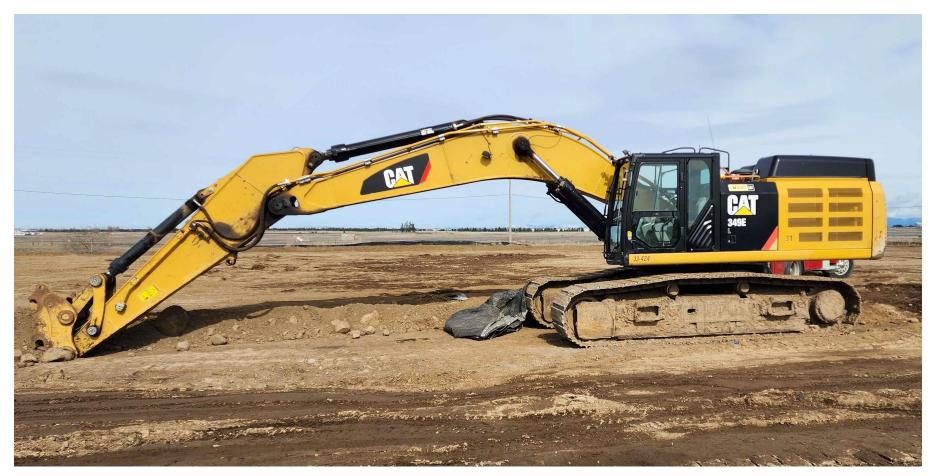
Photo 1. Excavator that was being repaired.

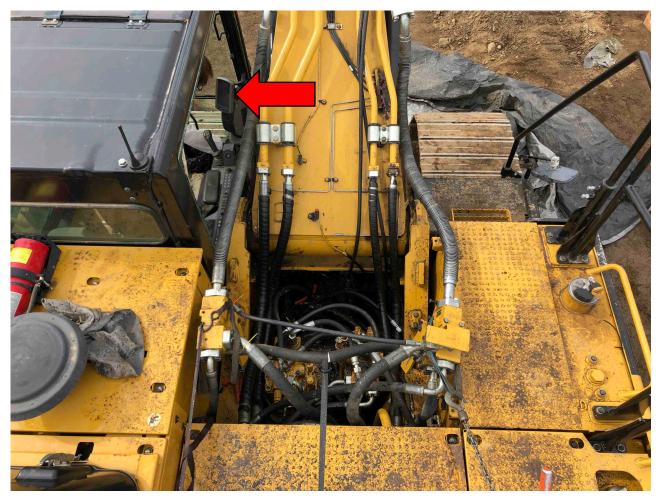
The worker also contacted the supervisor, whose GPS showed the mechanic's service truck was still at the site. Now around 40 miles away, he began driving back to the site. The friend arrived there first, found the mechanic unresponsive and upside down in the swing drive compartment, and called 911. First responders pronounced the mechanic dead at the scene. The medical examiner reported the mechanic died from suffocation caused by being trapped in a head-down position.

Photo 2. Swing drive compartment where mechanic was trapped. Arrow shows operator's cab where side window was shattered.

- Develop and enforce policies and standard operating procedures (SOP) in their written accident prevention program (APP) that:
 - Prohibit lone work and instead require using a buddy system where workers team up so they can observe each other and assist quickly when someone becomes endangered.
 - Require a formal job hazard analysis (JHA) be conducted jointly by supervisors and workers to identify hazards for lone work. Prevent hazards by implementing less hazardous work practices.

- If lone work is unavoidable, provide and require use of lone worker monitoring technology or communication procedures, such as two-way radios, in-person check-ins, wearable panic buttons or worker down apps for cell phones.
- Require supervisors to routinely observe workers to ensure they are following policies and procedures.

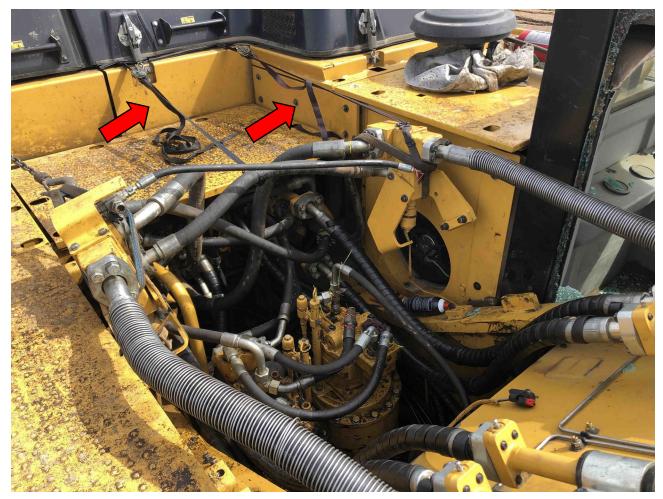
Photo 3. Diagonal view of swing drive compartment. Arrows show ratchet straps extending across platform to hold hydraulic components.

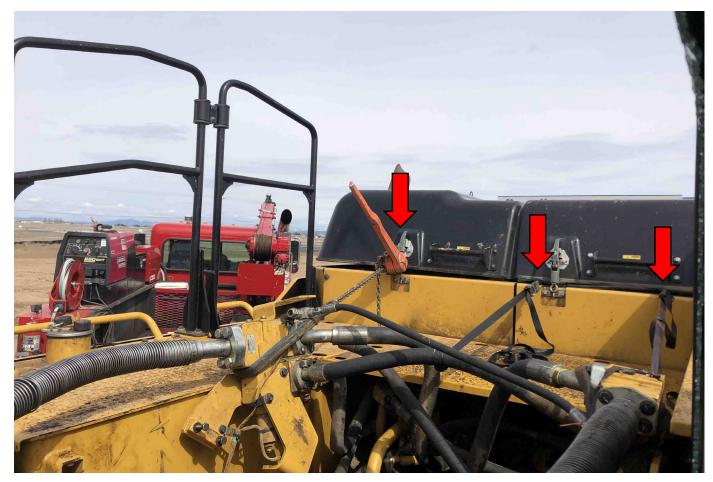
- The mechanic had prior experience installing excavator swing drives.
- Ratchet straps, a come-along, and tools for the job posed trip hazards near the swing drive compartment.
- The boom side operator's cab window was shattered presumably when the incident happened.
- The employer had no written safety policy for lone workers.

Photo 4. Arrows show how ratchet straps and a come-along pose trip hazards on the platform around the swing drive compartment.
