INCIDENT FACTS

71-252-2024

Driver Run Over by Semi-Trailer at Truck Stop

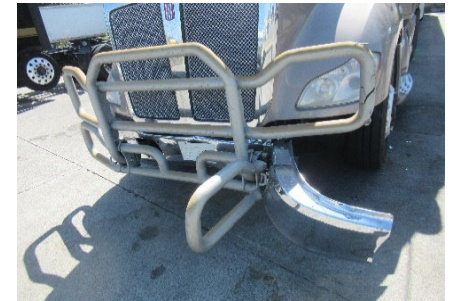
The driver returned from the store a few minutes later and walked between the trucks to get to his cab. The truck parked next to his suddenly pulled forward and turned left, which made the rear of its trailer pivot and sweep into the space where the driver was walking. The moving trailer struck the driver, pinned him against his trailer, and ran over him with its rear right wheels. First responders pronounced him dead at the scene.

Driver's truck with bumper damage caused by the trailer that ran over him.

- Assist drivers with pre-trip planning, including finding truck stops and rest areas with safe truck parking.
- Develop a clearly written accident prevention program (APP) with truck parking area safety policies and training. The policies and training should instruct drivers, whenever possible, to:

- Avoid unnecessarily walking between parked trucks, especially when the space between them is less than 8 feet wide.
 - Inform drivers in adjacent parking slots before doing a walk-around vehicle inspection.

- Use 45-degree angle herringbone drive-through (HDT) parking slots instead of straight back-in slots (SBI). HDT slots allow trucks to enter and leave without having to back up. This lets drivers see the entire parking slot and the edges of adjacent slots. By contrast, SBI slots limit maneuvering visibility at the rear of the slot, creating a hazard for drivers on foot.
