71-253-2024

Inexperienced Framers Falls 22 Feet from Upper Floor

SUMMARY

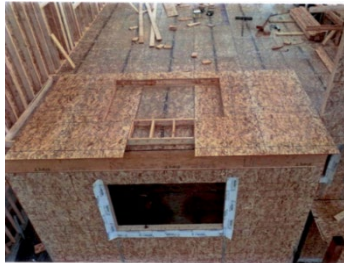
Unprotected floor where the framer fell.

The supervisor instructed the framer to cut out a window opening in a piece of wood sheathing being prepared for the wall assembly. After making the opening, the framer went to drop the cuttings down to a scrap pile on the ground. He walked on the wall assembly, which was laying on the floor, and then onto a small piece of attached sheathing that extended past the edge of the floor. The sheathing was not properly nailed down and gave way under his weight, causing him to fall 22 feet to the ground. The supervisor witnessed the fall, ran downstairs, and called 911. The emergency dispatcher guided him in giving first aid. When first responders arrived, they could not save the framer, who died of severe head injuries.

- Develop APP policies to use PFAS when fall prevention guardrails are not in place on open-sided floors.
- Discuss fall protection policies at crew meetings, monthly safety meetings, and annual stand-downs.
- Conduct recurring hands-on fall protection training and ensure workers show proficiency in practice.
- Require all levels of management to spot check workers and enforce fall protection policies and practices.
- Use a project timeline to communicate task schedules with workers and suppliers to avoid rushing.

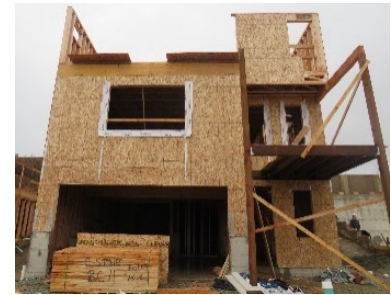
The framer was working with a supervisor on the unfinished, open-sided floor. The floor was still being framed, and the supervisor removed fall prevention guardrails in an area where a wall assembly was going to be installed.

- The employer had no fall protection system and work plan and did not enforce any requirements. The employer had been previously cited for fall protection rule violations.
- The framer was wearing a body harness but had no other personal fall arrest system (PFAS) components.
- Supervisors routinely used chalk lines in place of PFAS when guardrails were removed, but no lines were observed at the incident site. The owners were aware of but never corrected the unsafe practice.
- Workers were rushing to raise the walls so trusses could be placed on top of them upon delivery and to avoid the delay of having the trusses delivered on the floor and lifted by a crane later.

Open-sided upper floor where guardrails were removed.
