Gutter Installer Falls from Patio Roof

REPORT #: 71-255-2024s

FATALITY NARRATIVE

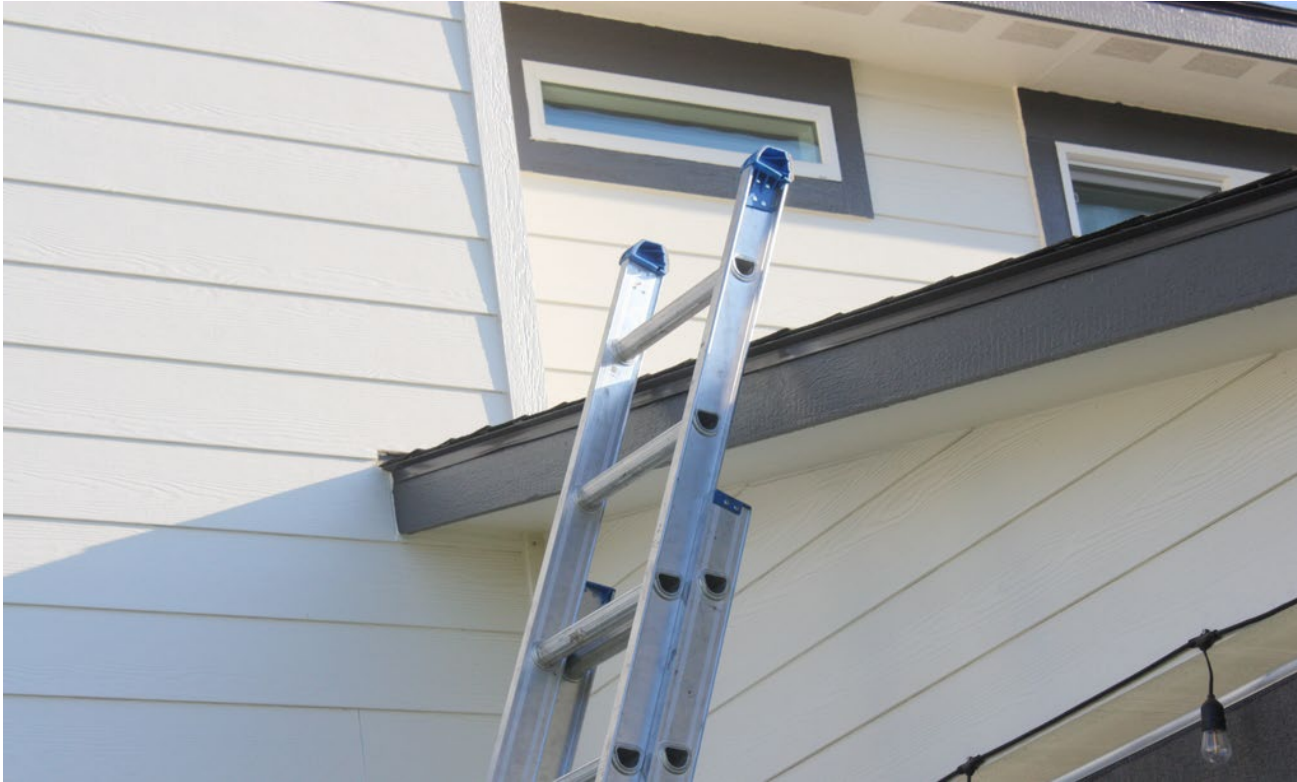
The installer's first task was to prepare the upper roof edge in order to hang the gutters. He went to the back of the house and used a ladder to get onto the roof of the patio.

Photo 1. The ladder the installer used to climb onto the patio roof in order to pry on the edge of the upper roof.

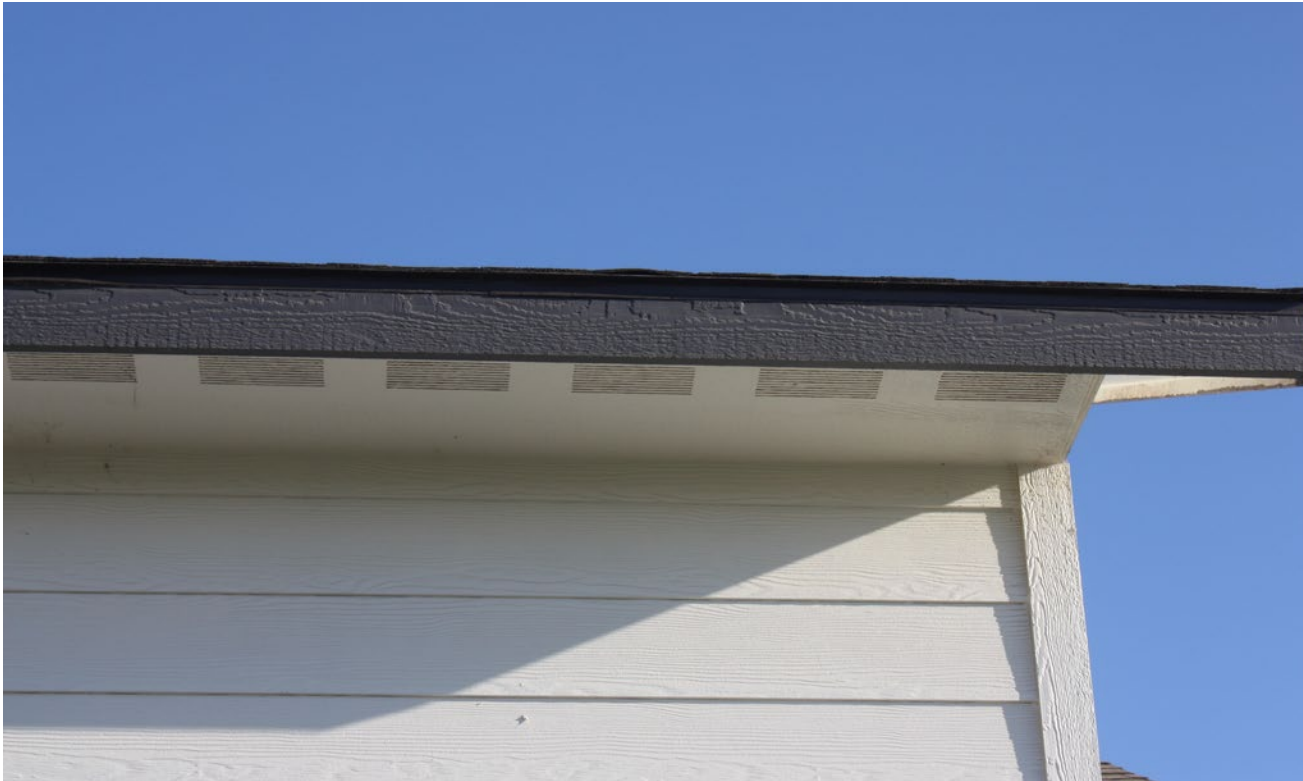
While standing on the patio roof, the installer started prying between the upper roof shingles and the fascia in order to make a space to attach the gutter flashing.

Photo 2. Upper roof above the patio where the installer was prying when he fell.

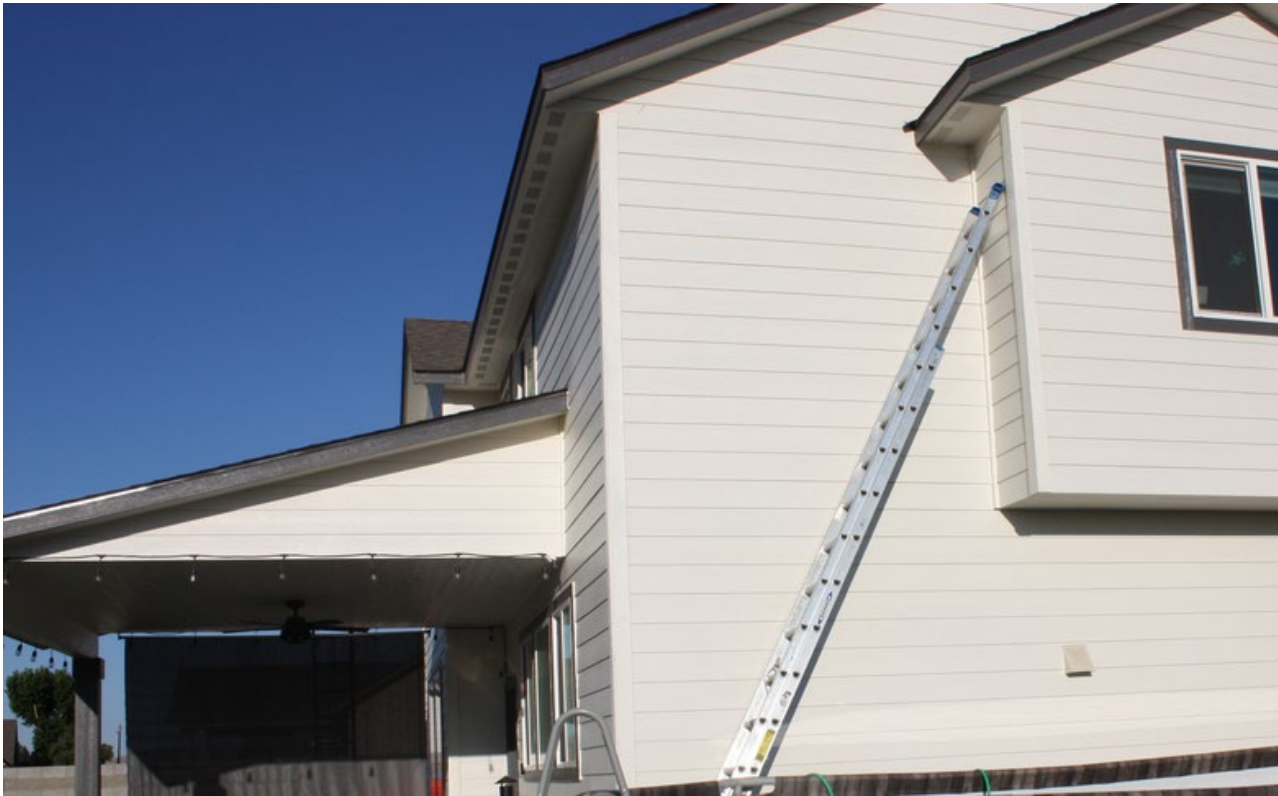
As he continued prying toward the corner of the upper roof, he reached the edge of the patio roof on which he was standing.

He either did not see the patio roof edge and stepped off or was extending his reach and lost his balance. He fell 13 feet to the concrete patio.

Photo 3. Edge of the patio roof where the installer was working and from where the fell, opposite from where the ladder was propped.

- Ensure that each employee on a walking/working surface with an unprotected side or edge four feet or more above the ground or lower level is protected by a fall protection system. See [WAC 296-880-20005\(1\)](#)
- Provide training for each employee exposed to fall hazards. See [WAC 296-880-10015](#)
- Document attendance and subjects discussed at crew-leader safety meetings. See [WAC 296-155-110\(6\)](#)

- Arrive on-site before work begins or appoint a supervisor to ensure that workers use fall protection and follow fall prevention safe work practices.
- During the pre-job safety meeting, go over the fall protection work plan and discuss workers' responsibilities and the details of how they will implement the plan.
- Make fall prevention a company priority and emphasize to workers to always use fall protection when required.

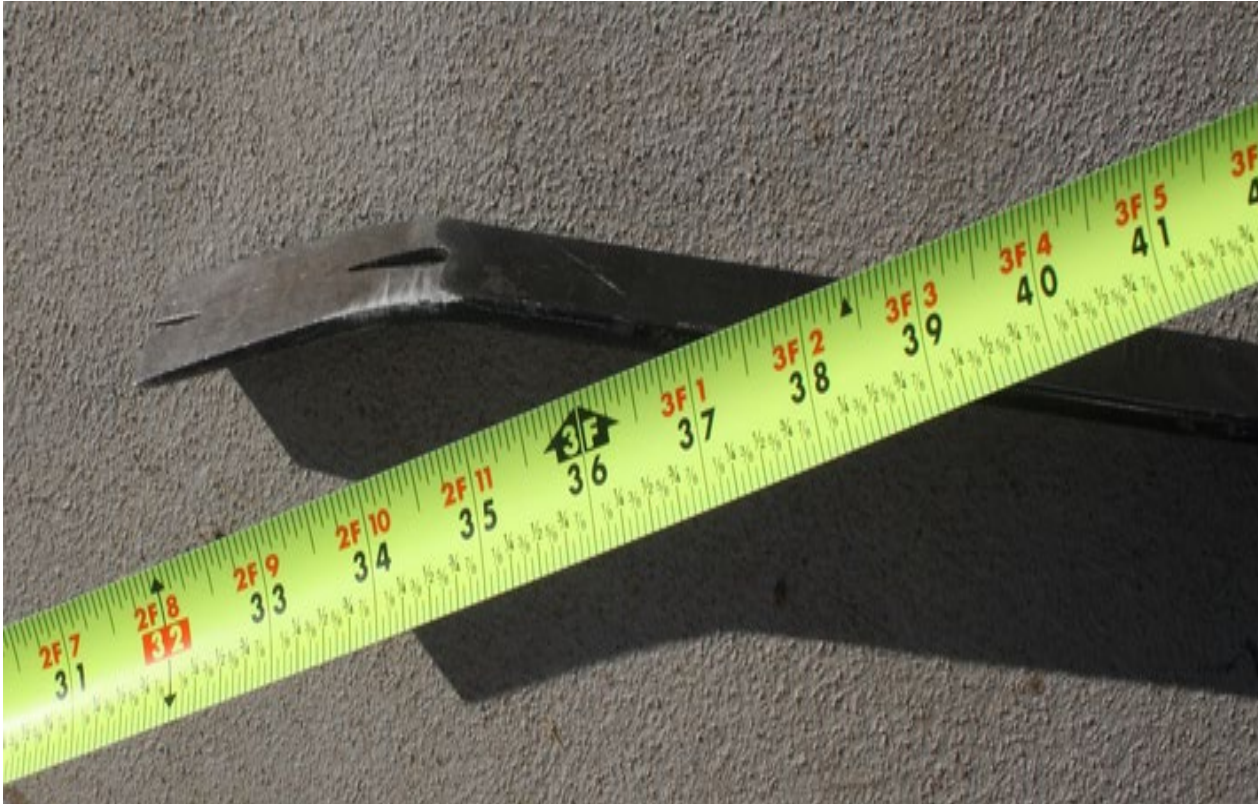
The employer, who had just arrived, and homeowner found him at approximately 7 a.m. on the patio with his pry bar nearby. He was wearing a tool belt but not the personal fall protection equipment that was available in the work truck.

Photo 4. The pry bar the installer was using with a tape measure showing the distance the pry bar was found from him after he fell.

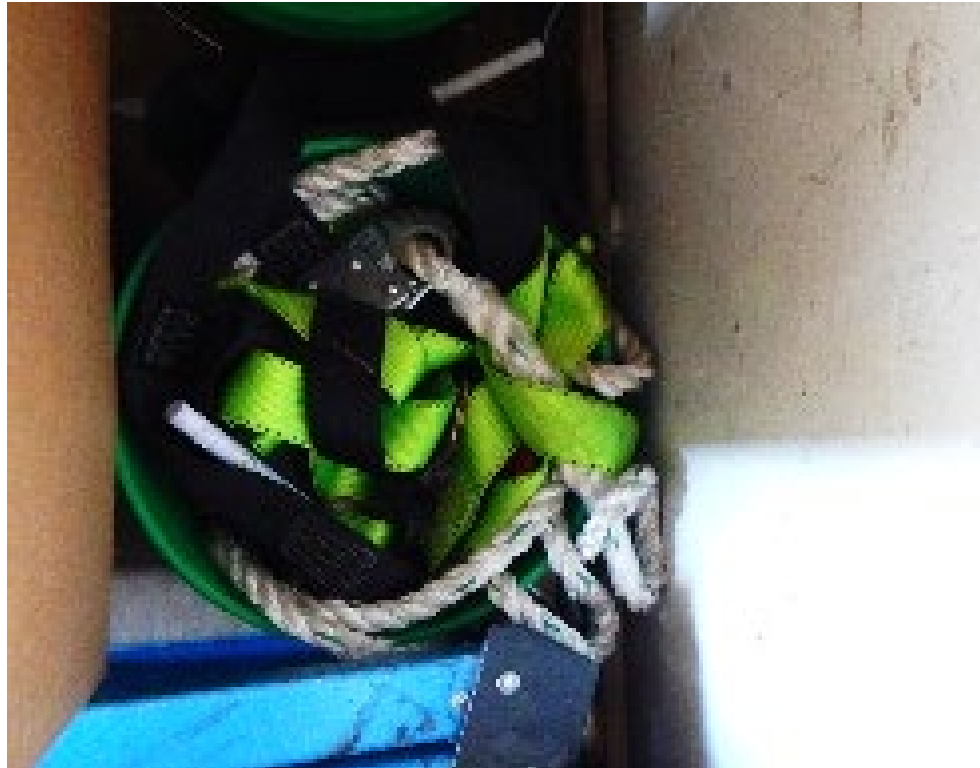
Photo 5. The personal fall protection harness, lifeline, and lanyard that were available in the work truck.
