Tree Trimmer Falls 25 Feet from Bucket

REPORT #: 71-257-2024s

EVENT TYPE: Fall from elevation

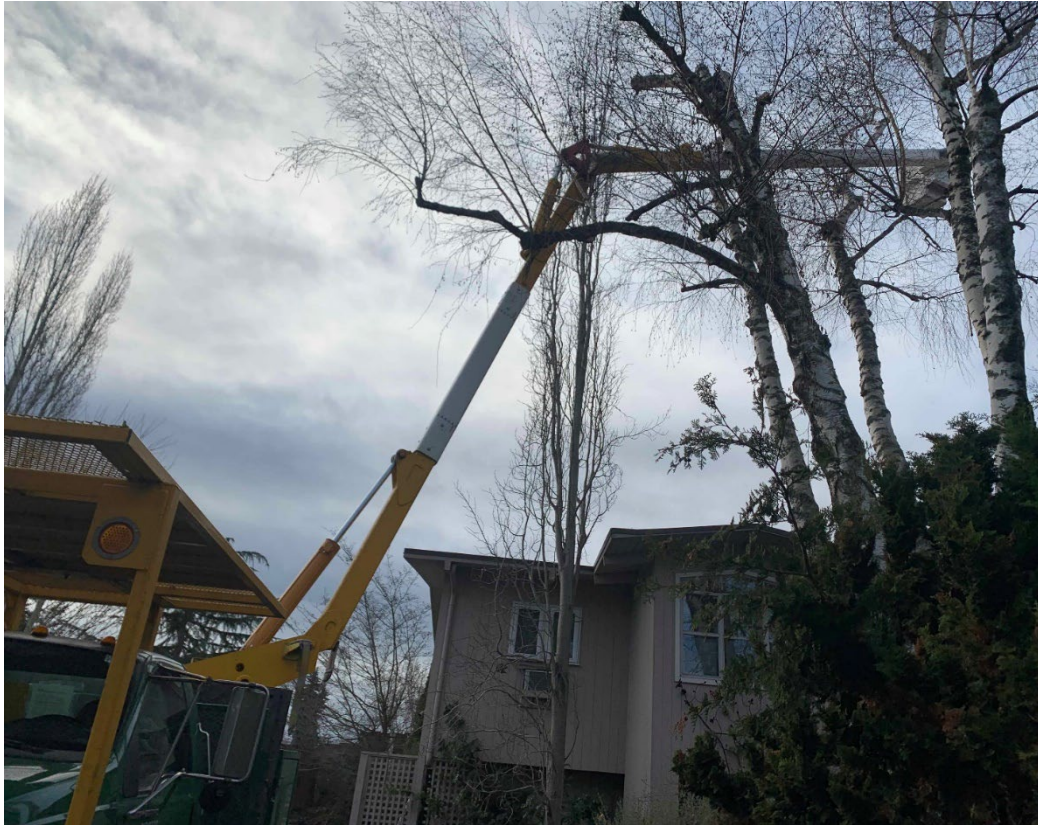
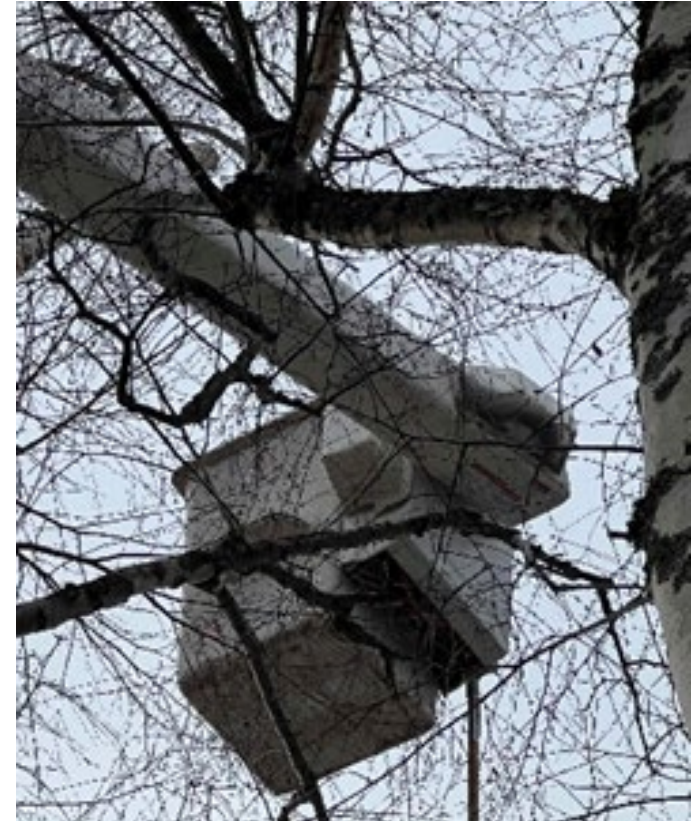
As the bucket went up, the ground crew saw the truck tilting toward the passenger side with its wheels off the ground. The bucket appeared to be caught and pressing on a branch with enough force to tilt the truck. When the bucket broke free of the branch, the truck's wheels slammed down and shook the bucket so violently it ejected the trimmer 25 feet to the ground. The ground crew ran to him, called 911, and began CPR as directed by emergency dispatchers. First responders soon arrived but pronounced him dead at the scene from severe fall injuries.

Photos 1 and 2. Left photo shows boom extended from bucket truck. Right photo shows bucket in branches.

- Develop and enforce policies and standard operating procedures (SOP) in their accident prevention program (APP) requiring:
 - o A co-worker be present to observe when the bucket operator enters the bucket.
 - o The bucket operator to give the co-worker visual confirmation they are wearing a personal fall arrest harness with the lanyard tied-off in the bucket before going up.
 - o The co-worker to yell “all stop” or use a small air horn and press the boom’s emergency stop switch when an unexpected hazardous situation needs to end quickly to prevent injury.

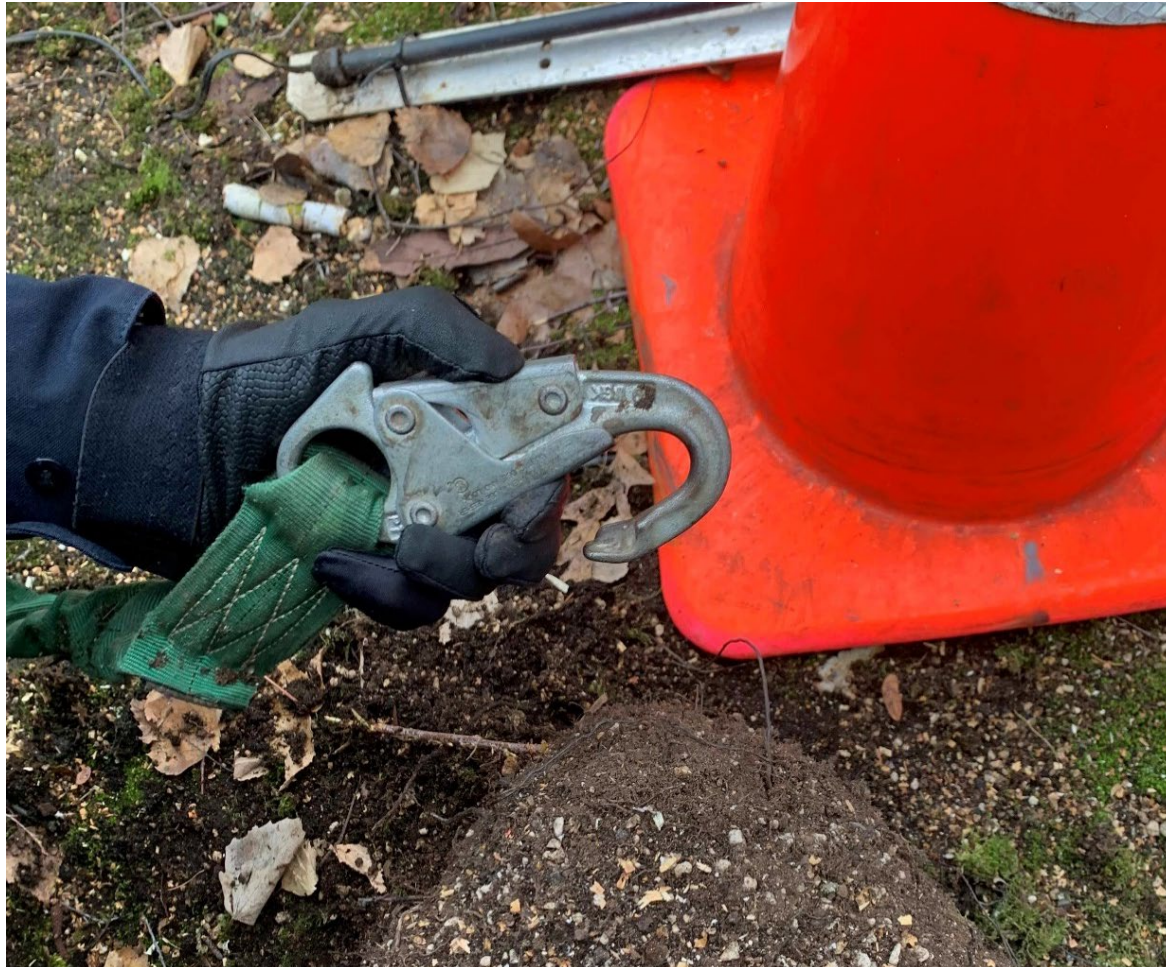
- The worker's fall arrest harness lanyard was not tied-off in the bucket.
- The crew had a safety briefing at the jobsite before starting work.
- The bucket truck manufacturer inspected and found the vehicle to be in safe operating order.

Photo 3. Unsecured snap hook on trimmer's fall arrest harness lanyard.

- Before elevating the platform (aerial bucket), ensure all persons on the platform wear a full body harness with a lanyard attached to either: (a) The manufacturer's recommended attachment point; or (b) The boom or platform if the manufacturer does not specify an attachment point. The employee must never attach a lanyard to an adjacent pole, structure, or equipment. See [WAC 296-880-30015\(2\)](#)

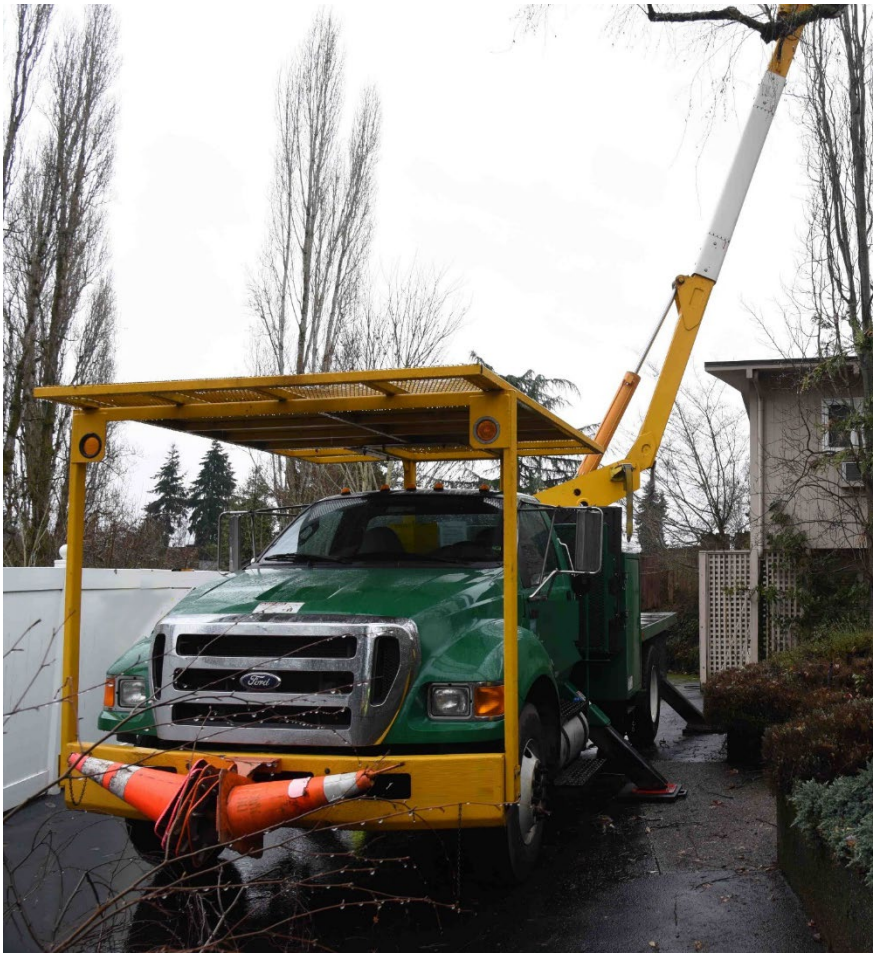
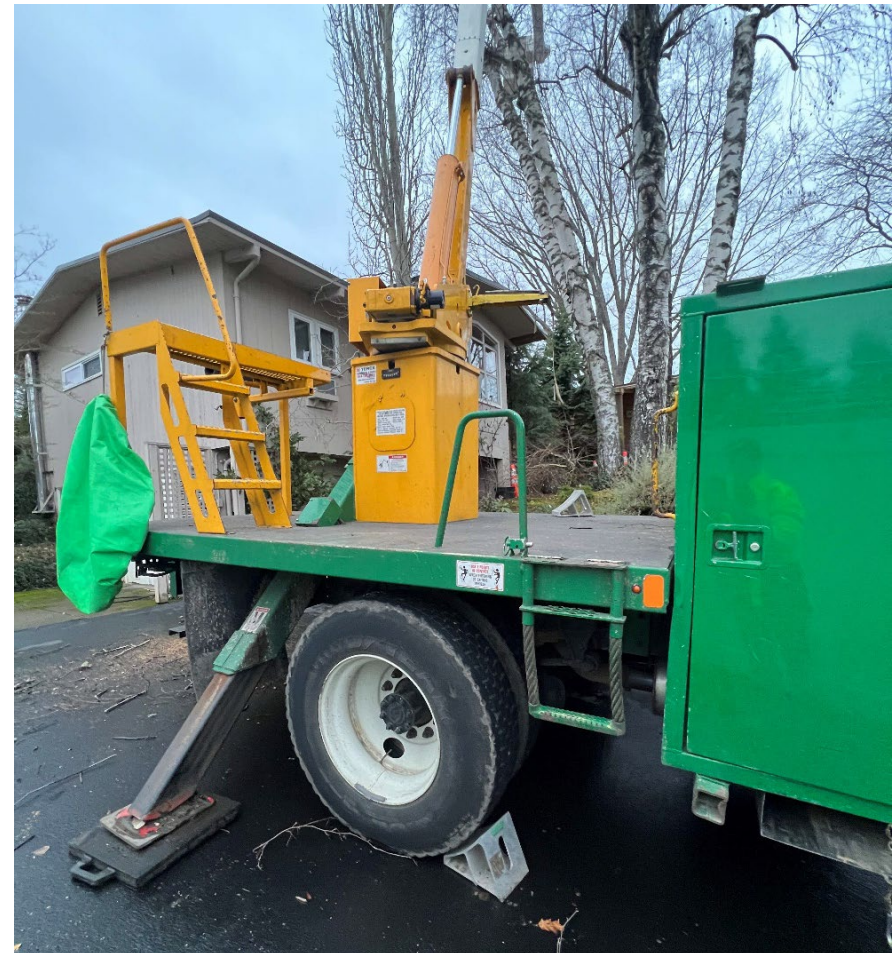
Photos 4 and 5. Left photo shows bucket truck with boom extended. Right photo shows truck's boom lift platform with extended outriggers and rear wheels chocked.

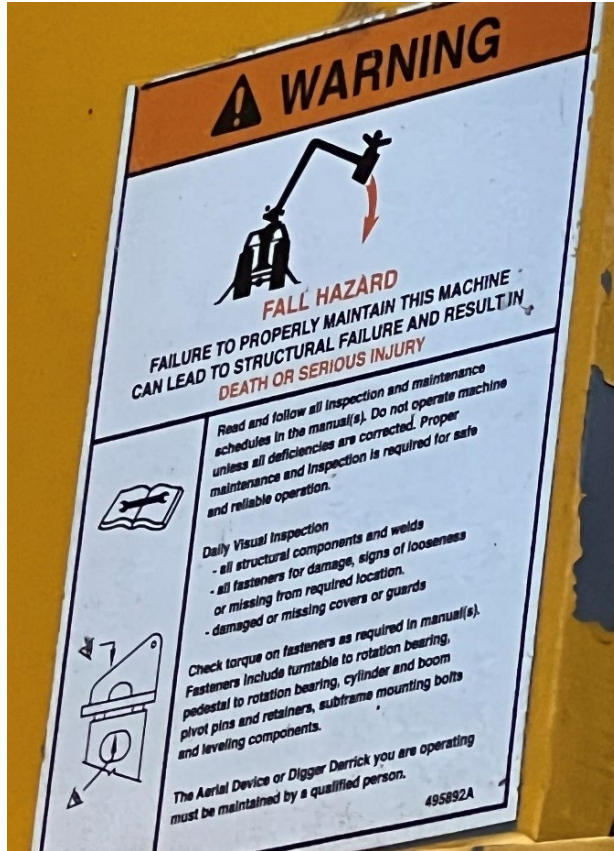
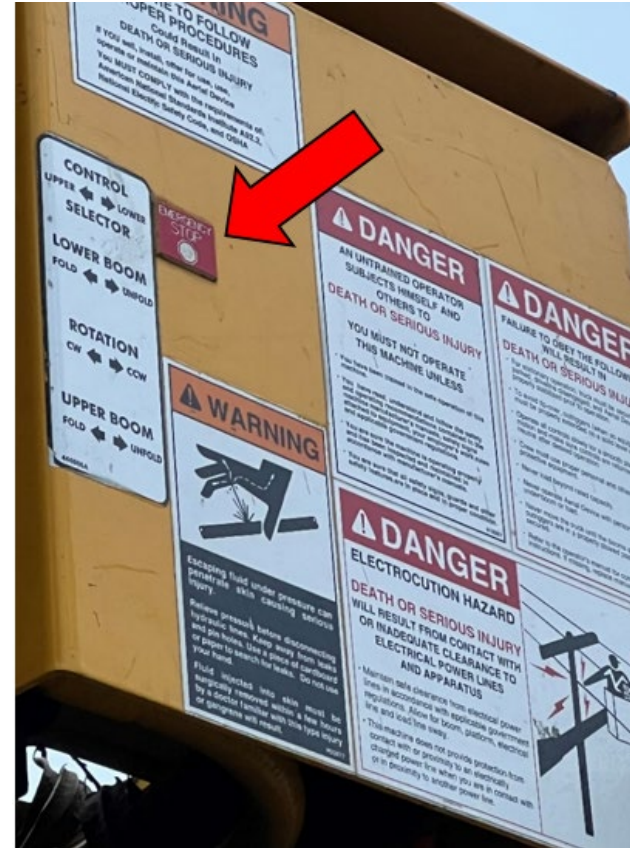
Photos 6 and 7. Left photo shows fall hazard warning label on base of boom lift. Right photo shows other warning and danger labels on base of boom lift. Arrow shows emergency stop switch.
