# AGRICULTURE FATALITY NARRATIVE

# Temp Worker Crushed By Rollaway Forklift at Family Farm

**REPORT #: 71-263-2025s**

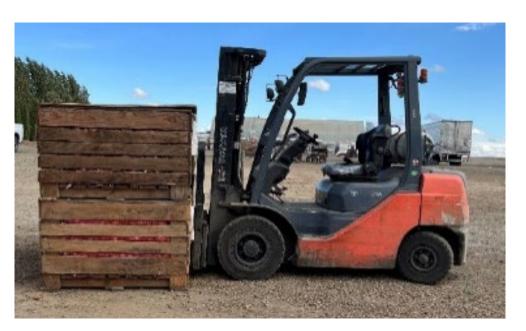
A 43-year-old seasonal farm worker was crushed by a forklift at an onion packing shed. He was working for a temp labor contractor who sent him to work as a pallet wrapper at a family-owned onion farm. He was two months into his third harvest season at the farm.

When he did not return for almost an hour, the supervisor went to look for him. He found the worker crushed between bins loaded on the forklift and bins stacked on the ground. He was unconscious and not breathing. The supervisor backed the forklift off the worker and saw it was in neutral with the parking brake not set. He then returned to the shed and alerted a coworker who called 911. First responders pronounced the worker dead at the scene.

- Develop and enforce PIT policies in their written accident prevention program (APP) that:
  - o Allow only workers who are trained to operate PITs and require supervisors to immediately stop workers who are not trained from using them.
  - o Perform a job hazard analysis (JHA) jointly with supervisors and PIT operators to identify rollaway and crush hazards, such as operating areas with any inclines.
- Establish clear safety communication with host employers to ensure temporary workers get an effective safety orientation, supervision, and training on the job hazards they will be exposed to.

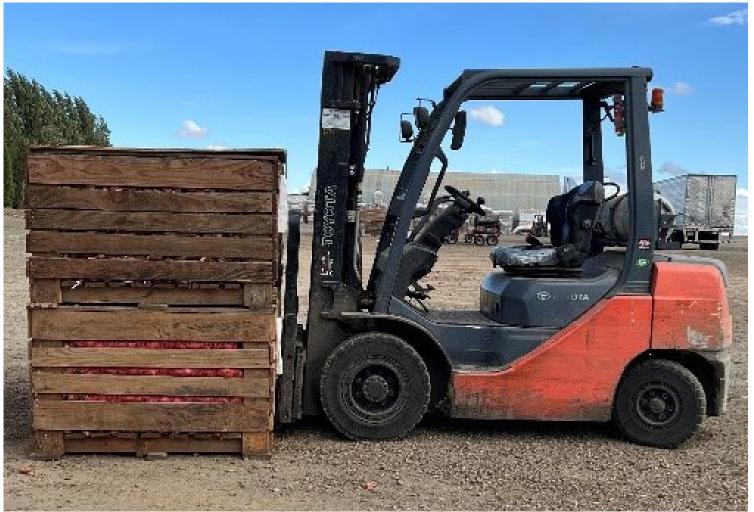
**Photo 1**. Forklift with onion bins retrieved by worker.

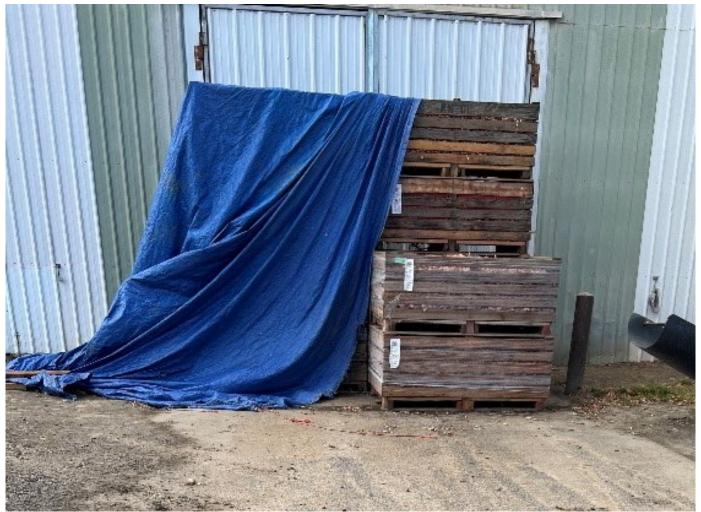
Photo 2. Bins where worker was crushed.

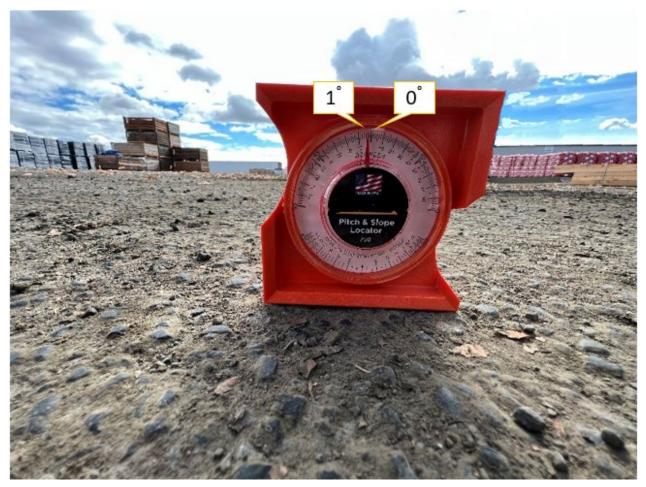
- The worker had been operating the forklift his entire time at the farm without training. The contractor only gave him an overview of forklift safety in an orientation before he began his job.
- The worker picked and lowered two bins, reversed, stopped, and left the forklift on a one-percent grade without setting the parking brake. The forklift then rolled forward into him as he stepped between the bins to adjust a tarp. The area was dark and the only light was from his forklift.

**Photo 3**. Pitch and slope indicator showing one-percent grade at incident site.

Use PITs equipped with automatic parking brake systems that can prevent rollaways by engaging when the driver releases the service brake and leaves the vehicle while it is still idling.
