# Maintenance Worker Crushed by Plywood in Service Truck

**REPORT #:** 71-268-2025s

**REPORT DATE:** July 10, 2025

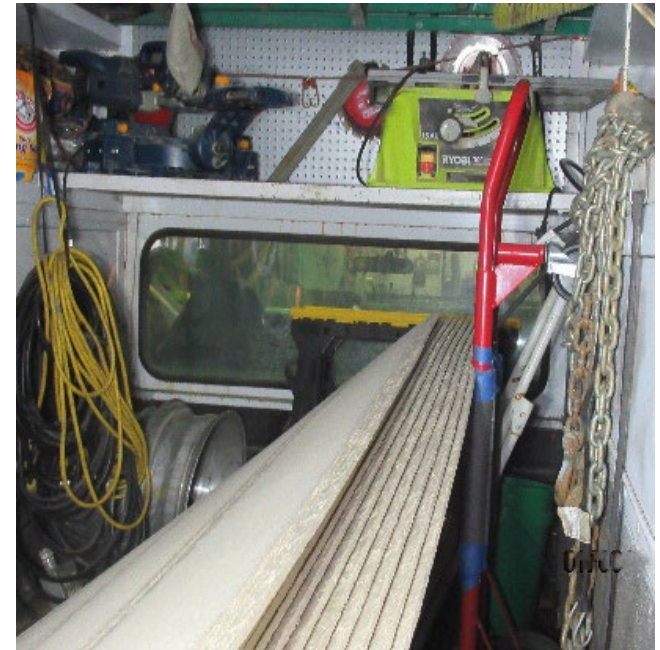
He had loaded 11 four-foot by eight-foot plywood panels in the back of an enclosed body service truck a week before. The panels were stacked upright against the left side of the truck body with the long edge down.

The stack of plywood had shifted to the right and pinned the worker by the neck against a metal cross brace between the dolly's rails. The employer then went in the truck and used his back to push the plywood up enough to pull the worker out. He called 911 and started CPR. When first responders came, they pronounced the worker dead at the scene.

- Perform a job hazard analysis (JHA) that assesses service truck cargo area hazards, identifies cargo organization and storage management solutions, and develops best practices, including daily checks to keep cargo secure, uncluttered, and easy to access. Update the JHA when new vehicles with different cargo area designs are used and when new types of cargo are hauled.

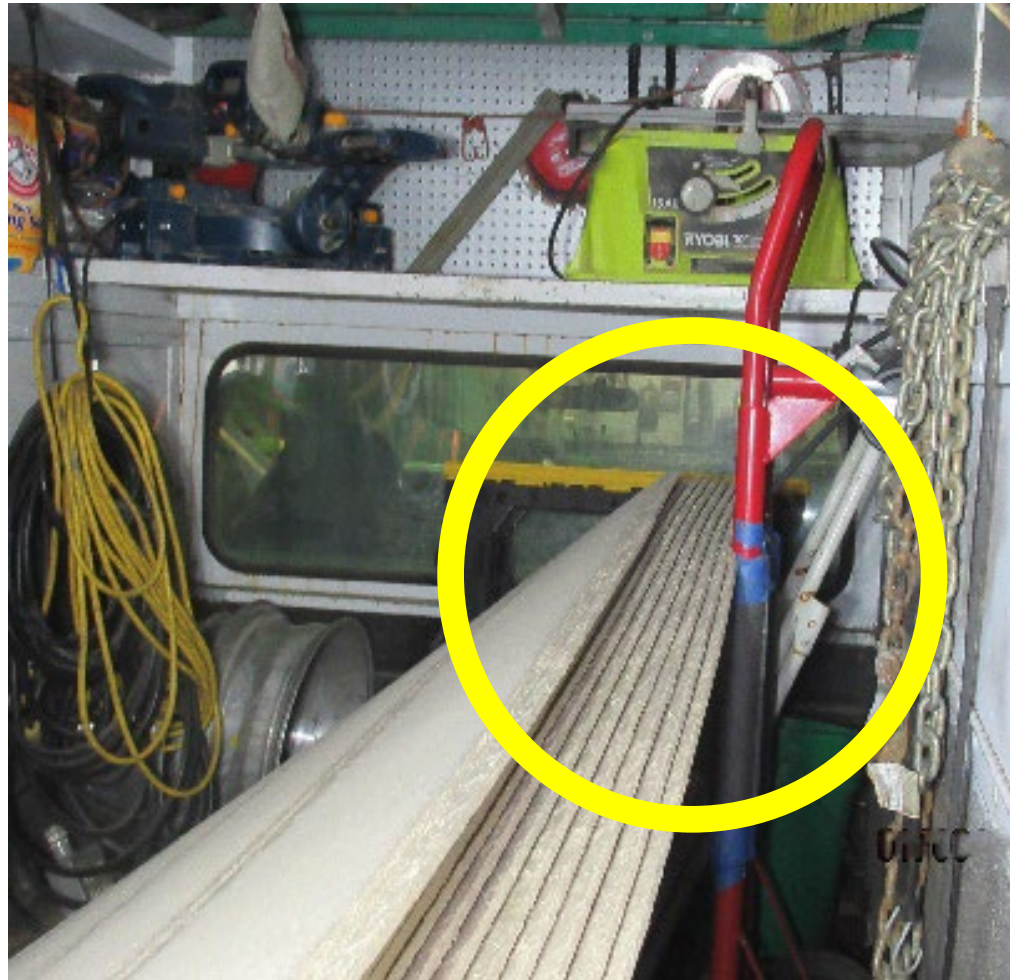
**Photo 1.** Crush point between plywood and dolly.

- Ensure workers load plywood flat and evenly on the truck floor and secure it with ratchet straps at multiple points. Use a panel rack or trailer if truck floor space is limited or if hauling plywood frequently. Require workers to use a buddy system when loading and unloading heavy cargo.
- Develop your written accident prevention program (APP) to have a service truck cargo policy with requirements to safely organize, secure, and store tools, equipment, and materials inside vehicle cargo spaces. Train workers how to meet requirements and enforce the policy.

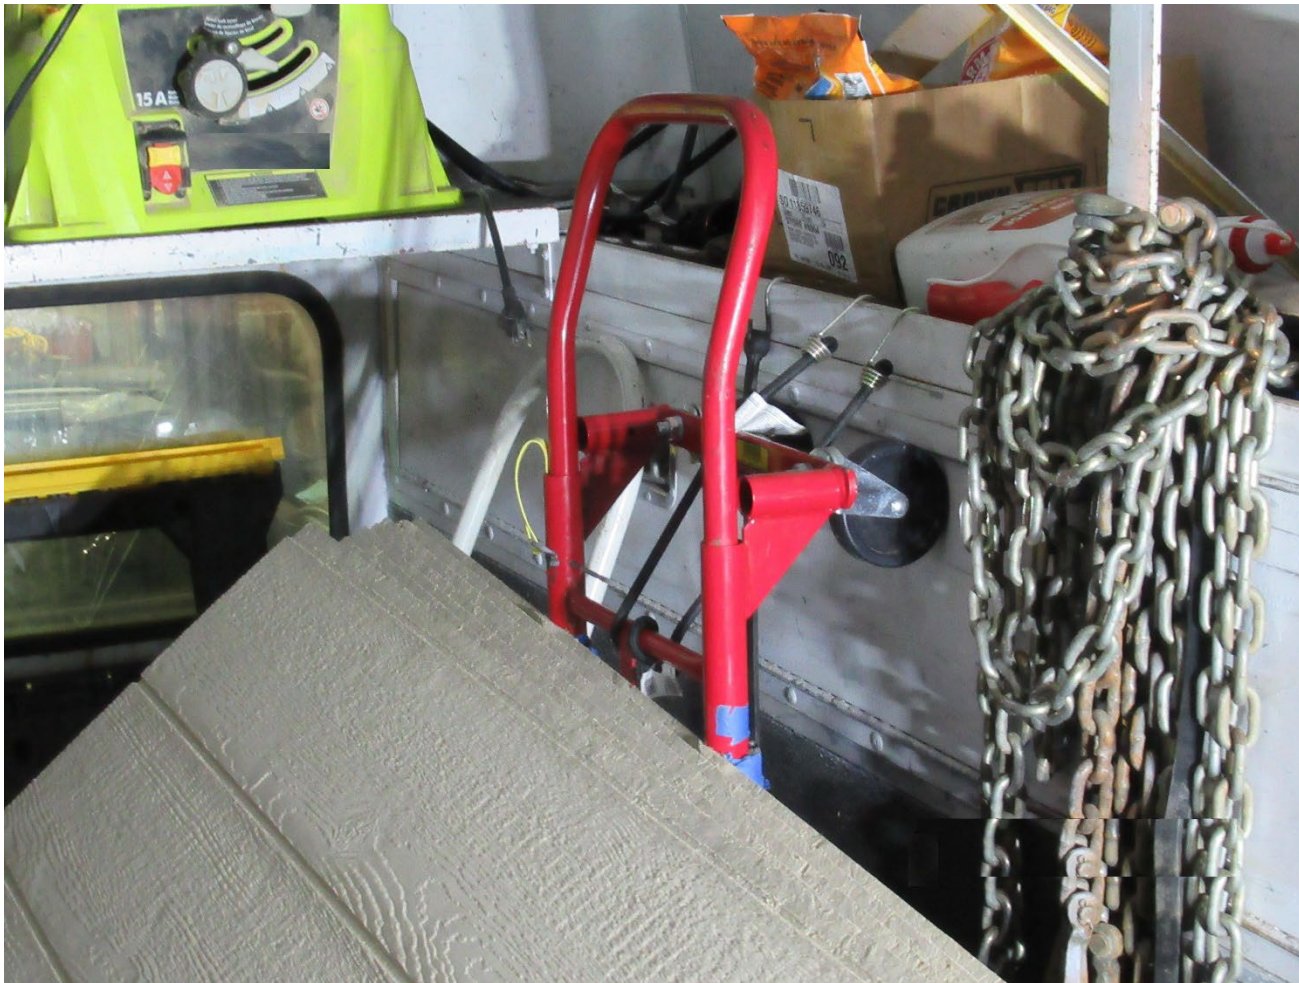
**Photo 2.** Close up of crush point.

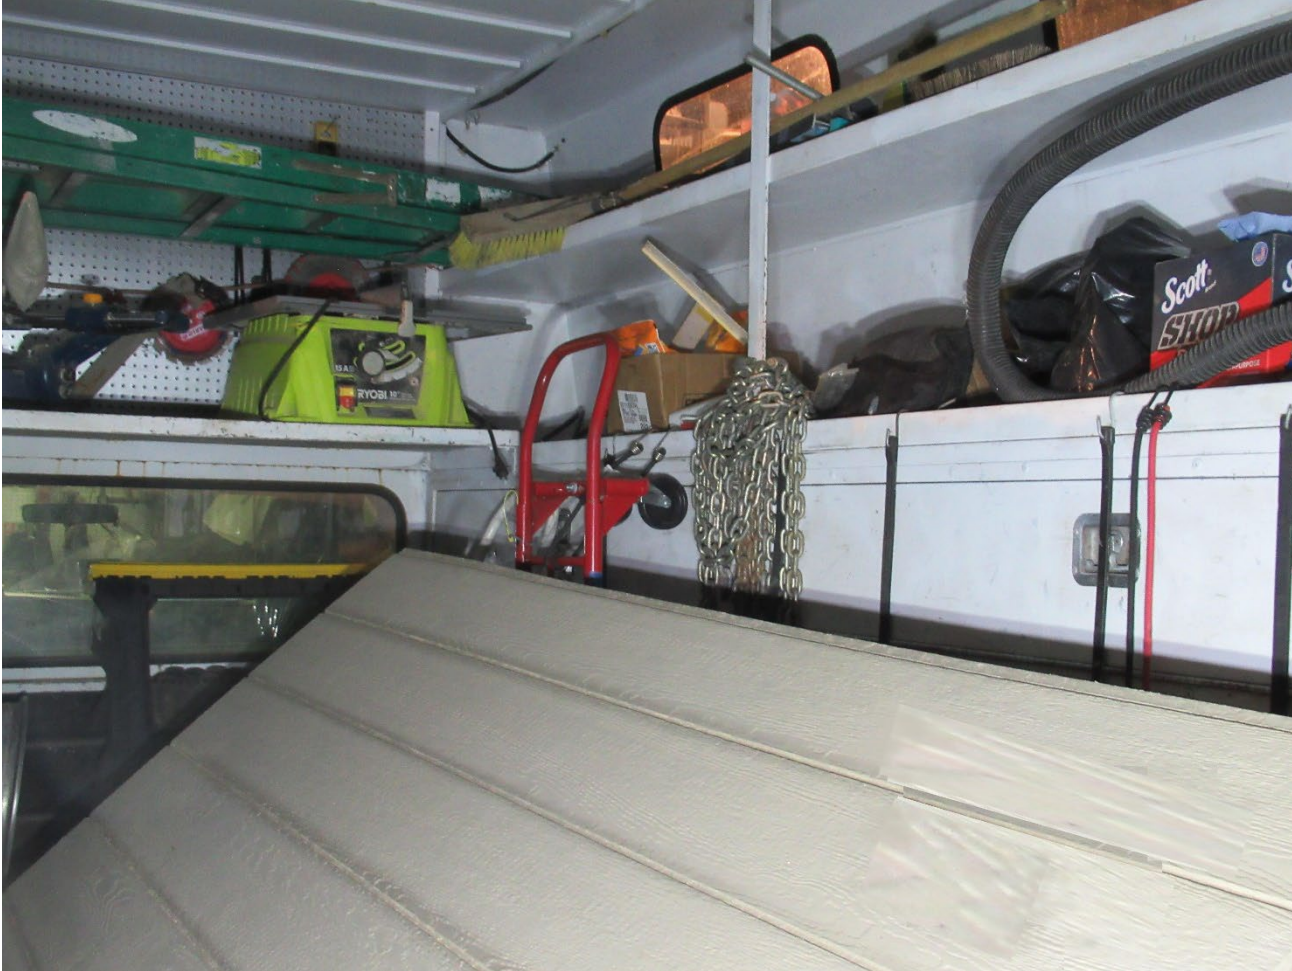
**Photo 3.** Plywood leaning against dolly.

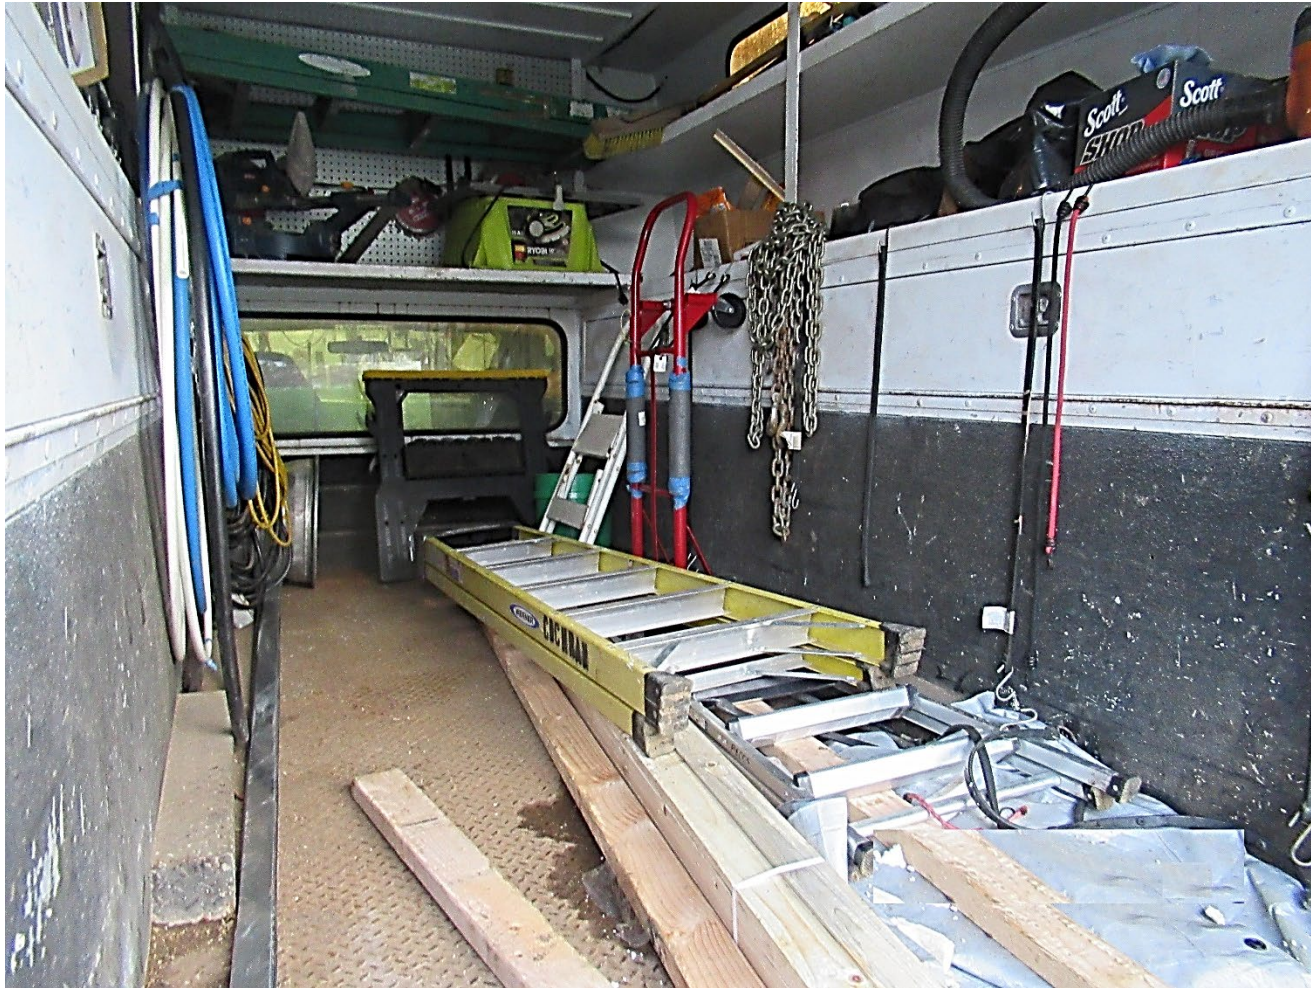
- Each plywood panel weighed between 35-40 lbs., for a total weight around 450 lbs. The crew had a safety briefing at the jobsite before starting work.
- Based on the worker's body position and the direction of his head, he had likely been standing and facing the plywood when something made it shift and fall toward him.
- It is unknown if the plywood had been secured or not.
- Lumber and ladders laying on the truck floor may have presented a tripping hazard.

**Photo 4.** Ladders and wood that were under plywood.

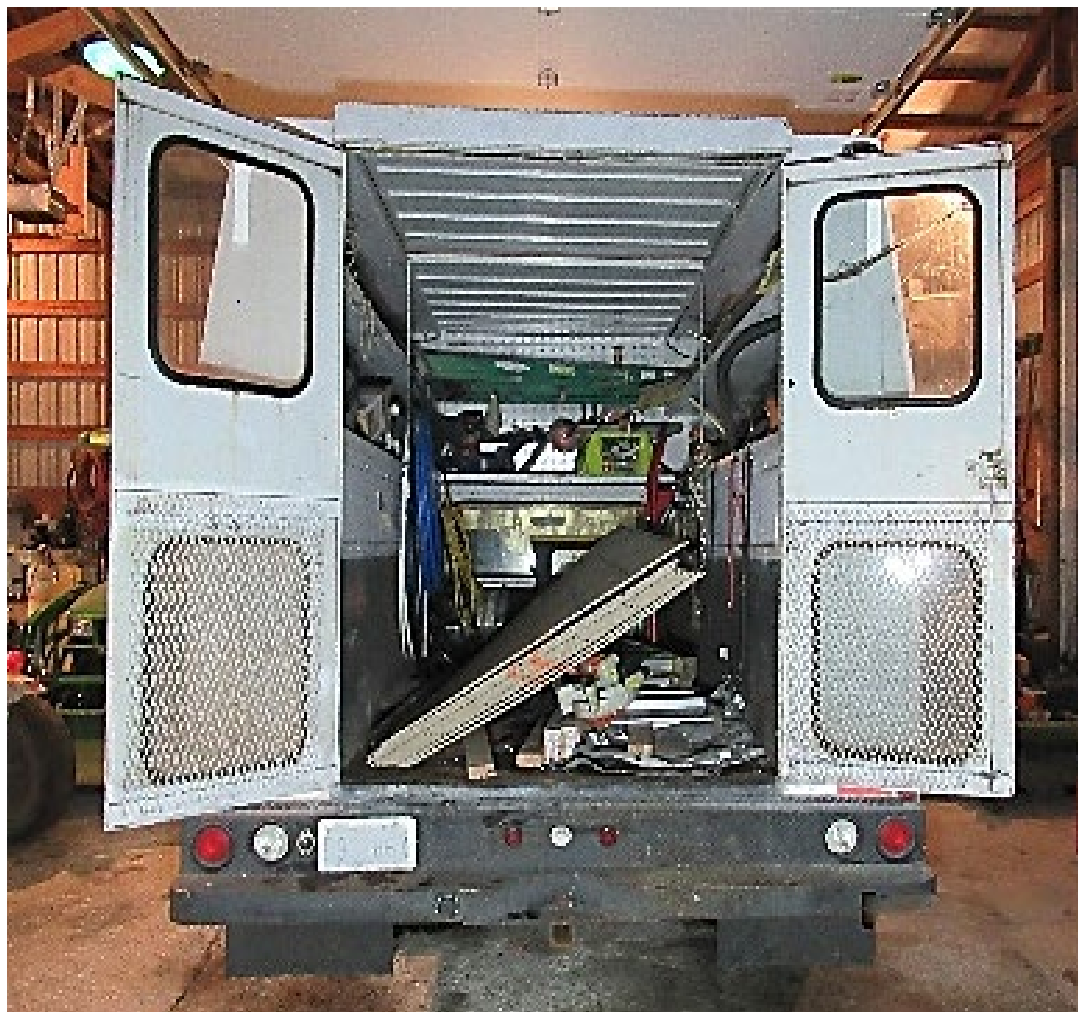
**Photo 5.** Rear view of truck cargo area.
