## Framer Falls 25 Feet from House Roof

**REPORT #:** 71-224-2022s

**REPORT DATE:** July 18, 2022

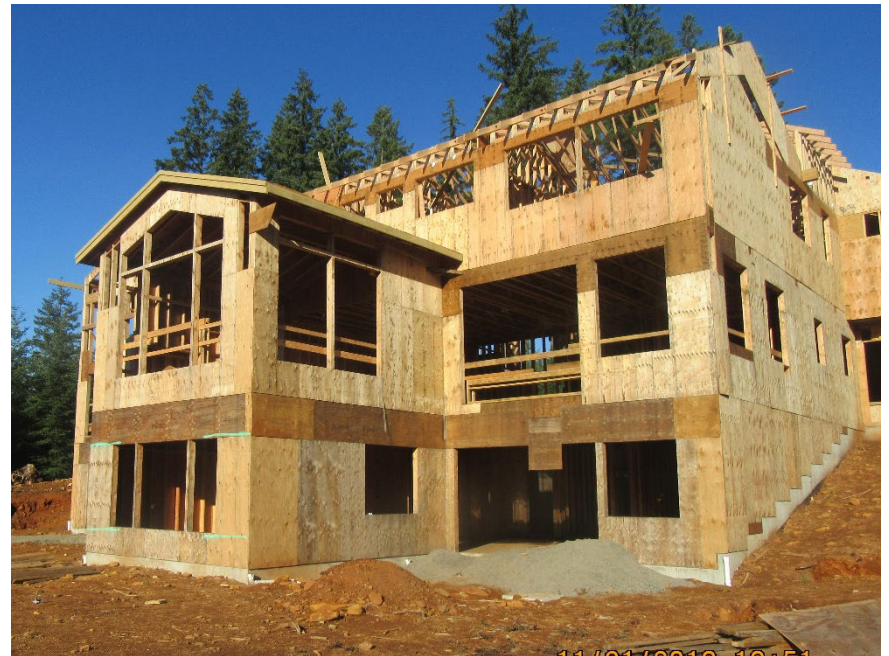
A framer was seriously injured after falling 25 feet from a sheathed low-pitched roof of a house being constructed.

Around 8 a.m., for an unknown reason, he went onto the already sheathed 4/12 pitch roof on the backside of the house. He was not wearing his personal fall protection harness; he had left it in his vehicle. The sheathed roof was wet with dew. While on the roof, he fell 25 feet to the ground below.
