Mechanic Crushed by Bin Destacker

Industry: Postharvest Crop Activities

Task: Replacing a bin destacker cylinder

Type of Incident: Crushed by machinery

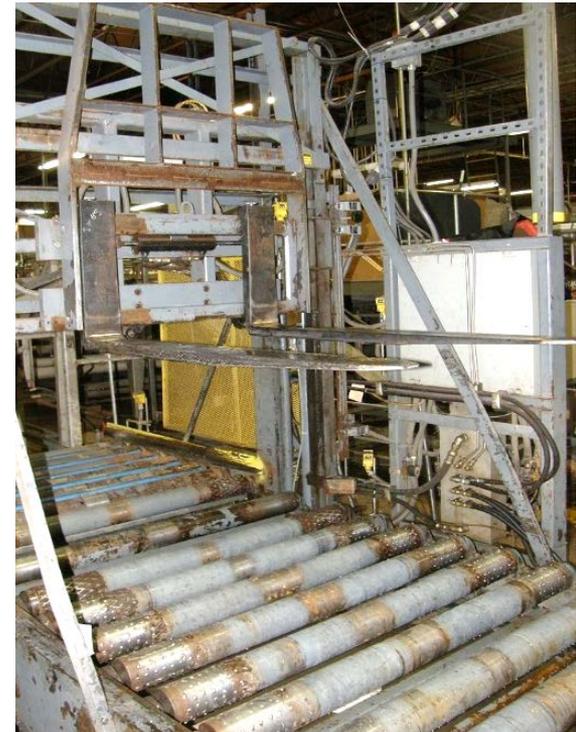
The mechanic was kneeling on the rollers underneath the destacker forklift assembly when he disconnected a hydraulic line that caused the assembly to fall and crush him.

Hydraulic hose fitting located under the rollers that the mechanic disconnected, which released the hydraulic pressure and caused the bin destacker forklift assembly to fall on him.

Photo 1. Bin destacker hydraulic cylinder (circled) which controlled the machine's forklift assembly that the mechanic was attempting to replace.

- Conduct a job hazard analysis of machinery and equipment, processes, and tasks to identify potential hazards employees might be exposed to.
- Develop written standard operating procedures (SOPs) of machinery and equipment to ensure safety of employees. The SOP should include maintenance and repair work.

- Develop and enforce written lockout and tagout procedures that are specific for each machine or piece of equipment.
- Ensure that employees perform appropriate lockout/tagout procedures to control hazardous energy before conducting maintenance on machinery.
