# ***FATALITY NARRATIVE***

## **Carpenter Falls 60 Feet from Bridge Platform**

**Industry: Highway, Street, and Bridge Construction**

**Task: Dismantling bridge concrete form**

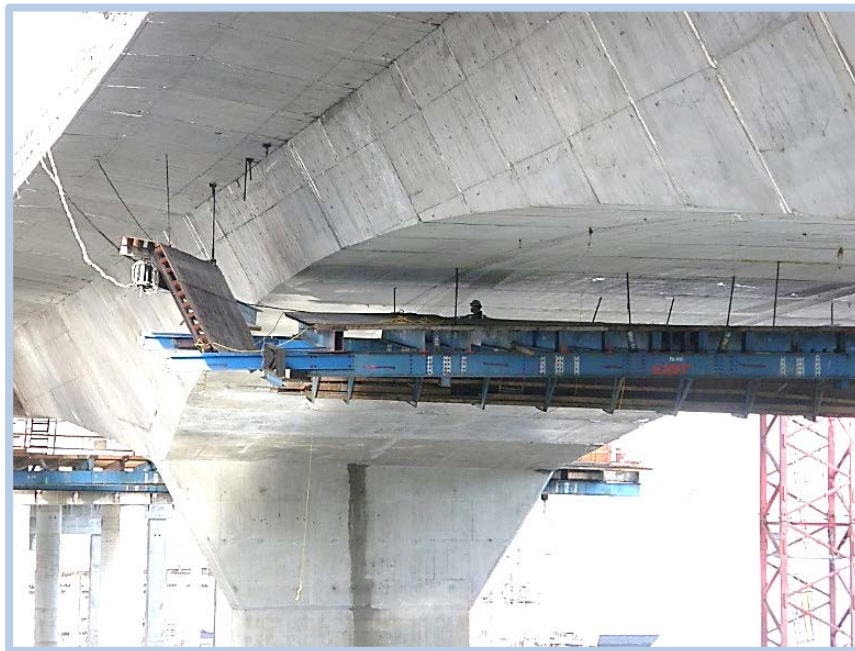
In March 2015, a 34-year-old journeyman carpenter died when he fell 60 feet from a concrete form suspended below a bridge.

Keeping the chain hoist in place, the victim wearing a full body harness with a retractable steel cable lanyard went to the top of the wing wall and cut the rod. Cutting the rod caused the wing wall to shift. The victim lost his balance and slid down the wing wall and fell into an opening between the wing wall and the main concrete form. His lanyard cable severed when it went over the steel edge of the main form and he fell 60 feet to a concrete pier below.

The investigation identified that the victim's fatal fall was due to improper use of the retractable lanyard. The victim was working more than 6 feet above his anchor point and during the fall the cable went over a steel edge of the form, both of which the lanyard manufacturer warns against. Also, there were retractable lanyards located above the victim that could have been used as an anchor point.

When an unplanned situation arises that exposes workers to fall hazards, stop, regroup and discuss what should be done to address the issues. If changes to the fall protection work plan are needed, make those changes and retrain all those involved.
