Groundskeeper Crushed when UTV Tips Over

REPORT #: 71-228-2022s

REPORT DATE: October 14, 2022

FATALITY NARRATIVE

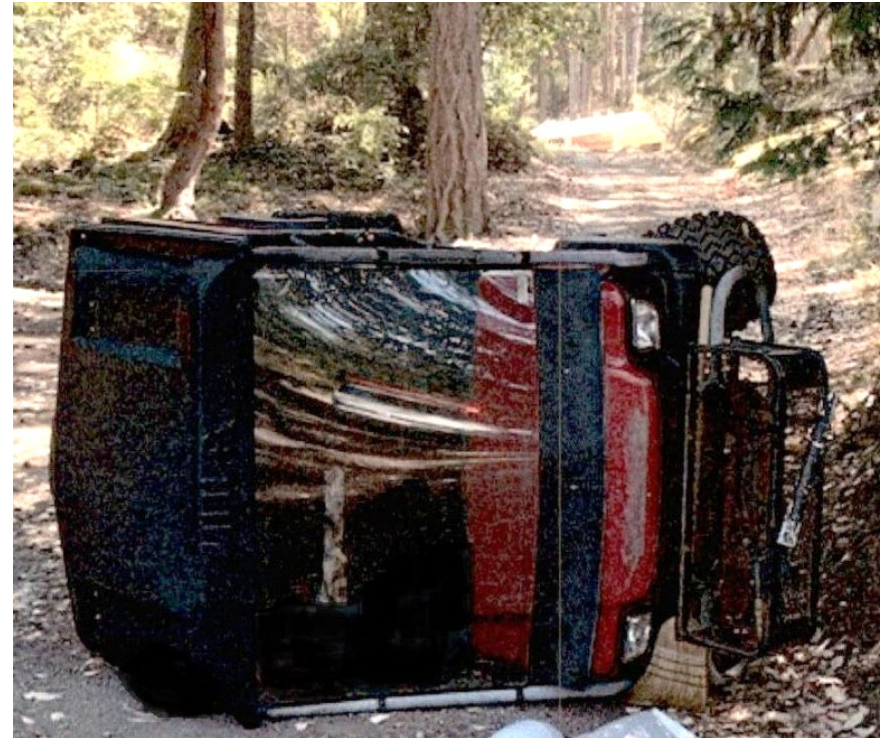
A 68-year-old residential property groundskeeper/caretaker died when the Utility Task Vehicle (UTV) she was operating tipped over. The UTV had no seatbelt.

As she drove the UTV downhill along the access road, the UTV swerved, and the front driver's side tire hit a tree root on the roadside embankment. This resulted in the UTV tipping over onto its passenger side.

The groundskeeper, unrestrained by a seatbelt, was ejected from her seat, pinned and crushed under the UTV's frame/rollover protective structure (ROPS). She died at the scene.

- The incident UTV's manufacturer provided lap-style seatbelts had been removed shortly after it had been purchased by the employer in 2007.
- The groundskeeper had been operating the UTV in order to carry out various tasks on the property without a seatbelt for 14 years.

- Do not remove or alter manufacturer provided safety features.
- Do a job hazard analysis (JHA) of tasks involving UTV vehicles as part of an APP. Workers should be involved in creating the JHA.
- Ensure that workers:
 - Always wear a seatbelt when operating or riding in a UTV.
 - Are trained and follow manufacturer guidelines for safe operation of equipment.
