# **SERVICES** FATALITY NARRATIVE

#### Window Cleaner Falls 50 Feet

REPORT #: 71-181-2019s

REPORT DATE: May 1, 2019

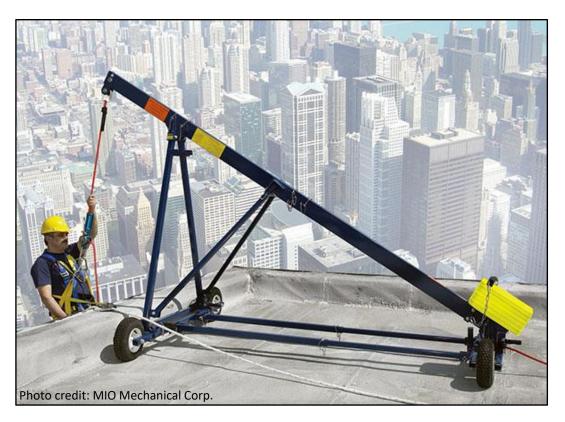
Example of roof rig mobile anchor point for suspended worker with Boatswain's chair (Not the incident rig, but a similar type).
