LANDSCAPING SERVICES FATALITY NARRATIVE

Tree Trimmer Dies when Tree Removal Rigging Fails

REPORT #: 71-234-2023s

REPORT DATE: February 27, 2023

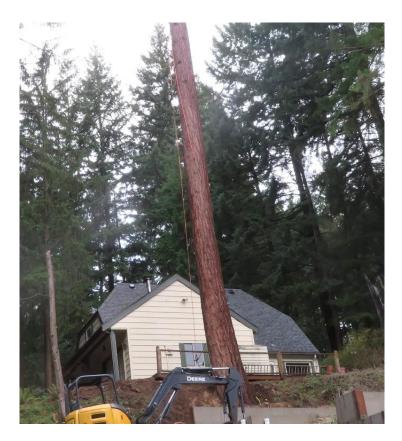
A 28-year-old tree trimmer died after he fell down an embankment, hitting his head against a rock.

However, they did not have a rope long enough, so they tied two ropes together. The knot tying the ropes together would not fit in the port-a-wrap so they did not use it. Instead, they wrapped the rope twice around the tree for friction to lower the tree sections.

The climber cut off a 330-pound section from the tree. It fell about one foot before the rope holding it became taut. The weight of the section caused shock loading on the rope, which lifted the tree trimmer and the other worker off the ground.

- Due to the rigging design and weight of the section they were lowering, the ground workers were unable to control it during descent.
- The employer did not develop a formal, written accident prevention program (APP) tailored to the needs of the particular workplace or operation and to the types of hazards involved.
- There was no qualified person to supervise at the site.

Develop APP policies that require a Job Hazard Analysis (JHA) with worker participation for each job. A JHA would have identified the hazardous rigging and lowering practices and the potential for being struck by the uncontrolled tree section.
