# CONSTRUCTION FATALITY NARRATIVE

#### Framer Falls 8 Feet from Rim Joist

**REPORT #: 71-264-2025s**

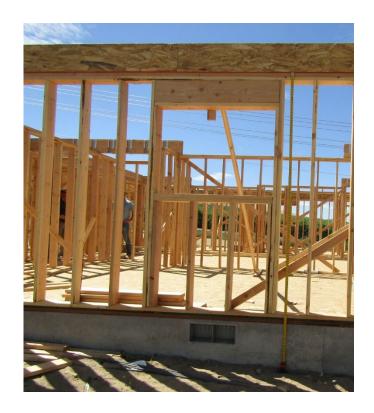
He sat down on a rim joist to wait. The joist was eight feet above the floor decking and had a window opening just below it. He was straddling the joist to support himself above the opening. He then leaned to the inside of the wall and lost balance. Unable to regain balance due to the opening, he fell headfirst to the floor decking below.

- The framer fell from an inside wall height of eight feet, three-quarters inches. The fall hazard to the outside of the wall was nine feet, nine and three-quarters inches. Fall protection was not used because workers were under the 10-foot trigger height for fall protection requirements while installing structural members.
- The framer attended weekly safety meetings where fall protection was a recurring main topic.
- The employer had a written accident prevention program (APP) with a fall protection plan.
- The project manager for the general contractor was on the jobsite when the incident occurred.

- Arrive on-site before work begins or appoint a supervisor to jointly conduct a site hazard assessment with workers to identify fall hazards and develop fall protection solutions.
- During the pre-job safety meeting, review the site hazard assessment and discuss workers' responsibilities to use fall protection and follow fall prevention safe work practices.
