## Roofer Falls 45 Feet through Skylight

**REPORT #:** 71-266-2025s

**REPORT DATE:** May 1, 2025

**SCENE:** Industrial building construction site

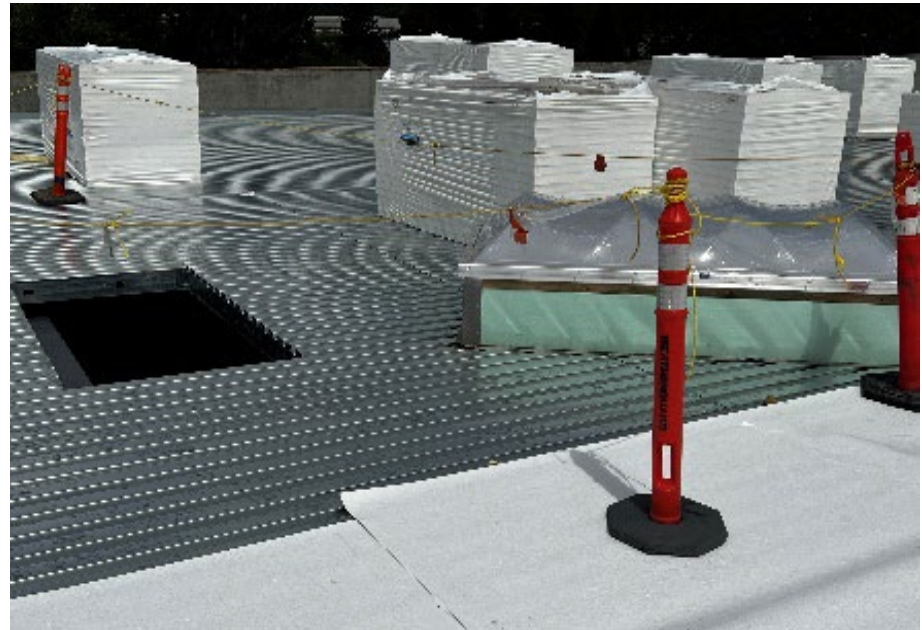
A 29-year-old roofer fell 45 feet through a hole in a roof while installing skylights. He worked for his employer, a residential and light commercial roofing contractor, for 16 months.

They selected an unsecured, approximately four-foot wide by eight-foot long lid and lifted it at opposite ends with the coworker holding the front. They took a half step forward when the coworker heard the roofer's end drop. He looked back and did not see the roofer, realizing he had fallen through a hole they did not know was under the lid.

- The employer, supervisors, and workers lacked understanding of state fall protection requirements for skylight holes and when a monitor or catch is acceptable to be used. The employer's fall protection work plan (FPWP) did not identify skylight holes as fall hazards.

- When roofers work around skylights and openings, provide fall protection guardrails, screens, covers, warning lines, safety nets, or personal fall protection systems and keep the area organized.
- Arrive on-site before work begins or appoint a supervisor to conduct a site hazard assessment with workers to identify fall hazards and develop protection methods and procedures in the FPWP.
