AGRICULTURE FATALITY NARRATIVE

REPORT #: 71-184-2019

Operator Crushed When Tractor and Sprayer Roll Over

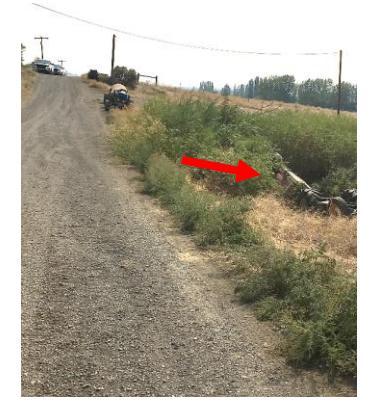
The slight downhill section where the tractor (indicated by arrow) left the gravel road and overturned.

mixing station. He drove out of an orchard block and onto a gravel county road. As he was driving along a slight downhill section in the road, the tractor and sprayer went off the left side of the road, down an embankment, and rolled over. He was thrown from his seat and the tractor landed on top of him, fatally crushing him.

- Employers should train tractor operators to use ROPS and a seatbelt to provide a protective zone for tractor operators in case of a rollover. The use of ROPS and a seat belt is estimated to be 99% effective in preventing death or serious injury if a tractor should rollover.
- When traveling downhill, operators should ensure that they operate the tractor at a safe speed and in an appropriate gear for the slope and terrain, this is especially important when towing equipment such as a sprayer.

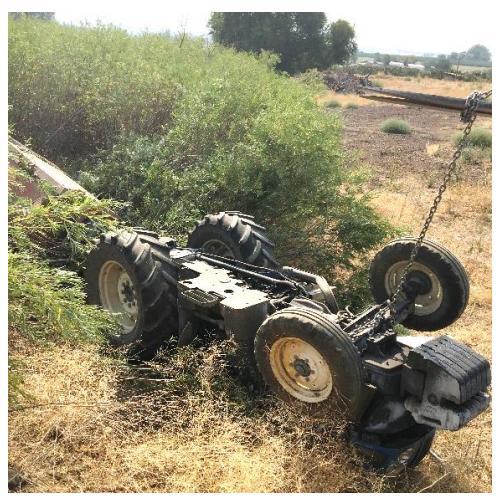
Overturned tractor with sprayer.

Investigators found that the tractor had a foldable rollover protective structure (ROPS), or roll bar, but the operator did not have it in the "up" position as required. While driving on the road, the tractor did not meet the Washington State ROPS exemption allowed in orchards where height clearances would interfere with normal operations. Additionally, the tractor did not have a seatbelt.

- Employers must provide a rollover protective structure (ROPS) for each employee-operated tractor that is covered by WAC 296-307-080. See WAC 296-307-08009.
- Where ROPS are required by WAC 296-307-080 employers must: a) Provide each tractor operator with a seat belt; b) Require each employee use the seat belt while the tractor is moving; c) Require that each employee tighten the seat belt sufficiently to confine the employee to the ROPS protected area. See <u>WAC 296-307-08012</u>.
