# Mechanic Crushed When Rollaway Semi-Truck Hits Trailer

- **REPORT #: 71-213-2022s**
- **REPORT DATE:** January 6, 2022
- **INCIDENT DATE:** September 25, 2020
- WORKER: 47 years old
- **INDUSTRY:** General automotive repair
- **OCCUPATION:** Semi-trailer mechanic
- **SCENE:** Outdoor trailer repair area
- **EVENT TYPE:** Caught in or between

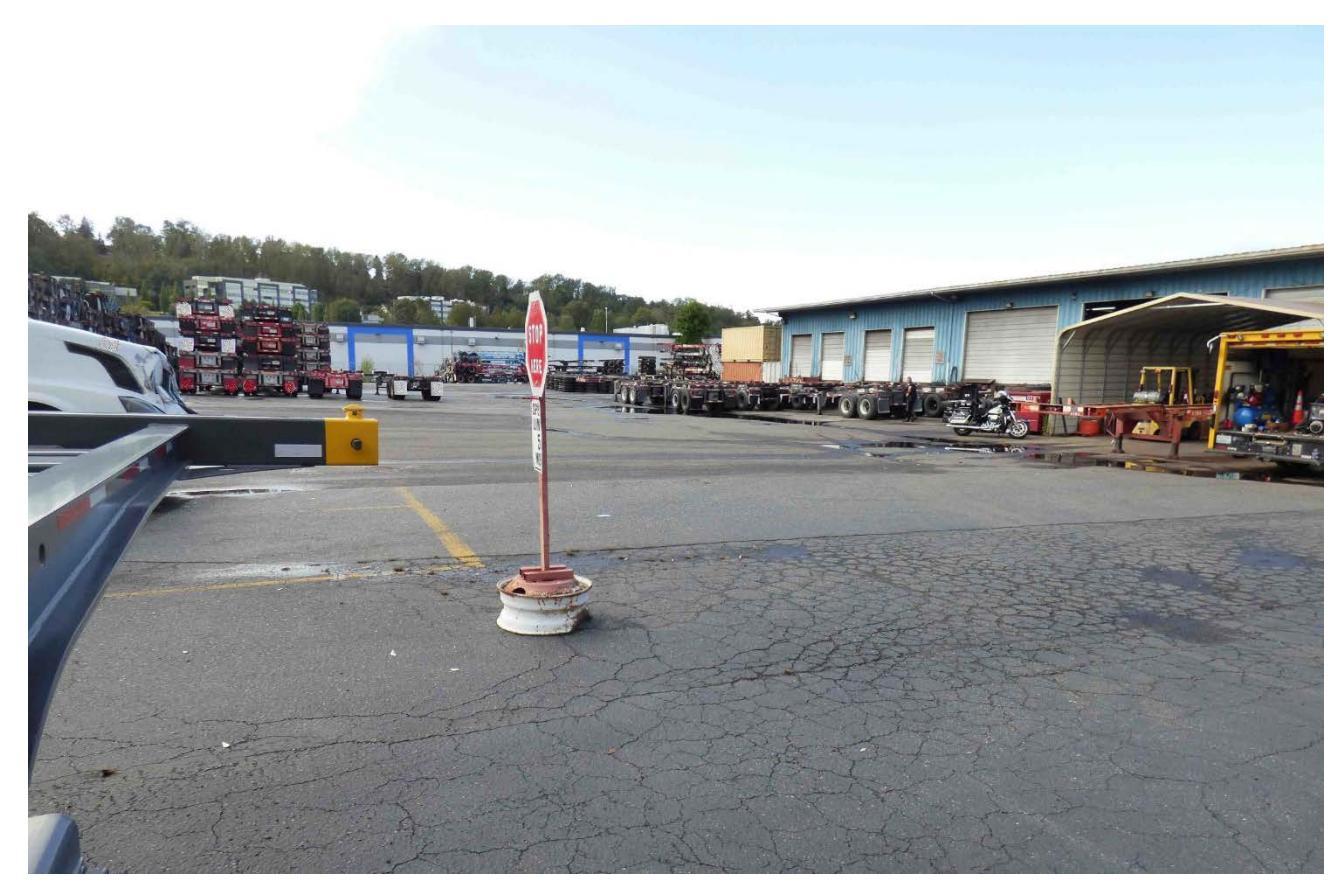
**Photo 1**. Incident scene showing customer's paved trailer leasing yard. The unattended semi-truck rolled from the parking area on the left side of the photo to the repair area on right where it hit the trailer that crushed the mechanic.

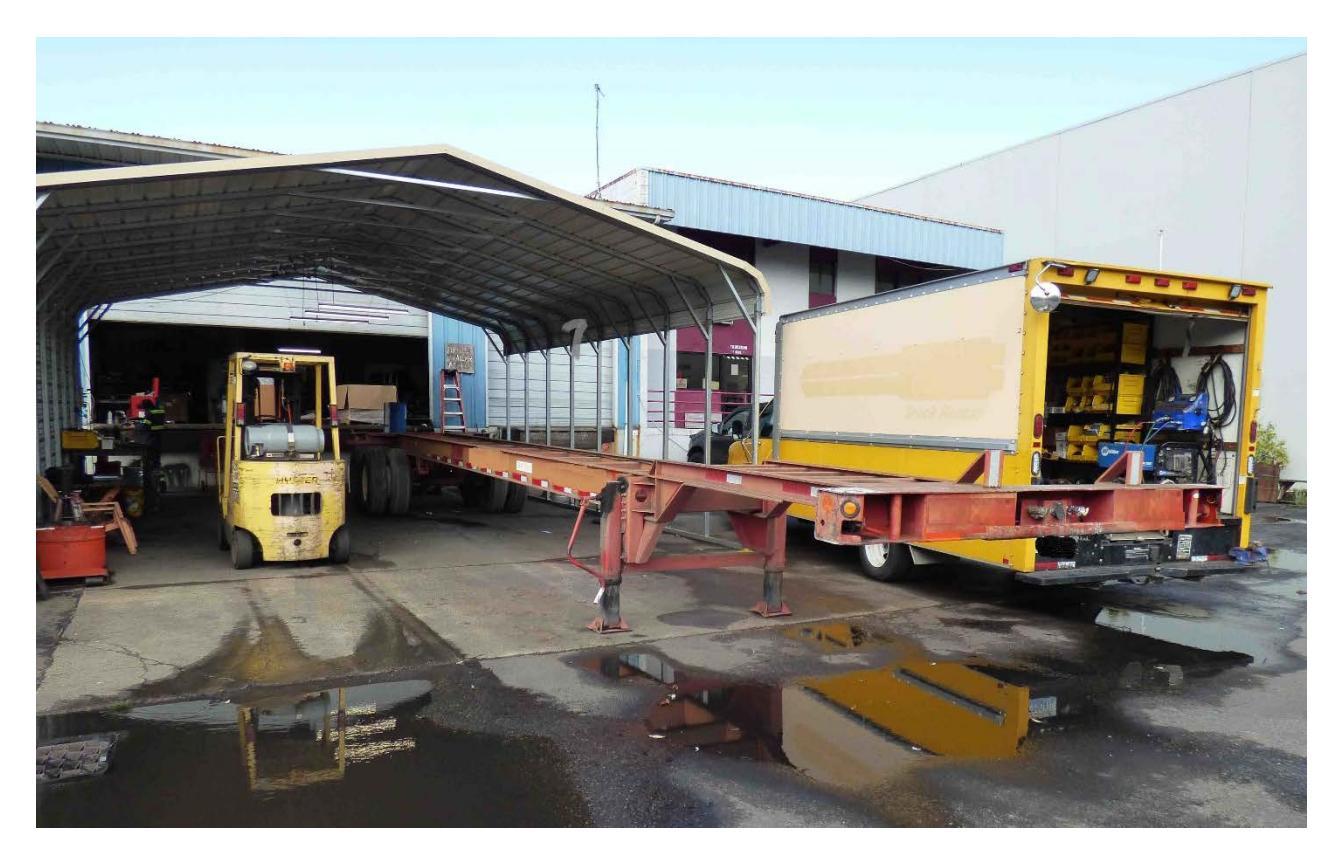
**Photo 2**. View showing outdoor repair area and front of the trailer that was hit by the rollaway semi-truck. The impact pushed the trailer off its jack stands toward the mechanic working behind it, crushing him against a large steel bumper jack.

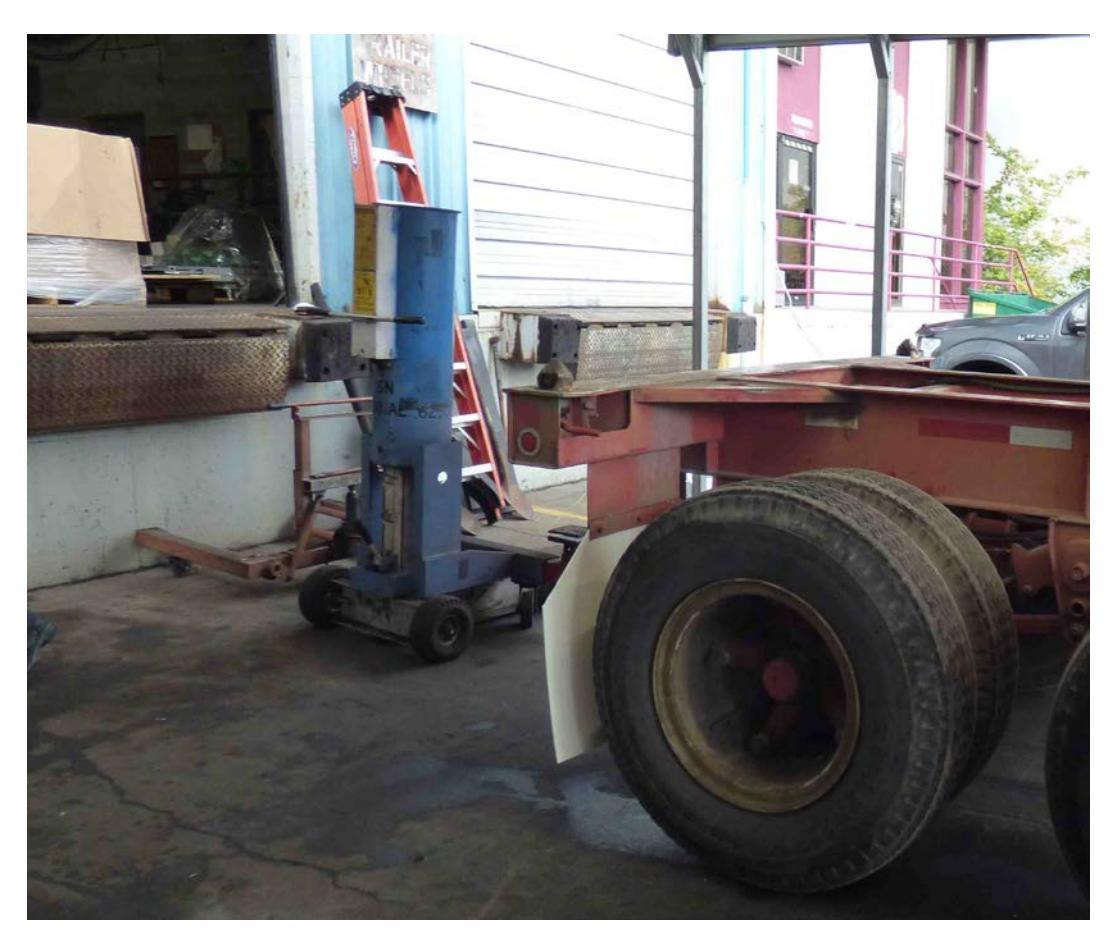
**Photo 3**. View of loading dock and blue steel bumper jack behind the trailer that crushed the mechanic.

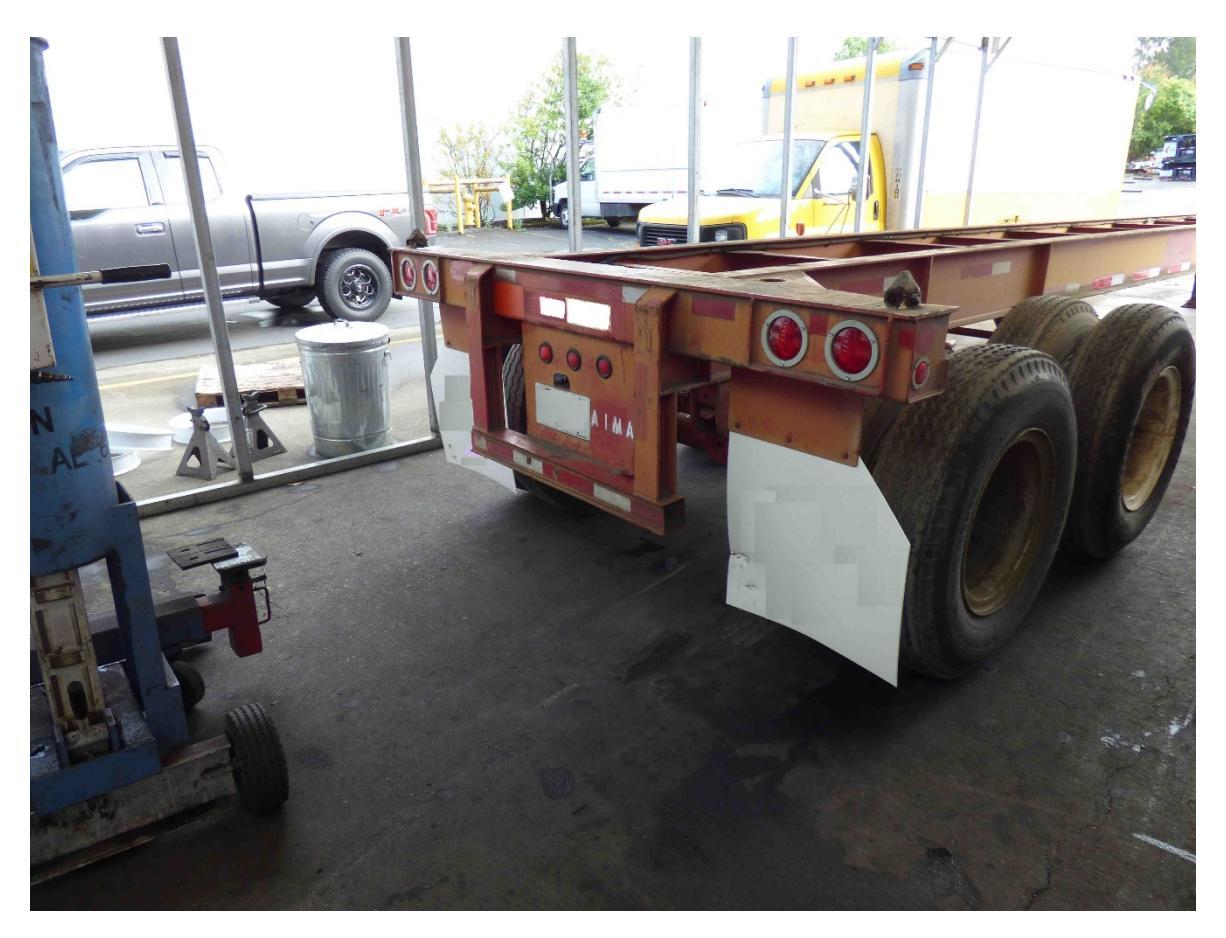
**Photo 4**. View of area where the trailer crushed the mechanic against the blue bumper jack.

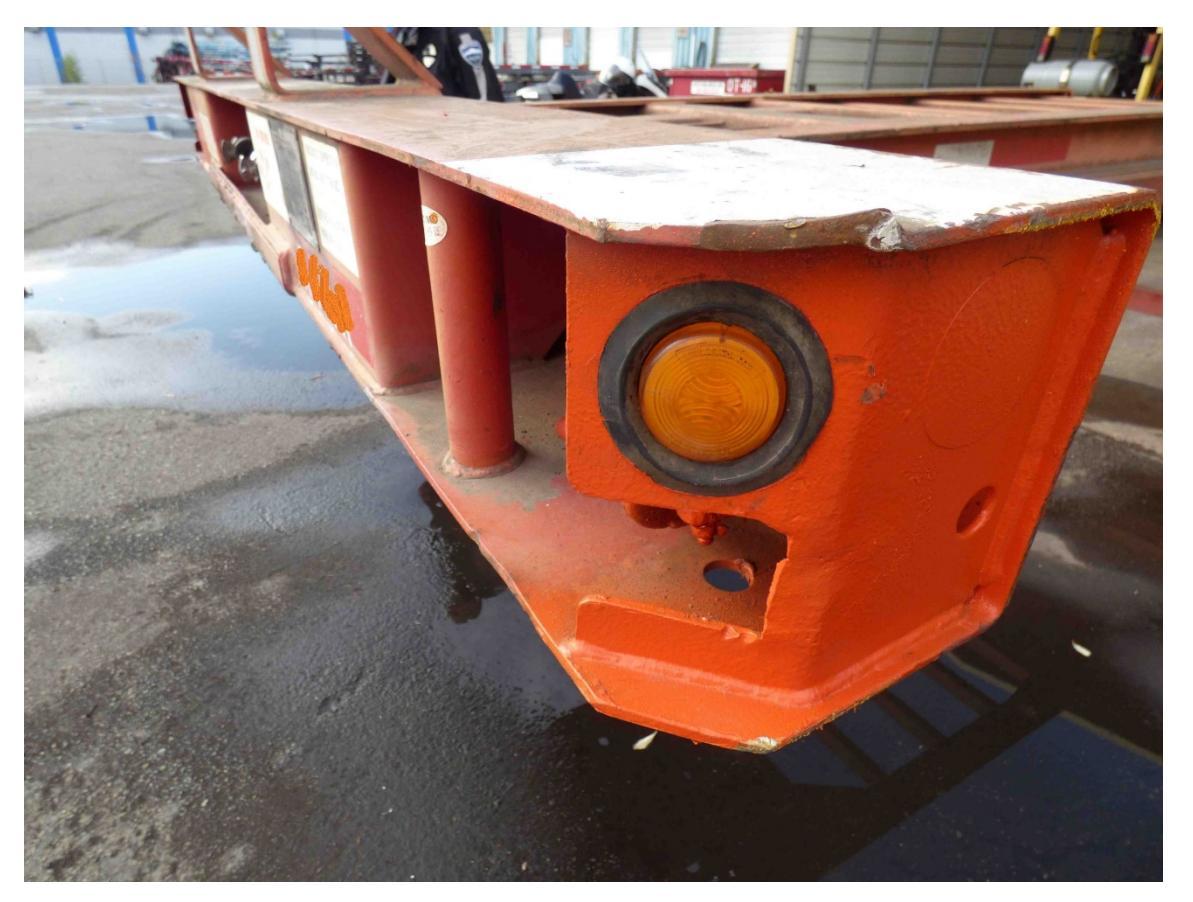
**Photo 5**. View of damage to the front of the trailer where it was hit by the rollaway semi-truck.

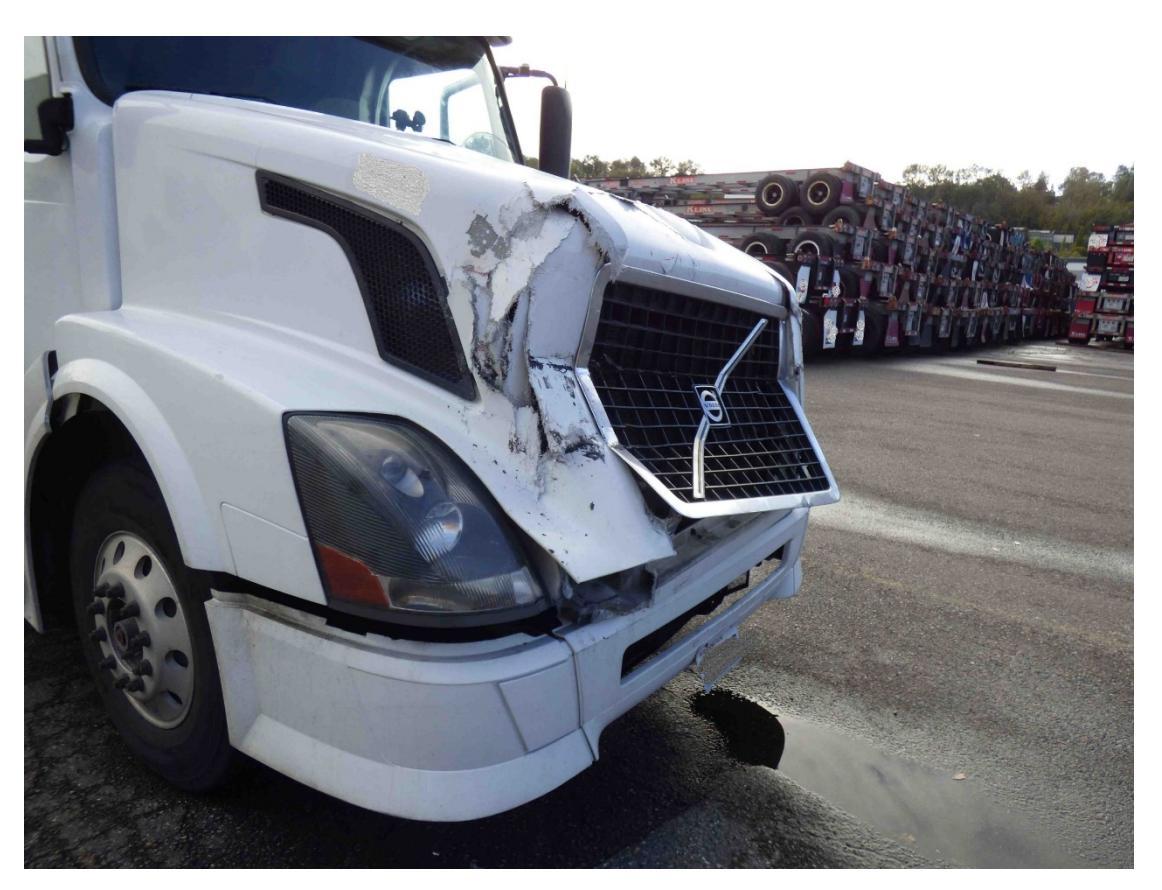
- 1) The second truck had rolled away because it was left on a slight incline with its engine running, automatic transmission in neutral, and parking brake not set.
- 2) The first truck may have briefly kept the second one from rolling, but when it left, the second truck was allowed to roll forward, gain momentum, and accelerate to 5 miles per hour over the 300-foot distance toward the hit trailer.
- 3) The office manager stated that drivers routinely dropped off trailers without stopping their engines and sometimes not setting their brakes.

**Photo 6**. View of damage to rollaway semi-truck's fiberglass engine hood that resulted from hitting the trailer that crushed the mechanic.

Make sure that before leaving any truck unattended, drivers first stop the engine, lock the ignition, remove the key, and effectively set the parking brake. If parked on any visible grade, drivers must turn the truck's front wheels to the curb or side of the road.

- Consider installing an electronic parking brake system designed to automatically apply the truck's parking brake when the driver has not set it before exiting the cab.
- Consider installing commercially available warning alarms designed to alert drivers that the truck's parking brake has not been set when they leave the driver's seat or open the cab door.
