## Media Company Grip Falls Down Empty Elevator Shaft

### SUMMARY

**SHARP Publication # 52-50-2021\_summary.** The full version of this investigation report, along with the detailed recommendations and discussions section, can be found at: [http://www.lni.wa.gov/safety-health/safety-research/files/2021/52\\_50\\_2021\\_MediaGripFall.pdf](http://www.lni.wa.gov/safety-health/safety-research/files/2021/52_50_2021_MediaGripFall.pdf)

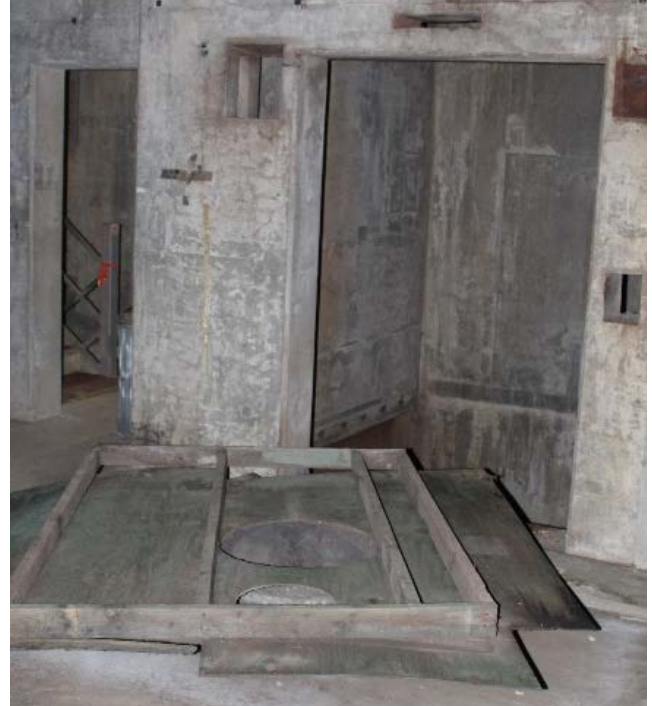
Two crew members returned to the facility where they discovered the grip at the bottom of an empty elevator shaft after having suffered an 86-foot fall.

Elevator shaft where grip fell with wooden guard on the floor that used to cover shaft opening.

- Conduct a site safety assessment (SSA) before working in any structures or environments.
- Enforce safe work practices to protect workers from hazards identified in an SSA.
- Develop policies prohibiting workers from entering structures or environments before approval to enter is granted and directions are given about what to do when hazards are encountered.
- Train workers to identify and avoid hazardous areas and follow procedures for safely responding to hazards.

In addition, FACE recommends that facility owners and managers identify the unique hazards at that location and communicate them to facility users through written references and walk around tours, whether the user has previously been on the site or not.
