Truck Driver Struck by Yard Tractor on Rainy Night

REPORT #: 71-214-2022s

FATALITY NARRATIVE

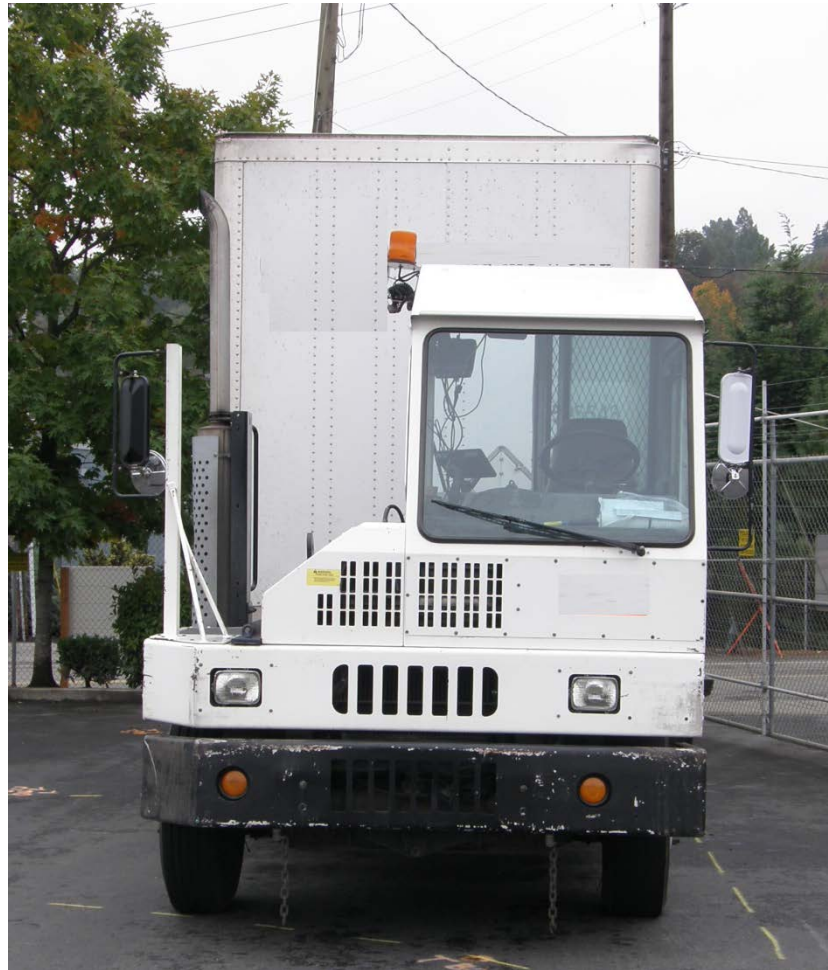
Photo 1. Front view of yard tractor that struck the truck driver who was walking in the terminal yard.

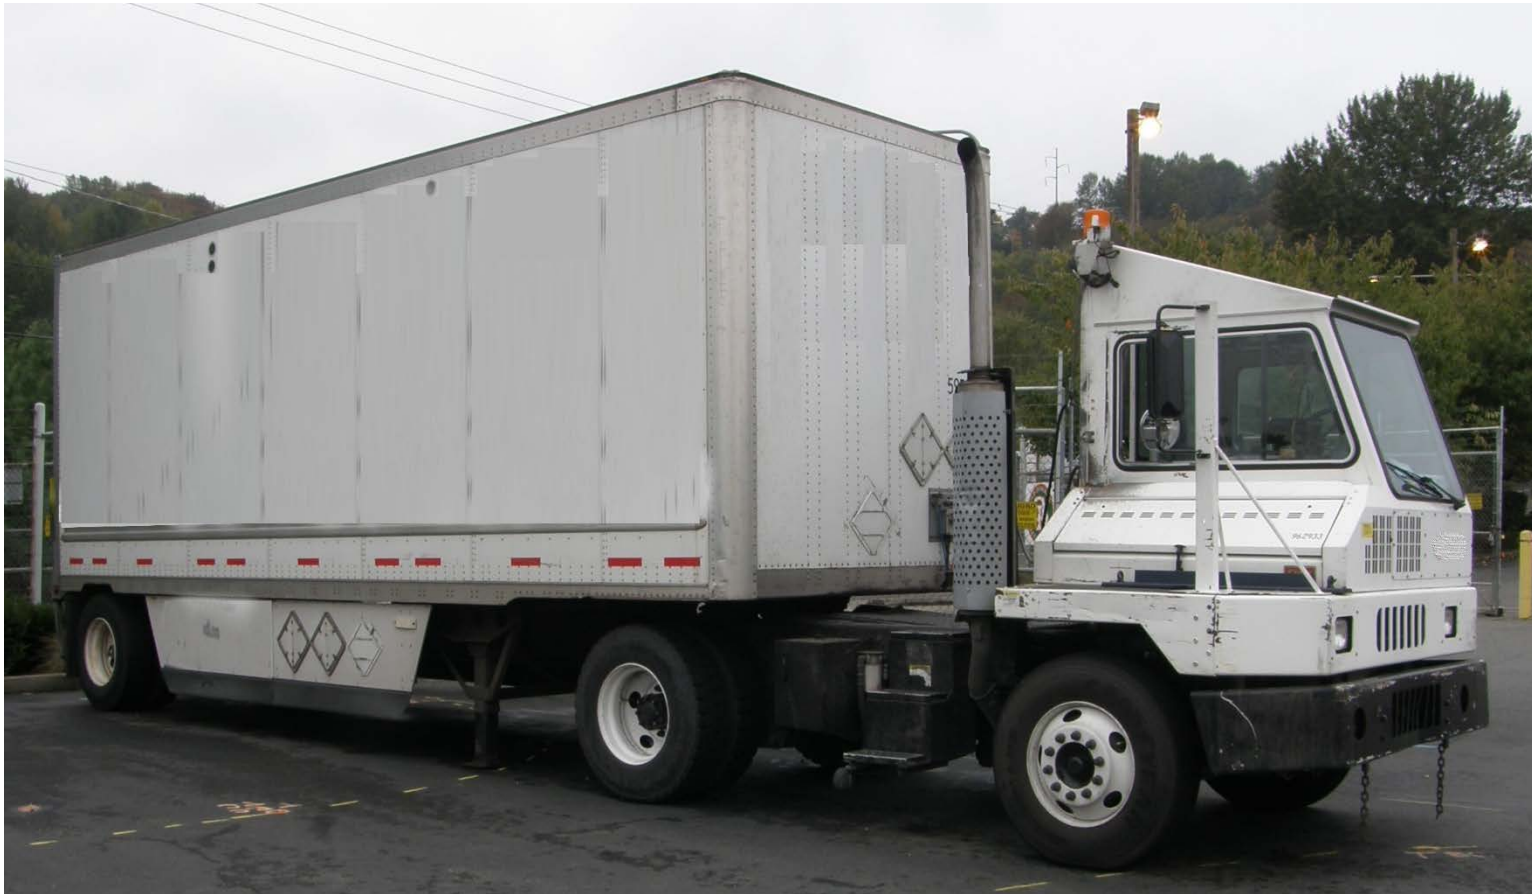
Photo 2. Side view of the yard tractor with trailer that struck the truck driver walking in the terminal yard.

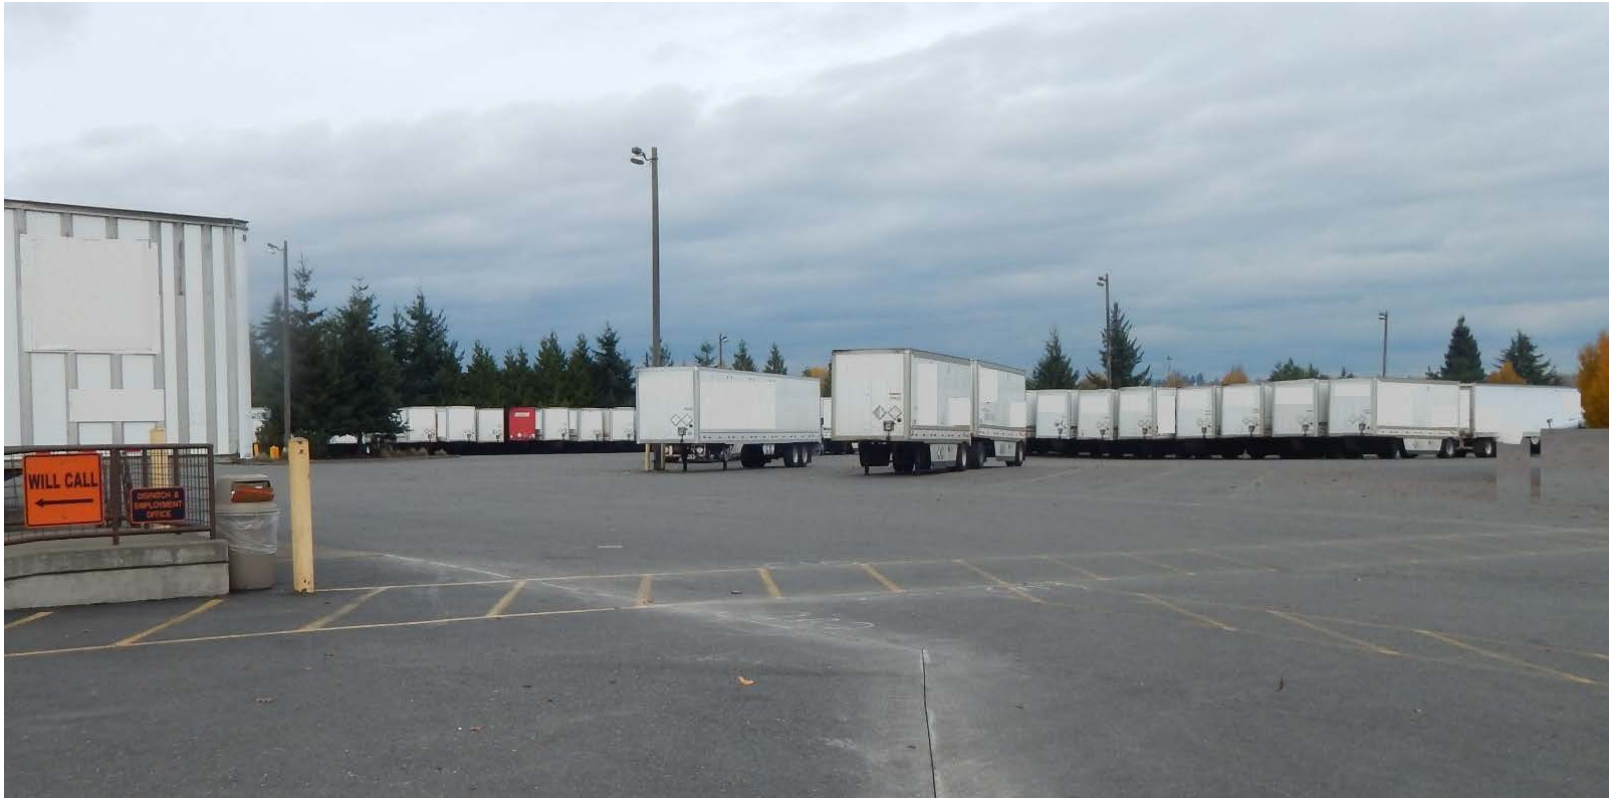
- 1) The employer did not require workers to wear high visibility reflective clothing during hours of darkness in the terminal yard. Pockets of darkness combined with the glare of light halos and reflections on wet pavement made it hard to see the truck driver walking in the yard.
- 2) The employer lacked an Accident Prevention Program (APP) with job hazard assessment policies and procedures to determine what Personal Protective Equipment (PPE) must be used to help prevent vehicle struck by incidents in dark and rainy conditions.

Photo 3. Northeast view of terminal yard area where the yard tractor struck the truck driver. The driver was walking toward the crosswalk from the trailer staging area in the background.

Ensure that all workers wear high visibility reflective clothing in trucking terminal yards.

Develop and implement a formal, written APP with pedestrian safety policies, hazard solutions, PPE requirements, and training to prevent struck by incidents in trucking terminal yards.

- Create and enforce policies that require workers to wear reflective clothing meeting ANSI “Class 2” standards, or “Class 3” for higher visibility in low light or nighttime conditions.
- Provide waterproof LED headlamps and flashlights to workers to use after dusk or before dawn.
- Install exterior lighting systems that provide uniform lighting with no dark areas and maximum visibility of pedestrians, vehicles, and structures during hours of darkness.
