Roofing Contractor Falls from a Boom-Supported Elevating Work Platform*

Case No.: 08WA05001

SHARP Report No.: 71-95-2010

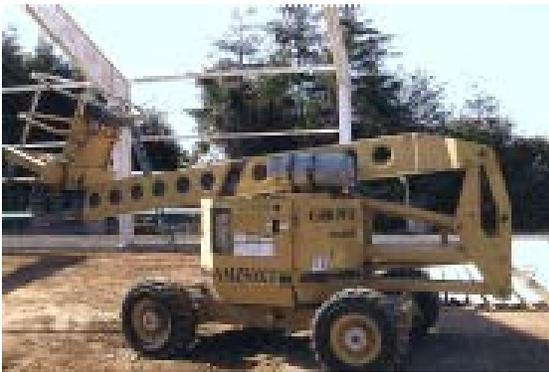
On September 27, 2008, a roofing contractor died when he fell from a boom-supported elevating work platform. The 53-year-old victim was working from a boom-supported elevating work platform to secure a roof truss while building an airplane hanger on a homeowner's property. He used the end of the boom just under the front of the platform to push against a truss girder so that he could line up the girder and bolt it. The shaft on the hydraulic boom snapped, causing the platform to flip backwards. He was ejected from the platform, fell, and hit a backhoe below before landing on the ground about 30 feet below. He was not wearing a body harness with a lanyard.

Boom-supported platform and roof truss at incident scene.

- ✓ All persons on boom-supported elevating work platforms must wear a full body harness and lanyard fixed to manufacturer provided and approved attachment points or the boom or platform if the manufacturer does not specify an attachment point. See [WAC 296-869-60040](#) and [296-869-20045](#)
- ✓ Do not position the elevating work platform against another object. See [WAC 296-869-60020](#)
- ✓ Only use the elevating work platforms for their intended purpose as specified by the manufacturer. See [WAC 296-869-60005](#)

- ✓ Use the proper equipment, tools, or methods, such as bracing or guying, designed for the purpose of adjusting material into position.
- ✓ Conduct a job hazard analysis which should account for site conditions, activities, and hazards.

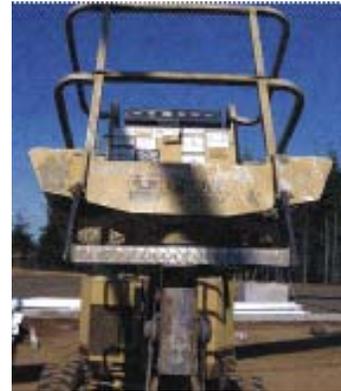
Front view of boom-supported platform.
