Fatality Narrative

Excavator Operator Killed When Excavator Rolls On Its Side*

Case No.: 07WA06101.

SHARP Report No.: 71-79-2009.

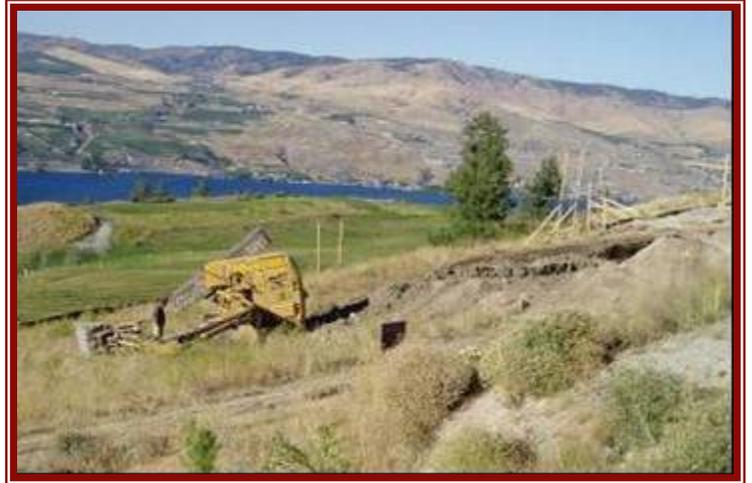
On August 17, 2007, a heavy equipment operator died when an excavator rolled on to its side. The 48-year-old victim had worked for his employer, a new single-family housing construction contractor, for five months and had about 25 years experience as a heavy equipment operator. He was operating an excavator to dig a foundation for a single-family residence at a development located on hilly terrain. As he was exiting the excavation by backing the excavator over the lip of the excavation, it rolled on to its top and then came to rest on its side. Emergency help was called but the victim was declared dead at the scene of multiple internal injuries and blunt impact to the head.

Photo of incident scene with excavator on its side outside of excavation.

- ! Employers should ensure that equipment operators are provided with appropriate training, information, and instruction on how to maneuver their equipment on difficult terrain.

- The equipment operator needs to have a clear understanding of the stability dynamics of driving their particular equipment on poor or uneven ground, hilly terrain, soft ground, potholes or driving over curbs for example.

- The operator should follow the equipment manufacturer's recommendations regarding proper equipment operation on uneven surfaces and hilly terrain.
- Using a ROPS equipped excavator or retrofitting a ROPS (Roll Over Protection System) to the excavator would help prevent fatal injuries in the event of an equipment roll over.

- Employers should explore installing active warning devices to alert operators when the machine's slope limits are approached.
