Stephen Thornton, Chief Electrical Inspector

Vol. 19 No. 5

May 2016

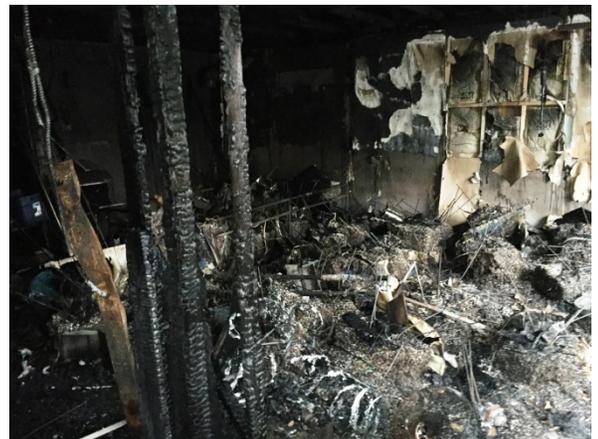
Ugly Picture: *If viewing this document online, click on the picture to open a larger image.* The renter of this property had an illegal marijuana growing operation located in a detached outbuilding. It is suspected, but not known if the unpermitted wiring contributed to the fire. The house used for drying and processing, including butane honey oil extraction, was not affected. The property owner purchased a permit and requested an inspection so power could be restored to the house. The renter will not be available for comment for many years.
