FATALITY NARRATIVE

HVAC Technician Falls Through Skylight*

SHARP Report No.: 71-124-2013

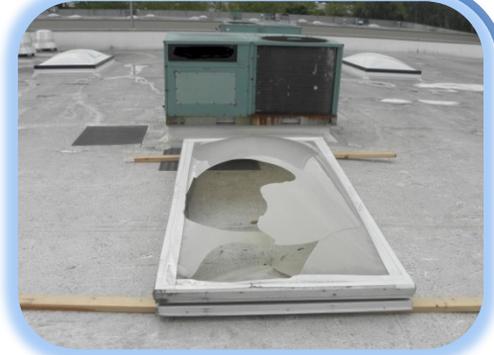
On June 15, 2012, a 44-year-old heating, ventilation, and air conditioning (HVAC) technician died when he fell through a skylight. The victim had worked for his employer, an HVAC contractor, for the previous four years. On the day of the incident, the victim and two other company employees were performing routine maintenance on rooftop HVAC units. The commercial building roof where they were working was flat and had unguarded skylights. The workers were not using fall protection. After they had been working for about four hours changing belts on HVAC units, the victim needed to go to their work van to get a belt. A coworker gave him the vehicle keys. As the victim was walking away from the coworker, he turned back towards him and began speaking to him. He then tripped on the lip of an unguarded skylight and fell through it. He landed approximately 26 feet below on a concrete floor.

- Develop and implement a written fall protection work plan including each area of the work place where the employees are assigned and where fall hazards of ten feet or more exist. See WAC 296-155-24611(2).

- When employees are working in the vicinity of skylights which have been installed and are not capable of sustaining the weight of a two hundred pound person with a safety factor of four, one of the following fall protection measures shall be implemented: See WAC 296-155-24609(4)(d)

- A standard guardrail system.
 - Cover or screen.
 - A personal fall arrest system consisting of a body harness, lanyard, connectors, and anchor points.

- A hazard assessment should be completed by employers before employees perform rooftop work, whether that work involves maintenance or construction activities.
- Architects, designers, contractors, and building owners should consider guarding skylights with screens or guardrails to protect workers who must perform work on rooftops.
