Well Driller Struck By Water Drill Pipe Sliding Off Back of Truck*

Case No.: 08WA03501.

SHARP Report No.: 71-90-2010.

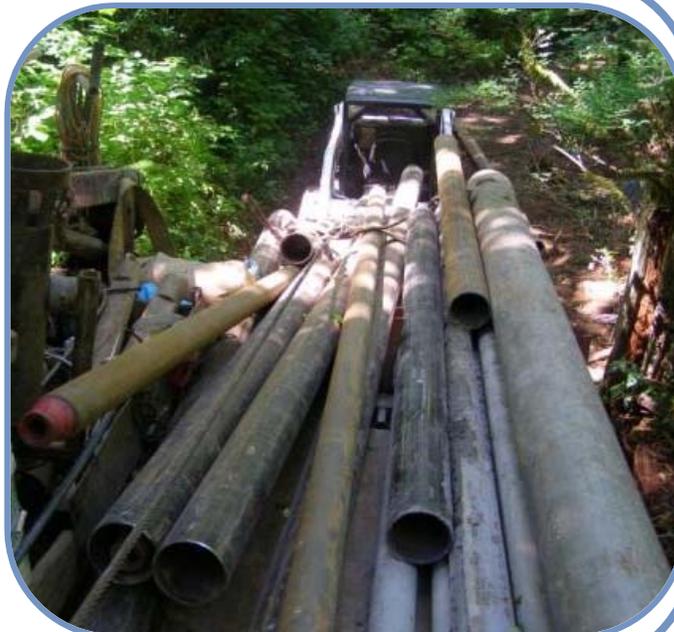
On July 8, 2008, a well driller operating a skid steer loader was struck by water drill pipes that slid off the back of a flatbed truck. The 23-year-old victim had over three years experience as a water driller and was employed by a water drilling company. The victim and another worker were bringing drilling equipment to a well drilling site. The access to the site was by an old logging road or skid road of about a 12 degree grade. The two workers cleared the access road of brush and leveled it using a skid steer track loader. They were attempting to travel up this road with the coworker driving a service flatbed truck loaded with tools, steel well drilling rods, and steel well casing pipe. The victim was following behind operating the skid steer track loader. The flatbed driver lost traction, so he backed up and tried again. As he was spinning the truck's wheels the unsecured load of rods and pipe slid backwards off the flatbed, pinning the victim in the operator's cab of the skid steer loader. The victim was taken to a hospital where he died of his injuries several days later.

- Securely tie down all flatbed truck loads of construction materials and supplies to be transported on public roadways or at job sites. See [RCW 46.61.655](#).
- Limit the height of material when transporting around the job site so that the load is stable and will not fall, slide or collapse. See [WAC 296-155-020](#).

- Maintain a safe travel distance when following a moving vehicle when either on a public roadway or job site.
- Do not modify or remove falling object protective guards that are installed to protect operators of skid steer loaders and other mobile construction equipment.
- Ensure that loads of materials transported by flatbed are securely tied down and guards or netting is used to prevent movement of objects off the rear of the vehicle.
