Fatality Narrative

Ironworker Falls While Moving Roof Decking Bundle*

Industry: Structural steel erection
Occupation: Journey-level ironworker
Task: Moving a bundle of roofing material
Type of Incident: Fall through roof opening

Release Date: May 24, 2007
Case No.: 06WA04701
SHARP Report No.: 71-58-2007

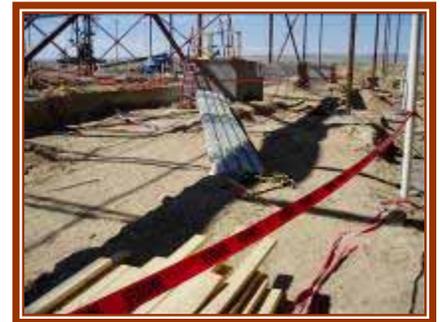
On July 25, 2006, a journey-level ironworker died after falling 30 feet while moving a bundle of roof decking. The 31-year-old victim had six years experience as an ironworker and had been employed with his current employer, a structural steel erection company, for two weeks. The job site was at a commercial building under construction. The victim was trying to reposition a bundle of metal decking to be used for sheeting the building's roof. The 1,500 lb. bundle had been hoisted by a crane and left on the roof's steel girders. The bundle of decking was intended to span 3 girders, but because of crane limitations, it was placed spanning only 2 girders with its ends cantilevered over the girders. The victim was using a come-along to move the bundle into position to span 3 girders and bear weight on each end of the bundle. The bundles were moved using a come-along attached to a beam with a cable, and a hook attached to the bundle. The victim was standing on the bundle, ratcheting the come-along, to move it into position. He was wearing a full body harness and was using the bundle as an anchor point to which he had tied-off his deceleration lanyard. The victim was standing on the cantilevered end of the bundle as it was moved, causing it to tip sending him and the bundle falling 30 feet to the ground below. Emergency responders transported the victim to the hospital where he was pronounced dead.

Photo: The bundle of roof decking on-site after the incident

- ! Employers need to develop a fall protection plan that includes the identification of hazards, fall prevention and protection methods, and the installation of protective systems.
- ! Employees must never tie-off to a bundle that is being “endo-ed” (moved end-wise) with a come-along to get the bearing weight on the end of the bundle.
- Appropriate anchorage points need to be identified and utilized.
- Lanyards need to be connected to a secured anchorage capable of safely supporting the worker.
- When placing bundled decking, ensure that the ends are supported by the structural steel.
