Fatality Narrative

Skid Steer Loader Operator Ejected and Crushed by Bucket*

Industry: New single-family housing construction.
Occupation: Equipment operator/Laborer.
Task: Moving dirt with skid steer loader.
Type of Incident: Struck by.

Release Date: November 29, 2007.
Case No.: 06WA076.
SHARP Report No.: 71-64-2007.

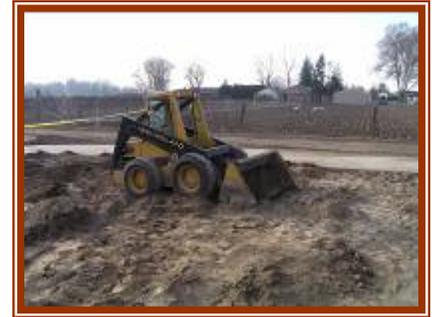
On December 1, 2006, a skid steer loader operator was ejected from the loader's seat and crushed under its bucket. The 20-year-old victim had been working for a residential construction contractor, as a laborer and skid steer loader operator for two weeks. The victim was working at a new housing development site operating the skid steer loader to move dirt and level a small area in preparation for landscaping the yard. He was observed operating the loader at a rapid speed with the bucket raised and full of dirt. A short while later a worker found the victim unresponsive under the bucket of the loader. He was taken to a hospital where he was declared deceased. An investigation determined that the victim, who was not wearing the provided seat belt, had been ejected from the seat of the skid steer loader and was crushed under the loader's bucket. The victim had not been trained in how use a skid steer loader.

Photo: The skid steer loader and site after the incident.

- ! Train workers to safely operate skid steer loaders and to recognize hazards.
- Travel with the bucket in the lowest possible position, especially when the bucket is loaded. This will help maintain skid steer loader stability and to prevent the equipment from tipping forward and rolling over.
- ! Do not operate at unsafe speeds; especially be aware when operating on uneven ground.
- ! Always use the provided seat belt or operator restraint device
- ! Never disable the operation-interlock switch for the operator restraint.
