Farm Worker Severely Injured When Struck By Wheel Rim

Type of Incident: Explosive separation of multi-piece rim wheel

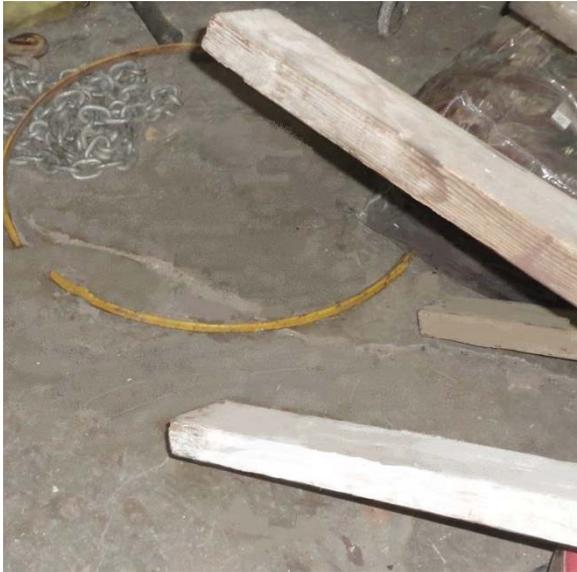
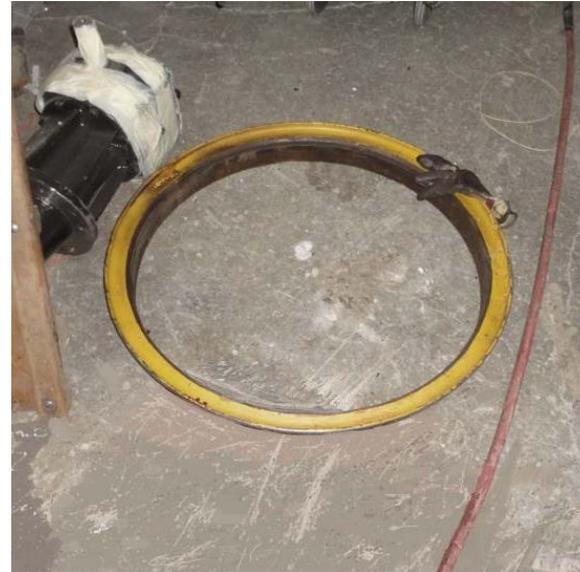
Photo 1

When he arrived back at the farm nearly four hours later, he found the severely injured worker in the shop, bleeding and disoriented. Two parts of the rim had blown away from the wheel assembly and hit the worker in his face and head. His jaw was broken in several places, many teeth were knocked out, his face was seriously cut, and he suffered a brain injury. He was not able to return to work for four months.

Two rings that explosively separated from the multi-piece rim wheel assembly and struck the worker as he was attempting to inflate a tire on a road grader.

- Implement a training program that covers the hazards involved in servicing rim wheels.

- Furnish a restraining device for inflating tires on multi-piece wheels.

Keep out of the trajectory of the wheel assembly when servicing inflated tires on multi-piece rims.

- Ensure employees know the hazards involved in servicing tires on multi-piece rim wheel assemblies, and that they never attempt tire servicing without proper training.
- Use a professional tire service to repair multi-piece rim wheels.

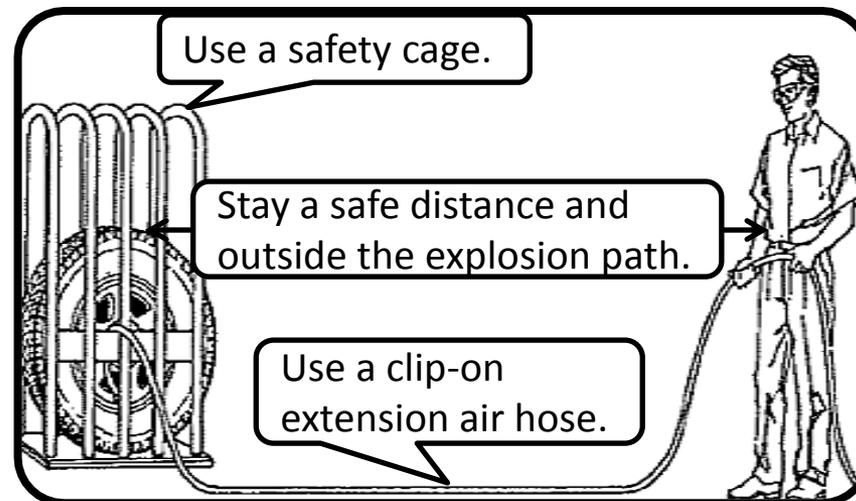
- Furnish an air-line assembly with a clip-on chuck, an in-line valve with a pressure gauge or a presettable regulator, and enough hose between the clip-on chuck and the in-line valve to allow the employee to stand outside the trajectory.
