FATALITY NARRATIVE

Tractor Operator Dies When Tractor Rolls Over On Road

Industry: Apple orchard
Task: Operating tractor on roadway
Occupation: Orchard laborer
Type of Incident: Tractor rollover

Incident Date: April 11, 2015
Release Date: October 19, 2015
SHARP Report No.: 71-141-2015
Case No.: 15WA01401

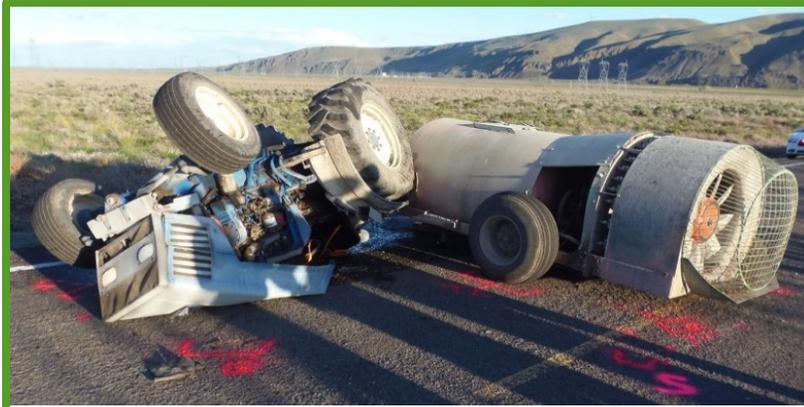
Incident scene showing the overturned tractor with an attached sprayer where it came to rest on a county road.

On April 11, 2015, a 57-year-old orchard laborer was fatally injured when the tractor he was operating rolled over. The victim was an experienced tractor operator and was a seasonal worker at his employer's apple orchard. He had spent the morning and early afternoon operating a tractor towing a sprayer to spray several blocks in an apple orchard. The orchard in which he had been working met the Washington State exemption for using a tractor's rollover protective structure (ROPS) or roll bar in the down or lowered position; this is allowed in orchards when tractor height clearances would interfere with normal operations. The tractor he was operating had been manufactured to have a foldable ROPS, but it did not have one installed, nor did it have a seat belt. In order to get to another orchard block, he had to travel a mile and a half on a

paved county road. He was traveling downhill along this road towing an empty sprayer when he drove the tractor to the right onto the road's soft, gravel shoulder. He apparently attempted to bring the tractor back onto the road, but overcorrected, causing the tractor to veer into the opposite lane and overturn. He was crushed under the tractor and declared dead at the scene. An investigation determined that speed may have been a factor. The tractor was in high gear and may have been going between 11 and 15 mph. The incident investigator confirmed that a local tractor dealership had ROPS available for the tractor model involved in the incident. If this tractor had been fitted with ROPS and the operator had been wearing a seat belt, he would have been protected from being crushed under the tractor.

- Employers must provide a rollover structure (ROPS) for each employee-operated tractor that is covered by [WAC 296-307-080](#). See [WAC 296-307-08009](#).
- Where ROPS are required by WAC 296-307-080 employers must:
 - a) Provide each tractor with a seat belt.
 - b) Require that each employee use the seat belt while the tractor is moving.
 - c) Require that each employee tighten the seat belt sufficiently to confine the employee to the ROPS protected area.
 See [WAC 296-307-08012](#).

- If your tractor does not have a ROPS, contact your local tractor dealer to have the tractor fitted with ROPS.
- Train tractor operators to use ROPS and a seat belt. The ROPS should be folded down only when necessary, otherwise it should be in the "up" position.
- Use the braking power of the tractor's engine by shifting to a lower gear when going downhill. Operating the tractor in a high gear can make it difficult to control.
- Traveling too fast while pulling a sprayer, trailer, or an implement can make it hard to maintain control of the tractor and could result in it jack-knifing or rolling over.
