FATALITY NARRATIVE

Ironworker Falls 72 Feet from Mast Scaffold

Incident Date: January 6, 2014
Release Date: July 22, 2014
SHARP Report No.: 71-132-2014
Case No.: 14WA00101

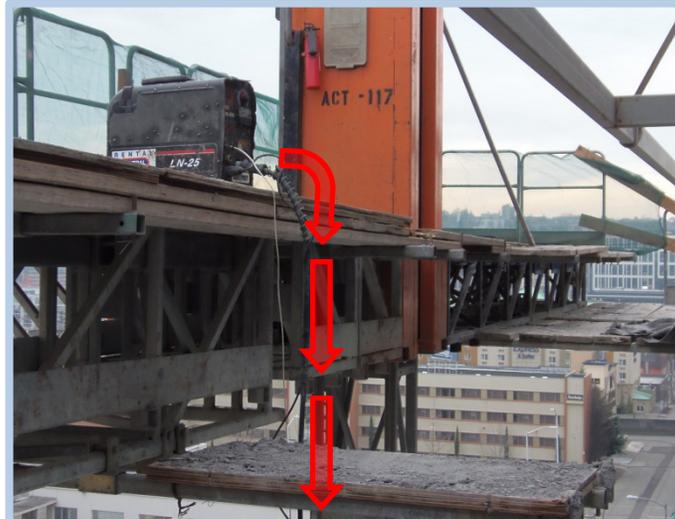
Incident scene showing the mast scaffold platform where an ironworker who had disconnected his fall protection was walking and tripped over a welding cable and fell 72 feet.

welded. Two employees observed the victim, who was not tied off, trip over a welding cable and fall into an opening between the building and the scaffold. He fell 72 feet from the scaffold to the concrete road below. Investigators determined, among other things, that the unprotected opening between the scaffold platform and the building was 55 inches; that neither vertical nor catenary lifelines were available on the section of the scaffold where the victim fell; employees were not properly trained in fall protection measures or in the operation and use of the mast scaffold; and the scaffold and its components were not inspected by a competent person.

- **Provide fall protection if a scaffold is too far from the work face.** Provide a guardrail system or have employees use a personal fall arrest system if the distance from the front edge of the scaffold platform to the work face is greater than 18 inches for plastering and lathing work and 14 inches for all other work. See WAC 296-874-20054.

- **Train employees who work on a scaffold.** Have a qualified person train each employee to: 1) recognize the hazards associated with the type of scaffold they are using, 2) understand the procedures to control or minimize the hazards. See WAC 296-874-20072.

- **Inspect scaffolds and scaffold components.** A competent person must inspect for visible defects before each work shift and after anything occurs that could affect the scaffold's structural integrity. See WAC 296-874-20034.

- **Fall protection work plan.** Develop and implement a written plan for each area of the work place where employees are assigned and where fall hazards of ten feet or more exist. See [WAC 296-155-24611\(2\)](http://WAC 296-155-24611(2)).

- Project general contractors and subcontractors should coordinate to ensure that work site safety responsibilities are clearly defined, understood, and carried out.
