Logging Injury Alert

Lowboy Operator's Fingers Amputated

Task: Coupling lowboy to trailer deck Occupation: Lowboy operator Release Date: 2019

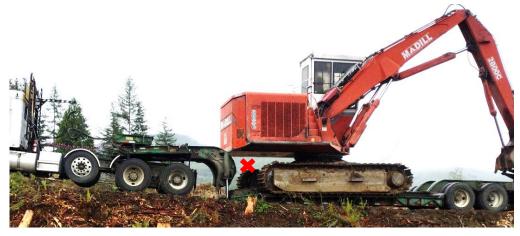
In May 2019, a lowboy operator had two fingers partially amputated after they were crushed between the trailer gooseneck and the processor counterbalance. The operator was coupling the lowboy gooseneck to a lowbed trailer deck after loading and chaining down a processor. After backing in the lowboy, he climbed under the machine counterbalance to place shims. The operator can only place shims by climbing in between the gooseneck and the trailer after the initial hookup is completed. The shims are stored on a keeper post on the rear of the gooseneck. He reached under the machine counterbalance to replace the cotter pin in the keeper post. As he was doing this, he steadied himself with his left hand on the support frame of the gooseneck. At this point, the trailer detached from the gooseneck and fell to the ground. The operator's left middle finger and ring finger were crushed between the processor counterbalance and trailer gooseneck, partially amputating them. Investigators determined that while the operator had prior experience, it had been over ten years since he had last worked with a lowboy. The employer assumed that because the operator had past experience he did not need training. Also, during coupling, the hooks of the trailer did not fully couple over the steel pins of the gooseneck. It can be difficult to determine when this happens, as there is no good way to visually inspect the connections of the components.

Incident scene showing the position of the operator (X) when the trailer detached from the gooseneck.

- Create a reference point on the trailer deck, by either painting or welding, to show when the trailer is all the way backed into the pins, ensuring proper coupling.
- Wait to position and chain down a load on the trailer until after coupling is complete. In this case, for coupling, the processor should have been positioned to the rear of the trailer deck rather than towards the front. After coupling was complete, the processor should have been repositioned forward and chained down. This sequence minimizes the overhead hazard for the lowboy operator.
- Site managers should verify that employees can safely operate new equipment and complete assigned tasks.
