INCIDENT FACTS

71-214-2022

Truck Driver Struck by Yard Tractor on Rainy Night

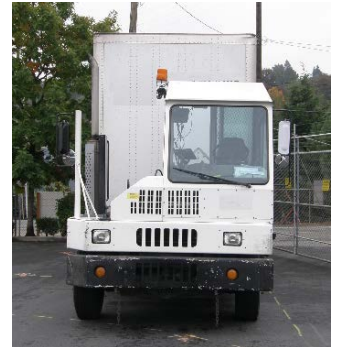
Front view of yard tractor that struck the truck driver who was walking in the terminal yard.
