Truck Driver Has Fatal Fall While Tarping Flatbed Trailer

REPORT #: 71-220-2022s

REPORT DATE: May 2, 2022

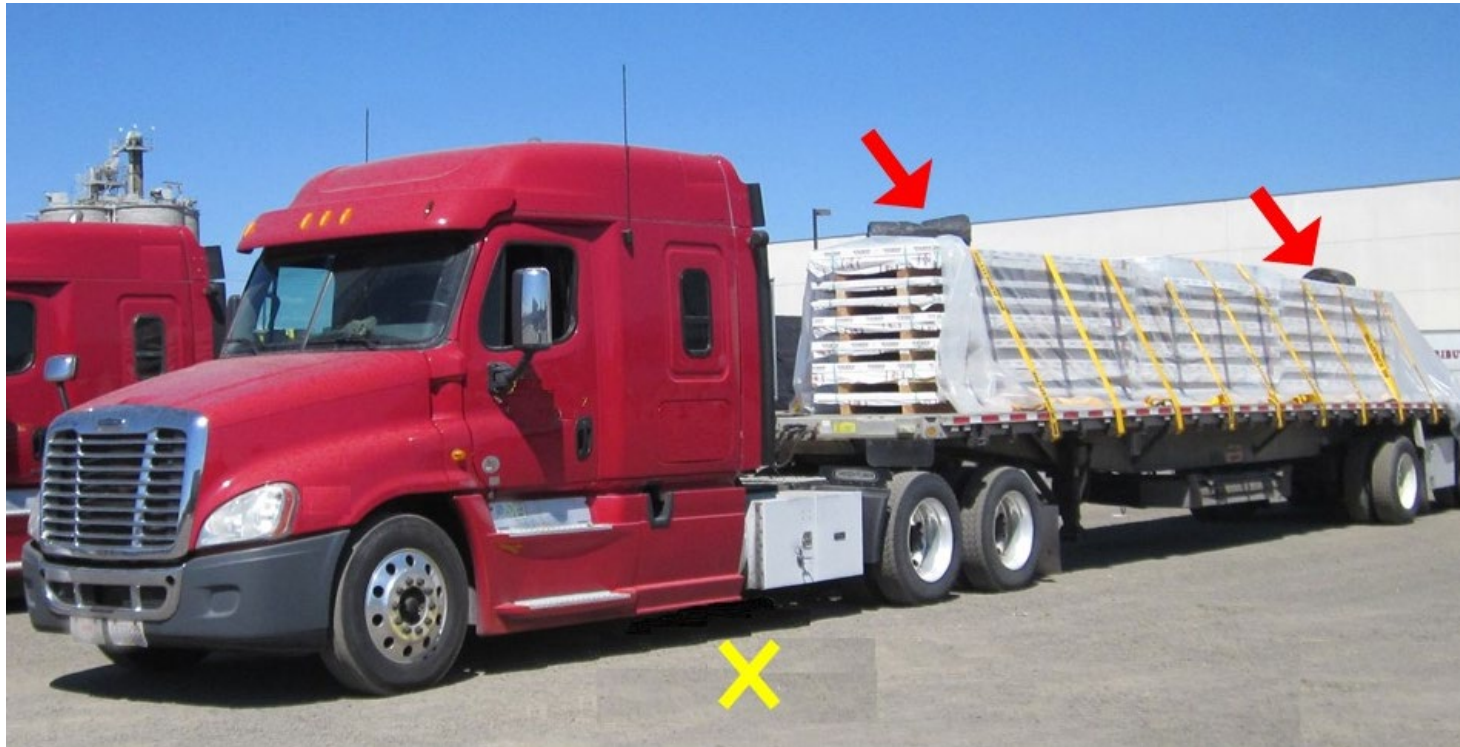
Photo 1. Front view of semi-truck with flatbed trailer at incident scene. After falling from the trailer on the passenger side, the injured driver got up, walked around the front of the tractor, climbed into the cab, and, while exiting the cab, fell again to the ground where he was found. Red arrows show locations of tarps placed on load. Yellow X shows where driver was found.

- Use fall protection, a tarping station or elevating work platform, if possible.
- Create a Job Hazard Analysis (JHA) specific for each type of trailer tarping operation. Routinely update each JHA. Include workers in JHA development.
- Regularly evaluate drivers to make sure they are following flatbed tarping safety procedures.

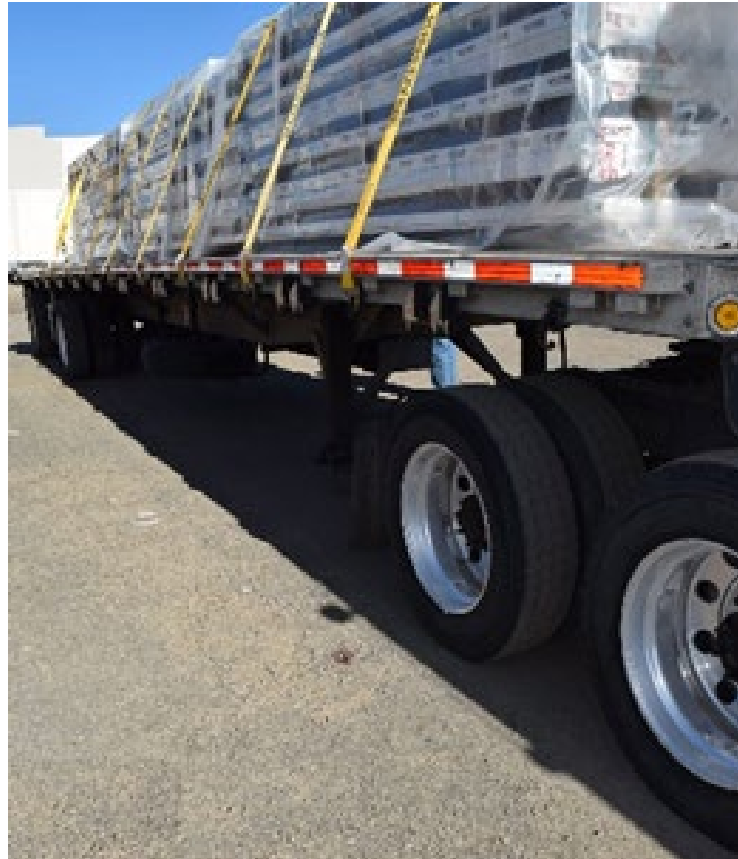
As the incident had no witnesses, investigators presumed from physical evidence that the driver had climbed on top of the trailer, placed tarps at the front and rear ends, and at some point afterward fell around 51 inches to the ground on the passenger's side. Evidence at the scene suggested that the driver got up after falling, walked around the front of the tractor, climbed into the cab, and, while exiting the cab, fell again to the ground where he was found.

Photo 2. View of flatbed trailer's passenger side where the driver fell while tarping load of sheet aluminum. The driver fell around 51 inches from the deck to the ground below.

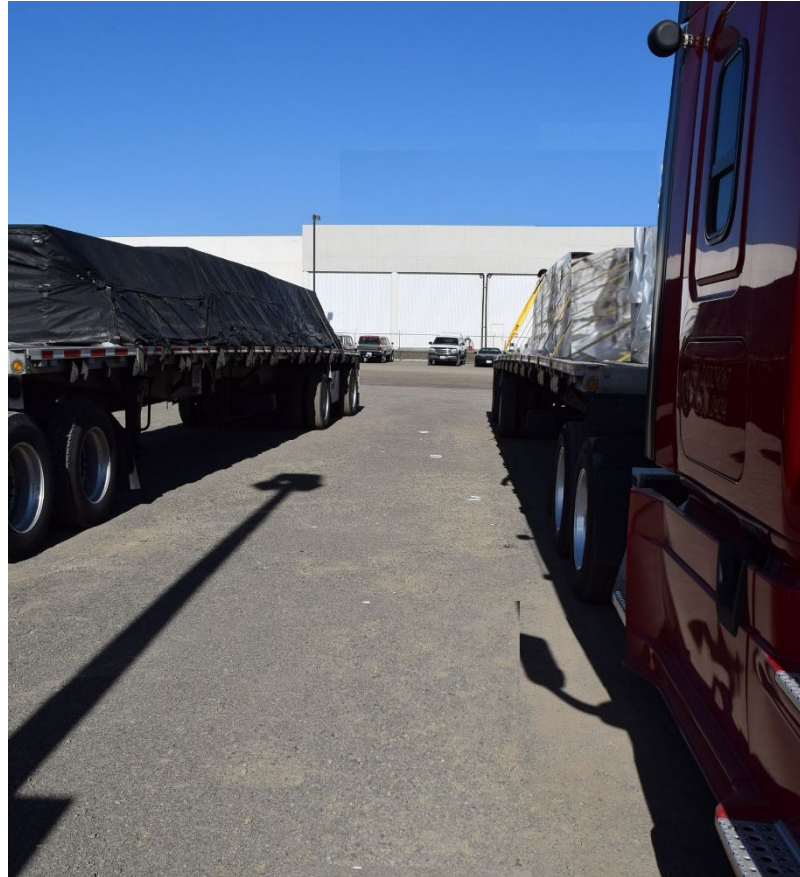
Photo 3. Another view of flatbed trailer’s passenger side where the driver fell while tarping load of sheet aluminum. Incident trailer on right. View also shows a fully tarped trailer on left.
