FATALITY NARRATIVE

Roofing Contractor Falls 35 Feet from Roof

Incident Date: Nov. 30, 2012
Release Date: March 12, 2014
SHARP Report No.: 71-129-2014
Case No.: 12WA05001

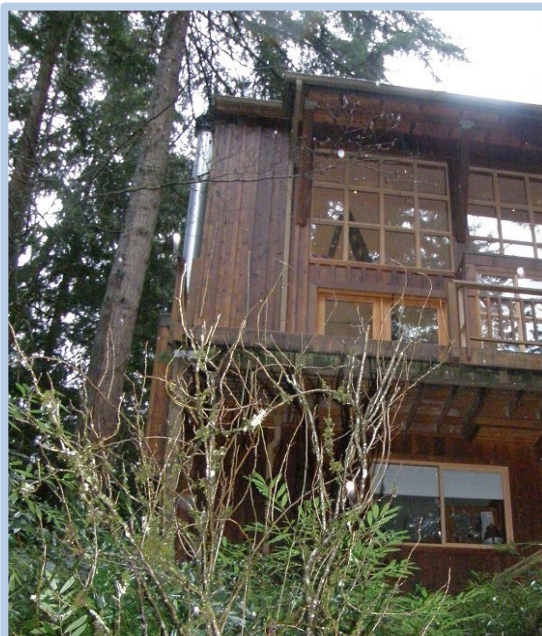
On Nov. 30, 2012, a 52-year-old roofing contractor died when he fell from a roof. The contractor was hired by a homeowner to repair a roof leak. He and an employee arrived late afternoon at the house, which was located on a hillside. It was raining lightly. The contractor accessed the cedar-shake roof by climbing up a ladder he placed in front of the house. The roof was approximately 6/12 pitch. He walked along the roof to the back of the house to inspect the section of the roof where the leak was occurring. His employee went to a deck on the back of the house where the homeowner had set up a ladder. The employee climbed up the ladder. Just as he got to the top of the ladder, the contractor, who was standing on the roof several feet above him, slipped and fell. As the contractor was falling, he grabbed the employee's extended arm. They both fell and as they did so, they hit and broke the deck railing below.

Photo of incident scene where a roofing contractor fell 35 feet from a roof and his employee fell from a ladder.

The contractor landed 35 feet below on a concrete walkway; the employee landed on the ground. The employee was taken to a hospital with serious injuries. The contractor died at the scene. He was wearing strap-on metal spike rubber pads over the soles of his boots and was not using fall protection.

- **Fall protection on steep pitched roofs.** Regardless of work activity, employers must ensure that employees exposed to fall hazards of four feet or more while working on a roof with a pitch greater than 4/12 use one of the following systems: fall restraint, fall arrest, or positioning device. See WAC 296-155-24609(7)(a).
- **Inspecting or estimating roof conditions.** While there are some exemptions from fall protection requirements, these exemptions do not apply to persons inspecting or estimating on roofs that would be considered a "hazardous slope" by definition. See WAC 296-155-24605(4)(b).
- **Hazardous slope.** A slope where normal footing cannot be maintained without the use of devices due to the pitch of the surface, weather conditions, or surface material. See WAC 296-155-24603.
- **Steep pitch roof.** A roof having a slope greater than 4/12. See WAC 296-155-24603.

- **Short-duration roof work.** All personnel who access a roof, even for a short period of time, in order to inspect, estimate, install a fall protection anchor, make repairs, or any other work activity which exposes them to a fall hazard should assess the risk of falling and take appropriate safety measures.
