Orchard Tractor Operator Dies When Run Over by Rotary Mower After Falling From Tractor

SUMMARY

SHARP Publication # 52-40-2017_summary The full version of this investigation report, along with the detailed recommendations and discussions section, can be found at: www.lni.wa.gov/Safety/Research/FACE/Files/OrchardTractorOperatorRunOver.pdf

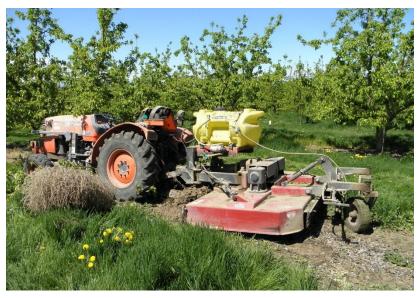
In April of 2013, an orchard worker died when he was run over by a rotary mower after he fell from the tractor it was attached to. The victim was using the tractor and mower attachment to cut the grass between rows of pear trees. The incident was not witnessed, but investigators believe that it is most probable that he fell when he attempted to dismount the tractor to retrieve his hat that may have been knocked off by a low hanging branch. He likely either failed to put the tractor in neutral when he stopped, causing the tractor to lurch forward when he removed his foot from the clutch pedal, or inadvertently moved the gear selector lever out of neutral as he stood up to dismount the tractor. In either scenario, it is assumed that the sudden or unexpected movement of the tractor caused

Tractor and mower attachment involved in incident

him to fall to the ground between the tractor and the mower. As the tractor continued to move forward, the victim's upper body was run over by the 1740 lb. mower. He was pronounced dead at the scene.

- Train operators to always shut down tractors safely before leaving the driver's seat. Ensure that they
 follow safety guidelines through frequent retraining and spot checks.
- Train operators to always mount and dismount tractors in a safe manner by using all steps and handholds available, and maintaining three points of contact.
- Keep clear of obstacles, such as low hanging branches, to the extent possible when operating a tractor with or without attachments.
- Consider using tractors equipped with operator presence sensing (OPS) technology or other interlocks that will lock out the powertrain and PTO if the operator leaves the driver's seat.
