# Dairy Worker Injured When Clothes Are Caught in Straw Spreader

**Industry: Dairy Cattle and Milk Production**

**Task: Greasing straw spreader**

Type of Incident: Caught in running machinery

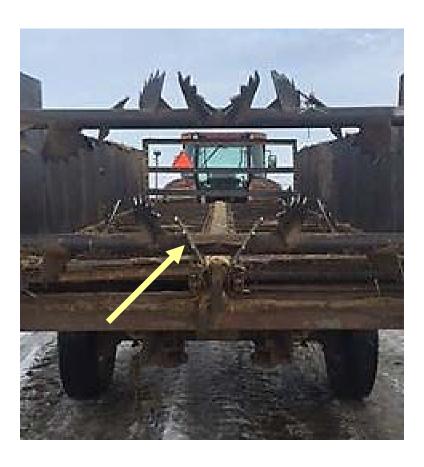
The worker told investigators that the farm mechanic had trained him to grease the straw spreader while it was running so that grease would go into the bearings. The employer's accident prevention program included information about lockout/tagout procedures, but not specifically for the straw spreader. The worker said that he had never received training in lockout/tagout procedures.

When the worker had finished greasing the bearings on one part of the spreader, he started to duck under the rotating beater bars to get to the next set of bearings underneath the machine. As he bent down, the metal teeth caught hold of his loose hooded sweatshirt and pulled his head and neck into the beaters.

The straw spreader had a mechanism to shut off automatically when jammed, but when the beater bars stopped rotating, he remained entangled in the machine and lost consciousness. Another employee found the injured worker caught in the teeth and shut off the power to the straw spreader. The coworker and a supervisor were able to cut him loose and call emergency services.

Photo of straw spreader bars. Arrow indicates where worker's clothing was entangled in rotating beater bar.

- Employers must develop, document, and use procedures to control potentially hazardous energy.
  See WAC 296-307-32013(1)
- Employers must provide training to ensure that employees understand the purpose and function of the energy control program.

- Always follow lockout/tagout procedures during machine maintenance and repair. Wait until moving parts come to a complete stop before servicing equipment.
- Employers should do spot-checks to ensure that new employees are receiving proper safety training.
- Never wear loose fitting clothing around rotating or moving machine parts.
