CONSTRUCTION FATALITY NARRATIVE

71-225-2022

Operator Crushed Between Forklift and Storage Rack

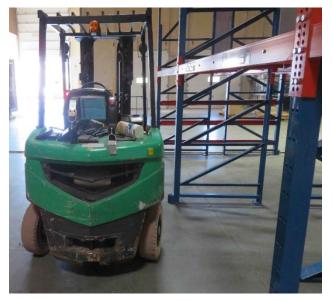
Rear side of forklift that struck and crushed the operator against one of the metal uprights.

release the parking brake. He asked for assistance, so the operator reached into the cab and released the parking brake. Once the brake released, the forklift started moving toward the metal racks. The coworker swerved to avoid the racks and the operator was crushed between the rear of the forklift and one of the metal uprights. The coworker then panicked and jumped from the forklift, which finally came to a stop when its forks ran into a wall. The operator was pronounced dead shortly after arriving at the hospital.

Employers must make sure employees successfully complete an operator training program before operating PITs. WAC 296-863-60005

- Train workers to:
 - Identify unexpected situations, not specifically addressed in the JHA.
 - Evaluate the hazards associated with unexpected situations.
 - Control the hazards safely if possible and check with a supervisor if they cannot or have questions.
- Instruct unauthorized workers never to operate PITs, even if only for a short time. Likewise, instruct authorized operators to prevent unauthorized workers from operating PITs.
