December 2023

Foreman's Leg Crushed in Power Takeoff Shaft

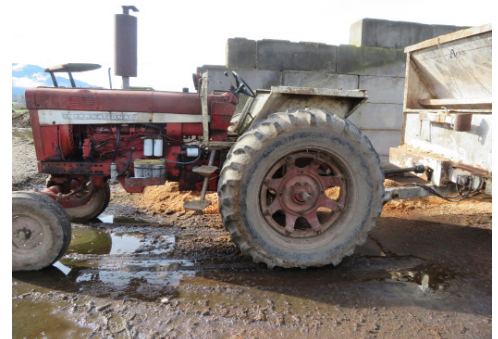
On a late winter day around noon, an experienced dairy foreman was filling barn stalls with sawdust bedding using an older model tractor with a sawdust throwing trailer attached to the tractor's power takeoff (PTO). The tractor and trailer were used two days per week, and only for this task.

Tractor and trailer involved in the incident.

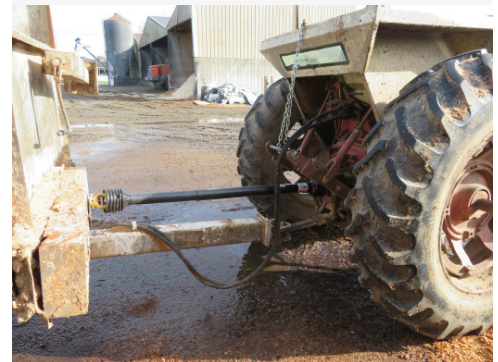
There was no guard covering the PTO driveline shaft between the tractor and trailer. The guard had broken and been removed the previous year, and had not been replaced.

The foreman stood on the front of the trailer above the rotating PTO shaft to check the belt, which he had done many times before. As he did, the PTO caught the right leg of his rain pant and his leg became entangled in the rotating shaft.

The foreman was standing on the front of the trailer above the unguarded power takeoff (PTO) shaft when the incident occurred. (Photo shows PTO shaft with guard installed)

Unguarded PTO shaft. The employer did not ensure that the power takeoff (PTO) shaft was guarded to prevent worker contact with rotating parts.

PTO was engaged during maintenance. The tractor was running and the PTO was engaged when the foreman stood on the trailer above the unguarded PTO shaft to fix the sawdust thrower's belt.

Repair or replace broken or missing machine guarding promptly. Remove equipment and machinery from service until repairs are completed. Always follow manufacturer's instructions for repair and modification.

- The employer must ensure that all power takeoff shafts, including rear, mid-mounted or side mounted shafts, are guarded by a master shield, including that:

- Power takeoff driven equipment is guarded to prevent employee contact with rotating members of the power drive system. When the tractor master shield must be removed to use specific power takeoff driven equipment, the equipment must provide protection from the part of the tractor power takeoff shaft that protrudes from the tractor. See [WAC 296-307-076\(3\)\(b\)](#)
