# Driver Run Over by Semi-Trailer at Truck Stop

**REPORT #:** 71-252-2024s

**REPORT DATE:** April 1, 2024

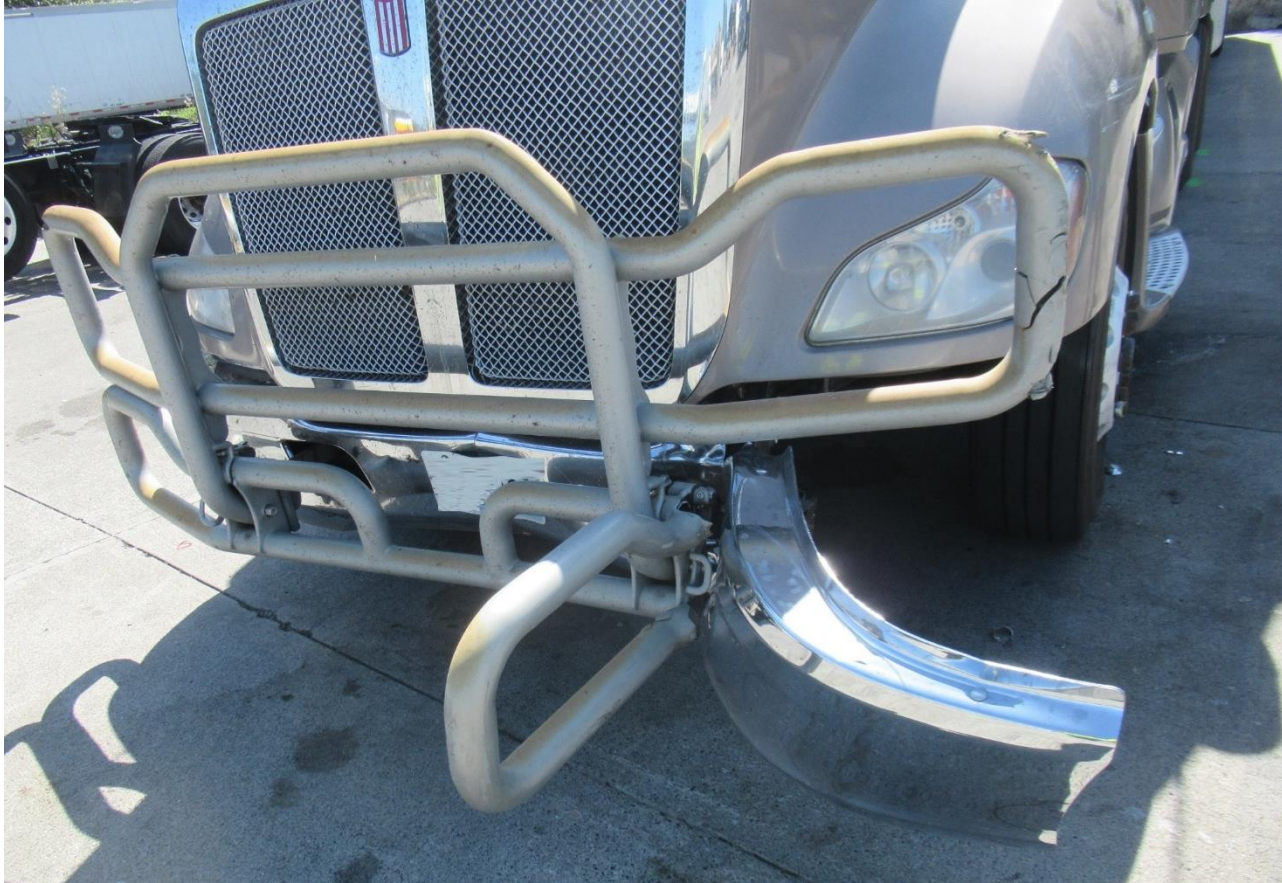
**Photo 1.** Deceased driver's truck with bumper damage caused by the trailer that ran over him.
