INCIDENT FACTS

71-257-2024

Tree Trimmer Falls 25 Feet from Bucket

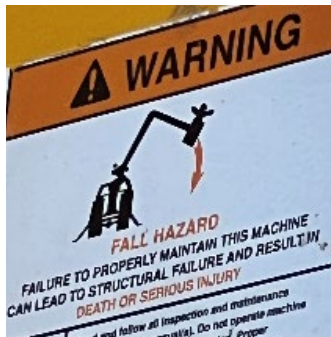
Fall hazard warning label on base of boom lift.

- Before elevating the platform (aerial bucket), ensure all persons on the platform wear a full body harness with a lanyard attached to either: (a) The manufacturer's recommended attachment point; or (b) The boom or platform if the manufacturer does not specify an attachment point. The employee must never attach a lanyard to an adjacent pole, structure, or equipment. See [WAC 296-880-30015\(2\)](#)

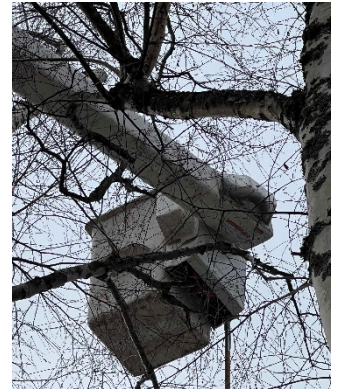
As the bucket went up, the ground crew saw the truck tilting toward the passenger side with its wheels off the ground. The bucket appeared to be caught and pressing on a branch with enough force to tilt the truck. When the bucket broke free of the branch, the truck's wheels slammed down and shook the bucket so violently it ejected the trimmer 25 feet to the ground. The ground crew ran to him, called 911, and began CPR as directed by emergency dispatchers. First responders soon arrived but pronounced him dead at the scene from severe fall injuries.

Bucket in branches.

- Develop and enforce policies and standard operating procedures (SOP) in their accident prevention program (APP) requiring:
 - A co-worker be present to observe when the bucket operator enters the bucket.
 - The bucket operator to give the co-worker visual confirmation they are wearing a personal fall arrest harness with the lanyard tied-off in the bucket before going up.
 - The co-worker to yell "all stop" or use a small air horn and press the boom's emergency stop switch when an unexpected hazardous situation needs to end quickly to prevent injury.
- Update policies to reflect changes in site conditions and fall protection equipment. Review policies with workers at crew meetings, monthly safety meetings, and annual fall prevention stand-downs.
- Provide recurring hands-on fall protection training and ensure workers maintain skill proficiency.
