REPORT #:

71-263-2025

Temp Worker Crushed By Rollaway Forklift at Family Farm

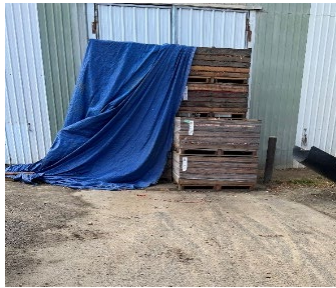
Bins where worker was crushed.

When he did not return for almost an hour, the supervisor went to look for him. He found the worker crushed between bins loaded on the forklift and bins stacked on the ground. He was unconscious and not breathing. The supervisor backed the forklift off the worker and saw it was in neutral with the parking brake not set. He then returned to the shed and alerted a coworker who called 911. First responders pronounced the worker dead at the scene.

- Make sure powered industrial truck (PIT) operators are trained. See [WAC 296-863 60005](#)
- Neutralize the controls and set the brakes when getting off the PIT. See [WAC 296-863-40020](#)

- Use PITs equipped with automatic parking brake systems that can prevent rollaways by engaging when the driver releases the service brake and leaves the vehicle while it is still idling.
- Develop and enforce PIT policies in their written accident prevention program (APP) that:
 - Allow only workers who are trained to operate PITs and require supervisors to immediately stop workers who are not trained from using them.
 - Perform a job hazard analysis (JHA) jointly with supervisors and PIT operators to identify rollaway and crush hazards, such as operating areas with any inclines.
- Establish clear safety communication with host employers to ensure temporary workers get an effective safety orientation, supervision, and training on the job hazards they will be exposed to.

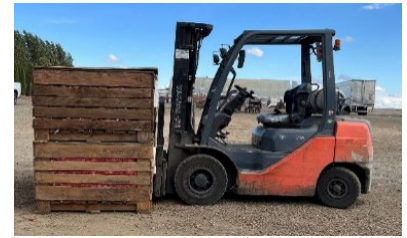
- The worker had been operating the forklift his entire time at the farm without training. The contractor only gave him an overview of forklift safety in an orientation before he began his job.
- The worker picked and lowered two bins, reversed, stopped, and left the forklift on a one-percent grade without setting the parking brake. The forklift then rolled forward into him as he stepped between the bins to adjust a tarp. The area was dark and the only light was from his forklift.
- The contractor and host employer became aware the worker was using the forklift without training after his first week at the farm. They did not effectively communicate with each other and with the crew supervisor and contractor's safety manager to prevent the worker from using the forklift.

Forklift with onion bins retrieved by worker.
